# Harold Hess Lustron House

Closter, New Jersey

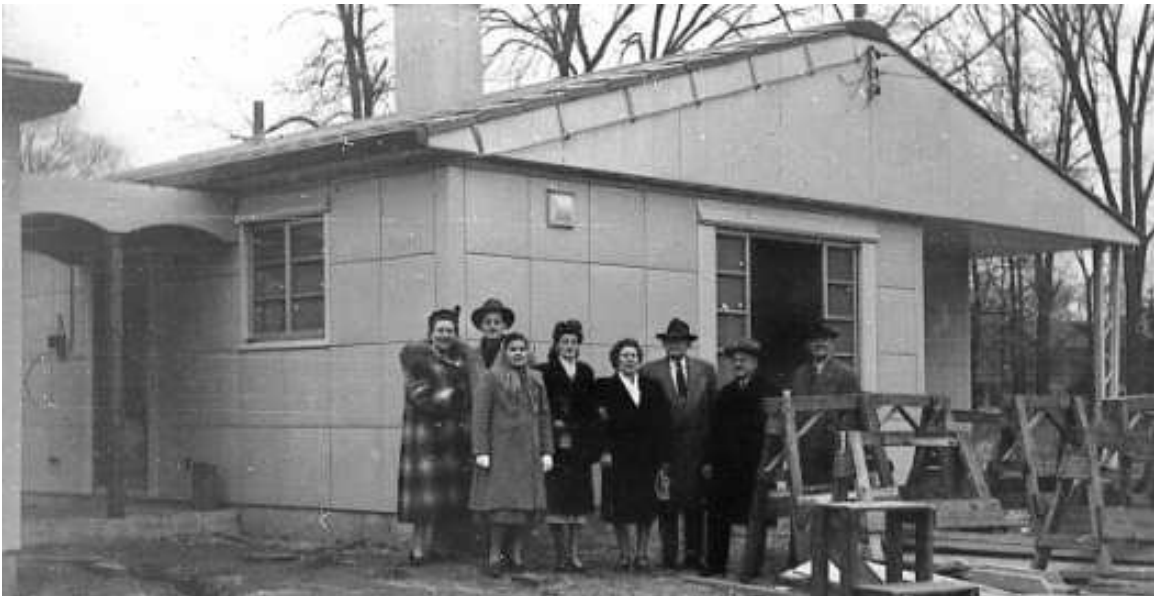
*Fig. 1 – This image of the Harold Hess family taken in 1950 in front of their new home is included in the Borough of Closter’s Historic Preservation Commission’s website at [http://closterhistory.com/documents/history\\_closter\\_10-14.pdf](http://closterhistory.com/documents/history_closter_10-14.pdf). Note that the breezeway was not yet enclosed.*

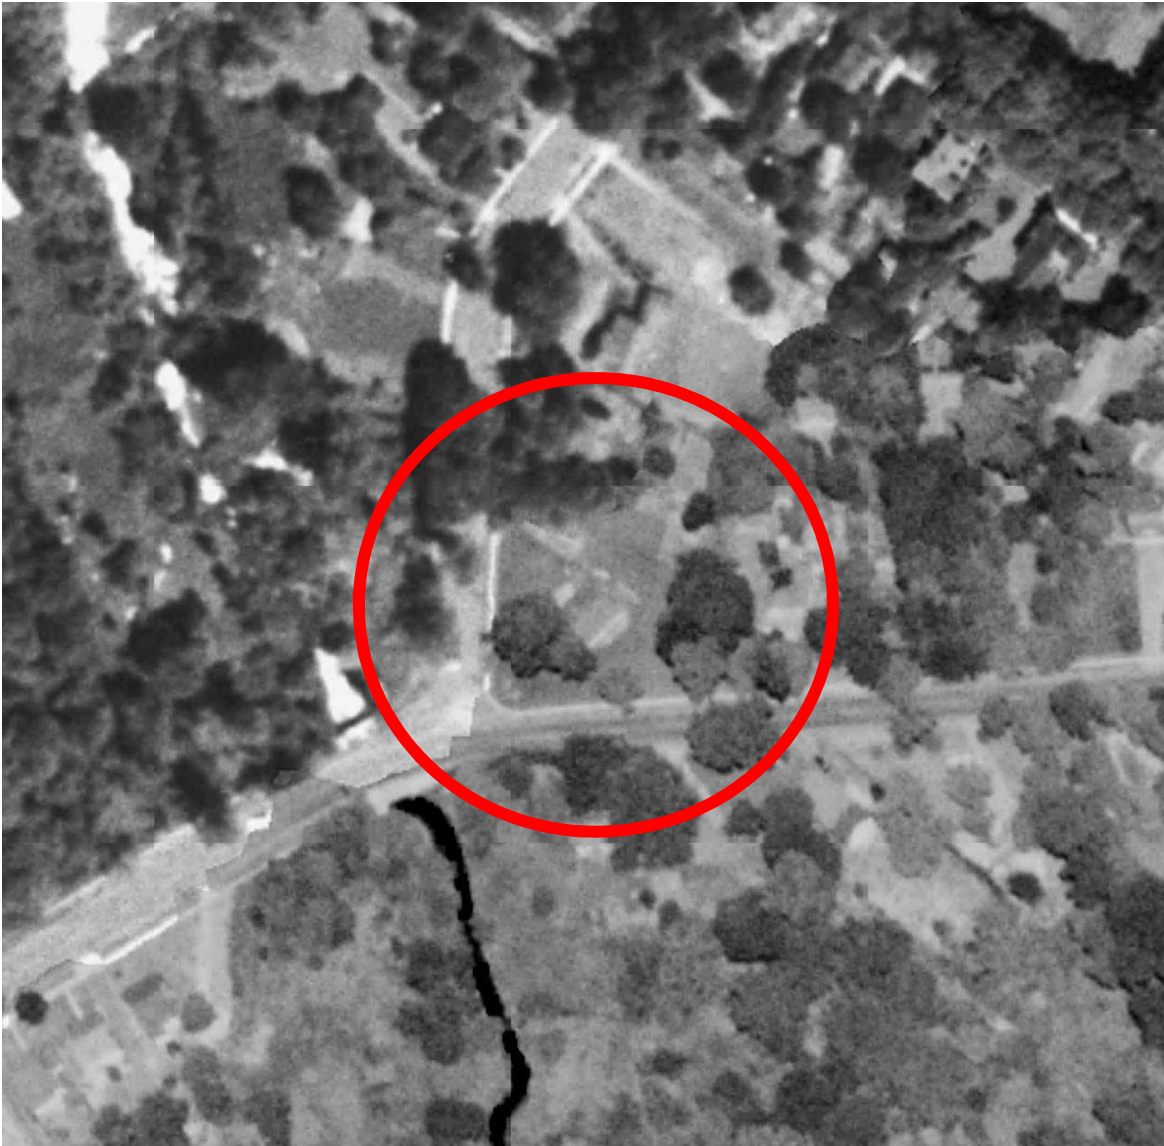
*Fig. 5 – 1953 aerial view of 421 Durie Avenue, Closter, New Jersey. Note that there were some large trees on the property shortly after the construction of the house. Most of the surrounding area appears to be lawn area. It is impossible to determine whether there were planting beds based on this image. Image from [Historicaerials.com](http://Historicaerials.com).*

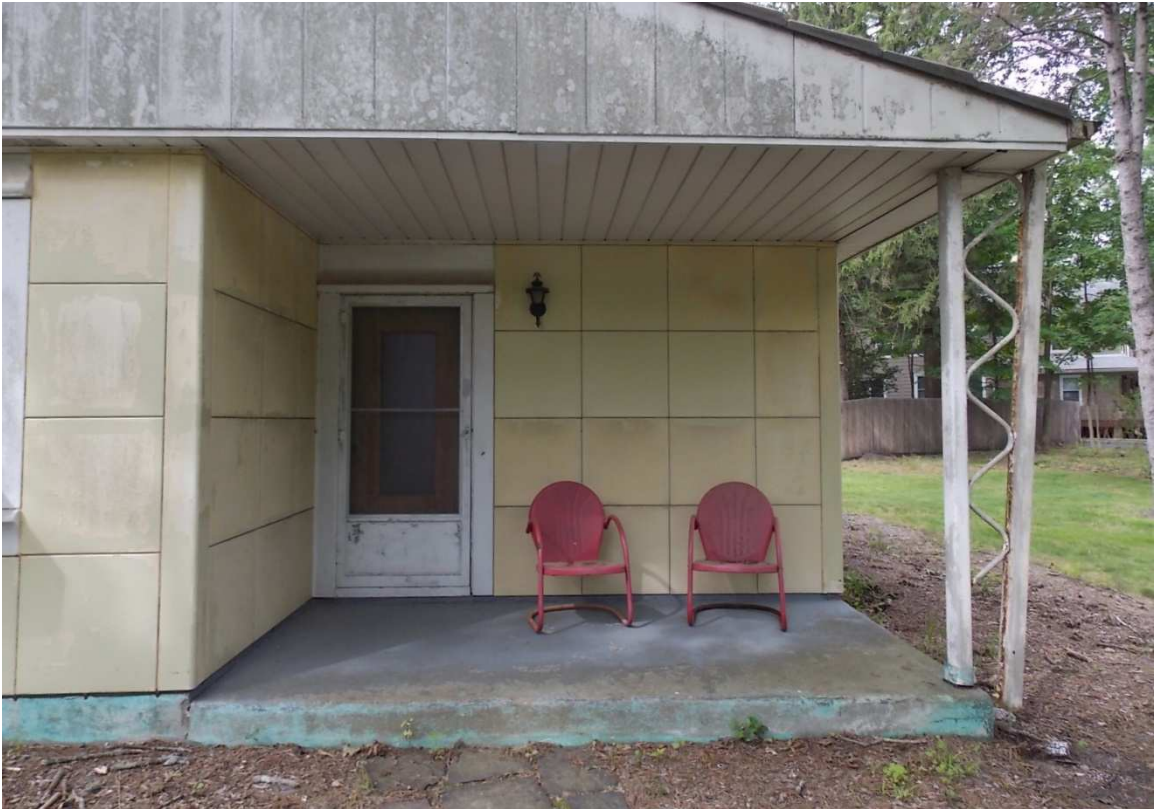
*Fig. 7 – The flagstone walkway to the front porch should be re-graded to create a handicapped accessible path from the driveway to the front door. The remaining foundation area should be left exposed, photo taken June 2017 looking east.*

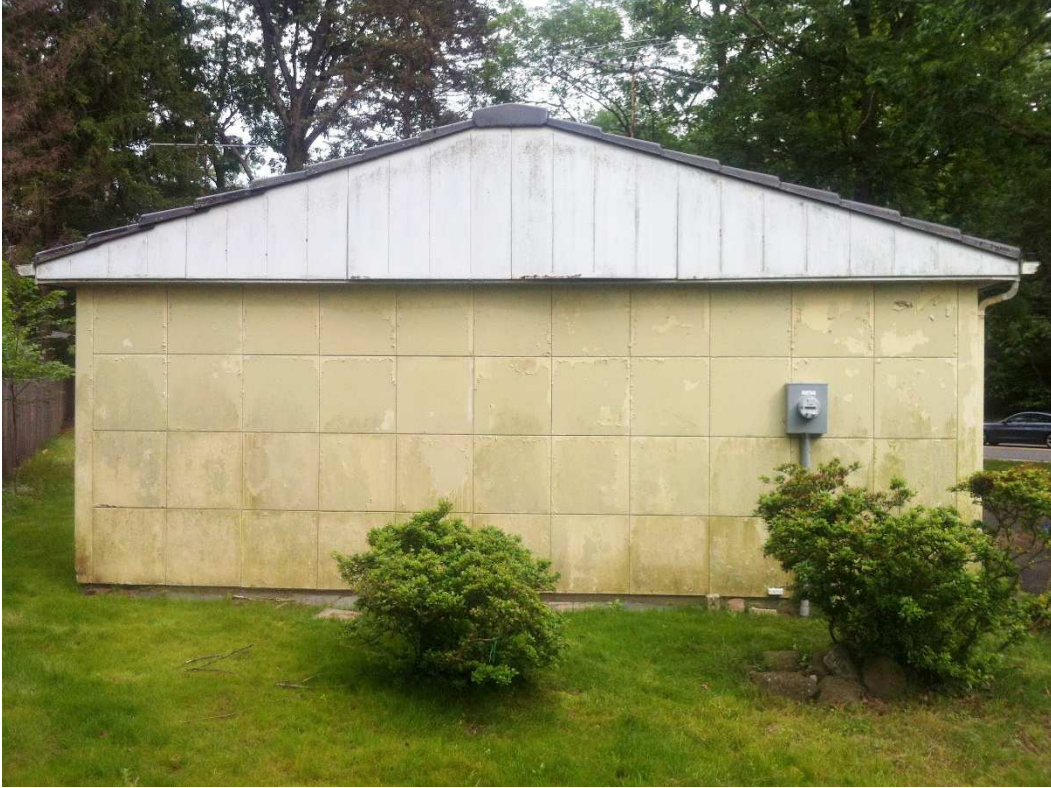
*Fig. 8 – Plantings along the west side the garage appear to be haphazard and poor specimens, photo taken June 2017.*

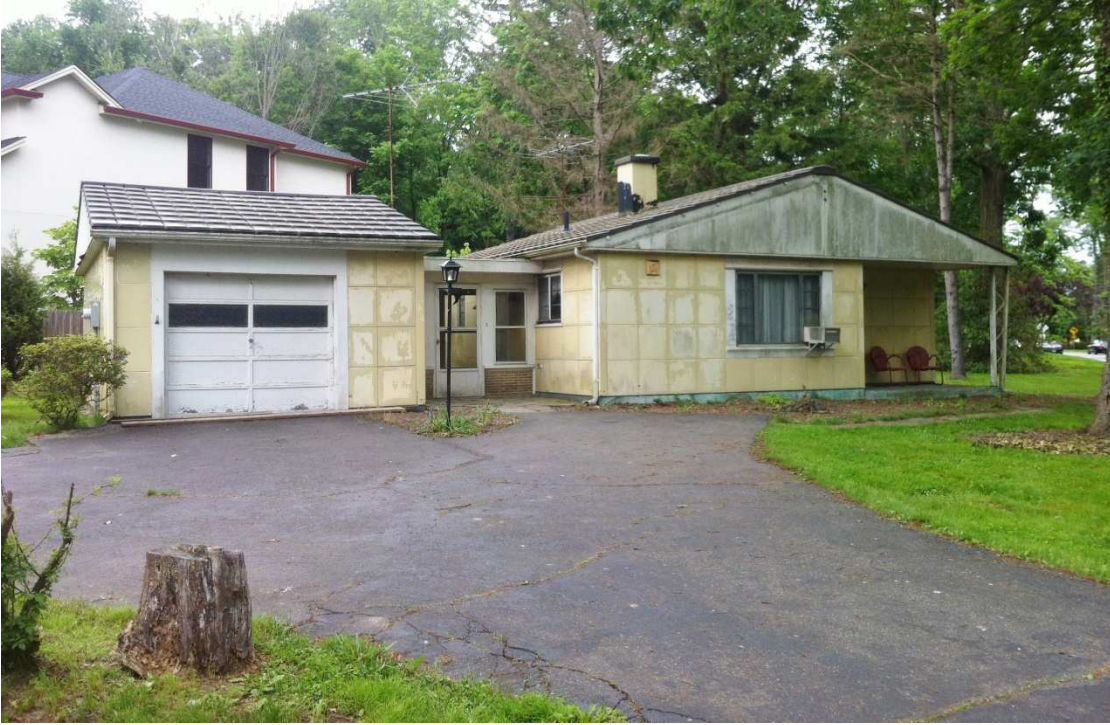
*Fig. 10 – The asphalt driveway requires repair and sealing. The stump adjacent to the driveway should be removed and a new tree planted in its place. Photo taken looking east, June 2017.*

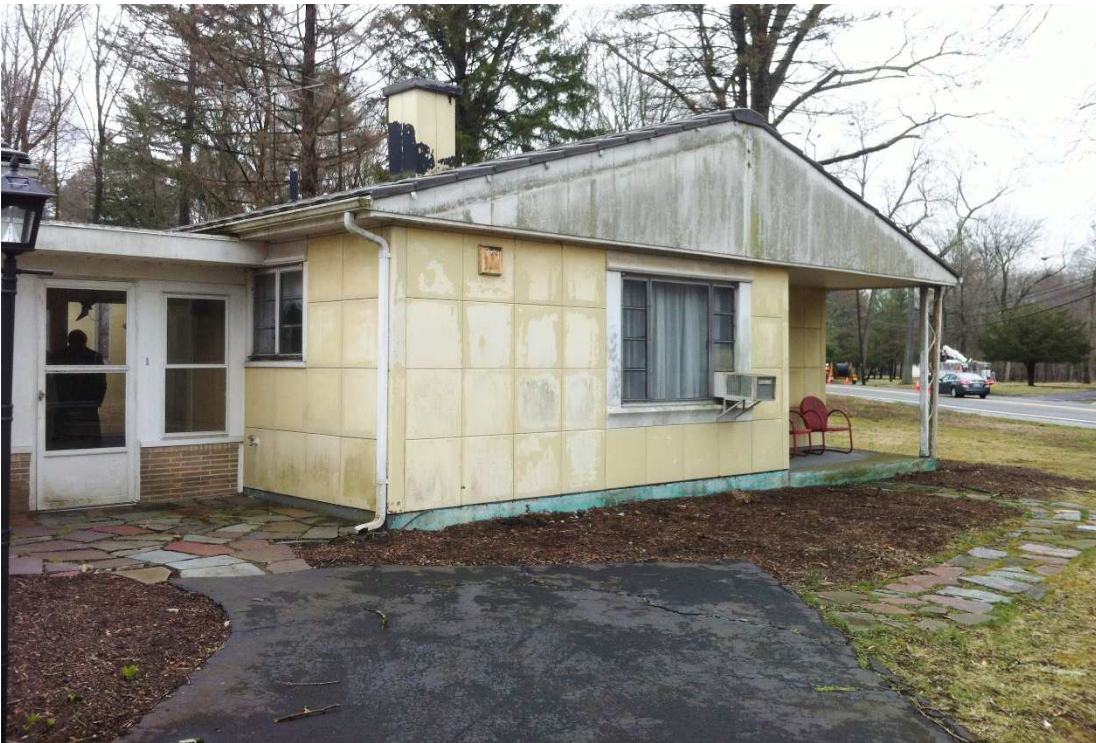
*Fig. 11 – The flagstone paving in front of the breezeway should be re-laid, photo taken looking southeast March 2017.*

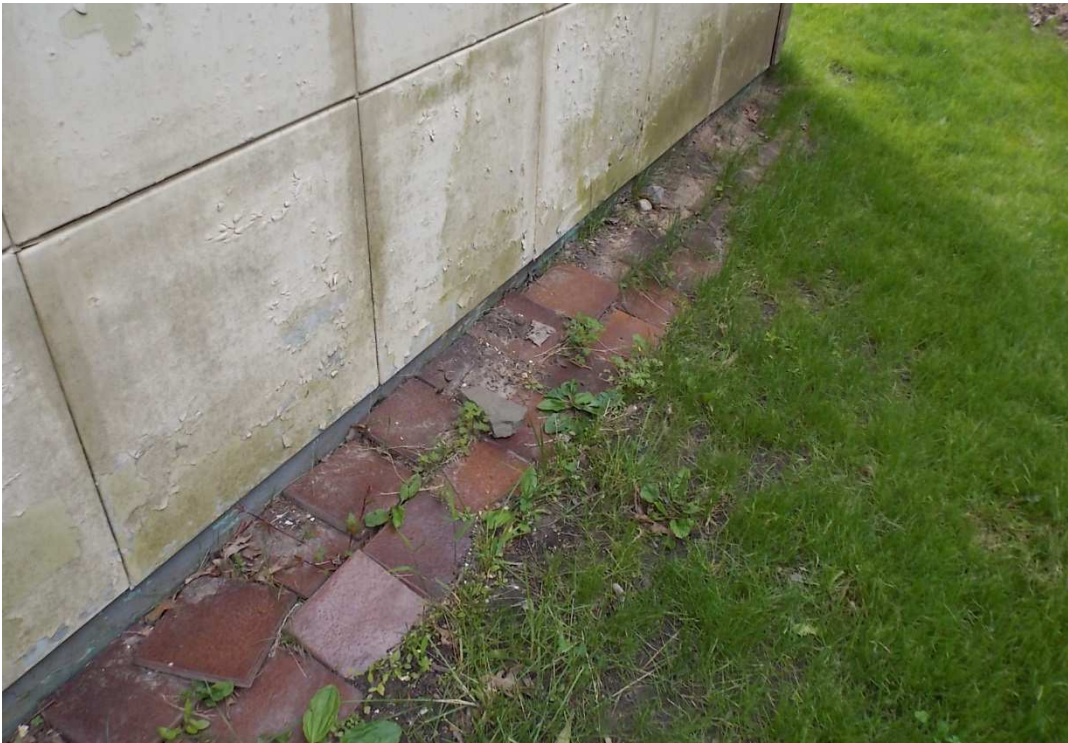
*Fig. 13 – The vitreous clay tiles along the garage foundation should be reset, photo taken looking west, June 2017.*

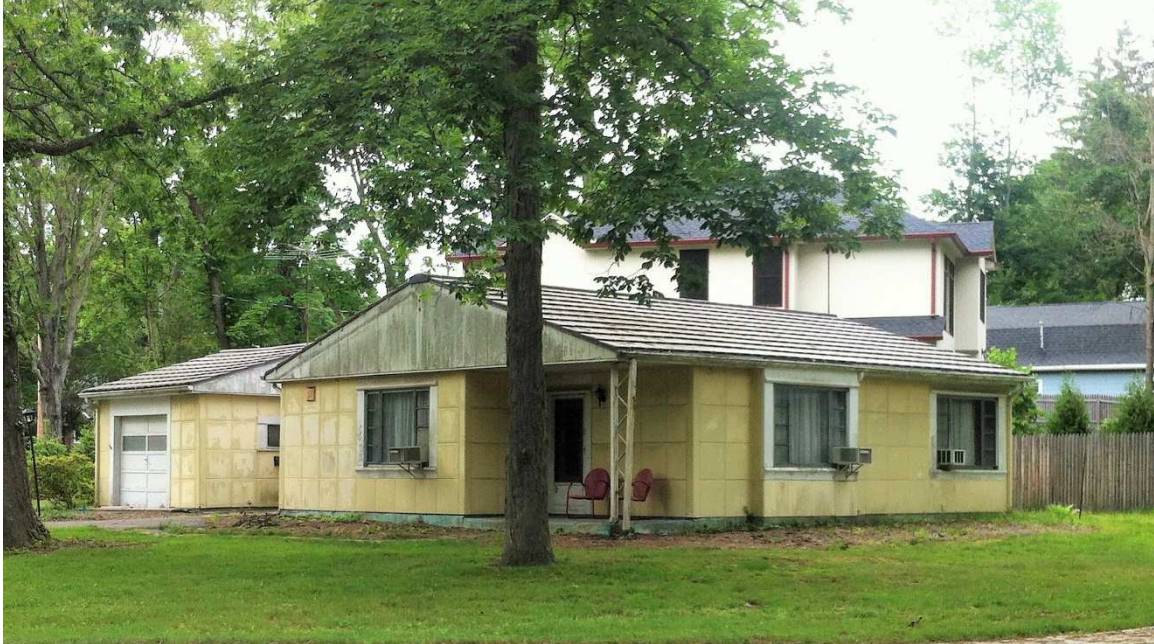
*Fig. 14 – View of left and front side of the house looking north across Durie Avenue, photo taken June 2017.*

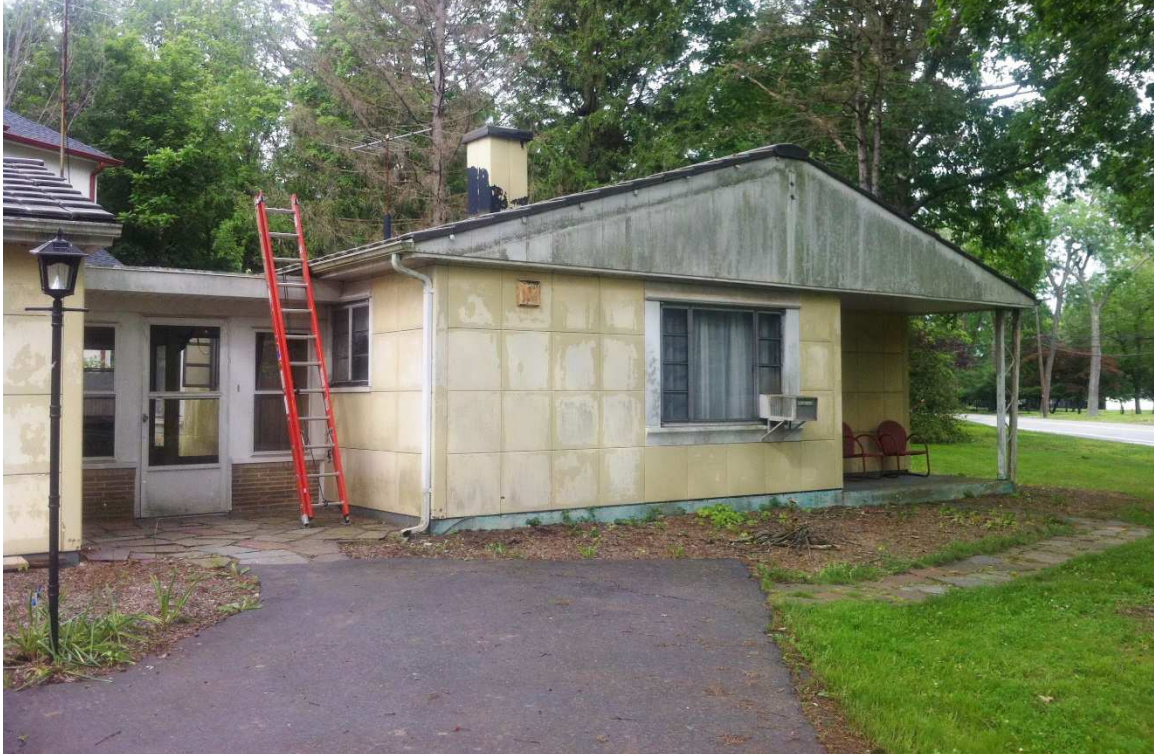
*Fig. 18 – View of breezeway entrance and left façade (as noted on the Lustron drawings) of house looking east, photo taken June 2017.*

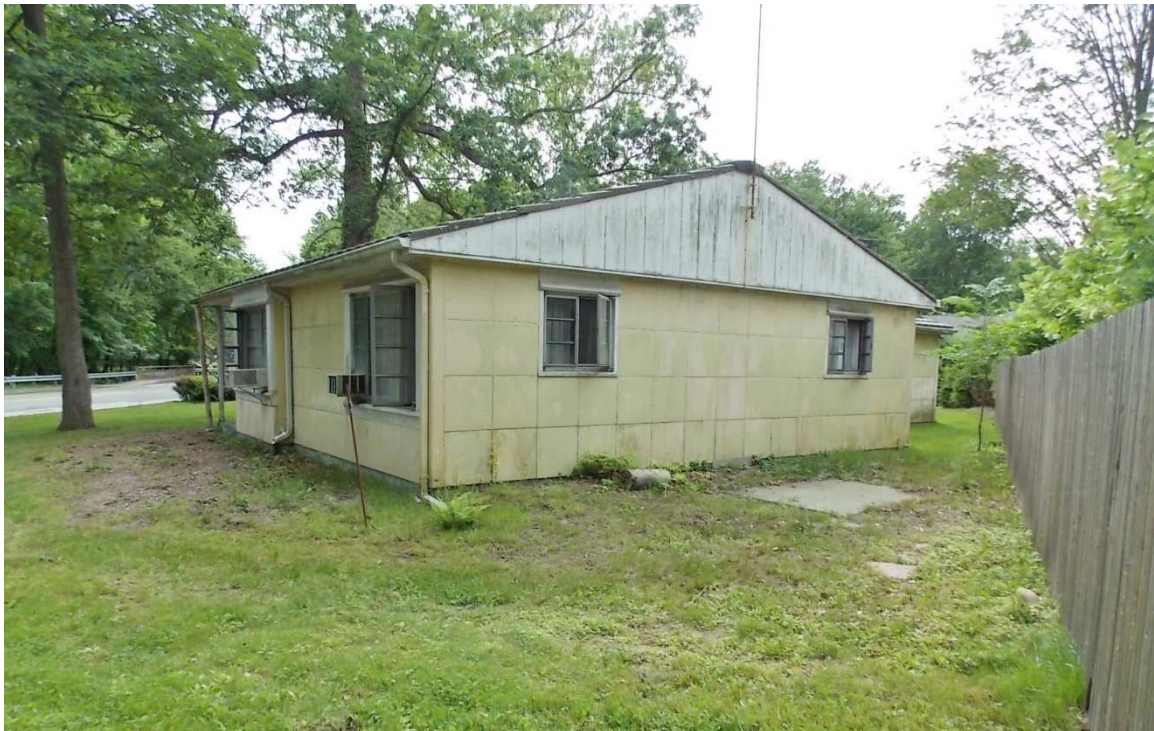
*Fig. 19 – View of front and right facades (as noted on the Lustron drawings) looking west, photo taken June 2017.*

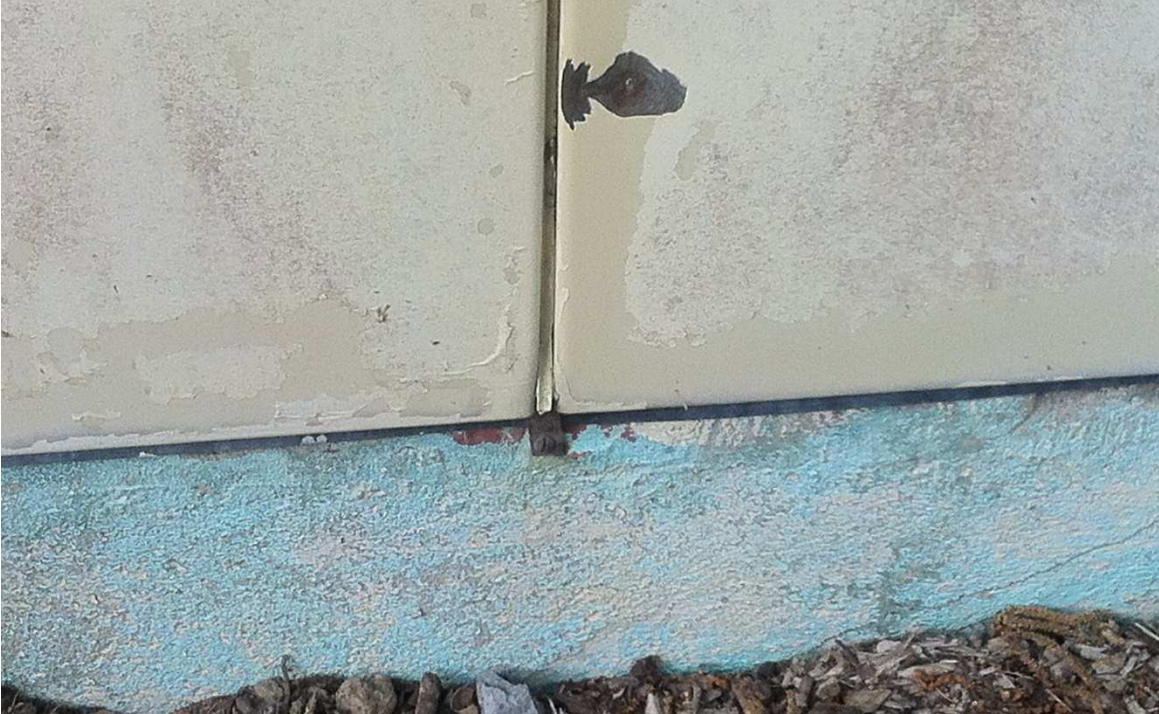
*Fig. 20 – View looking west of exposed concrete foundation wall which was previously painted a turquoise color, photo taken June 2017.*

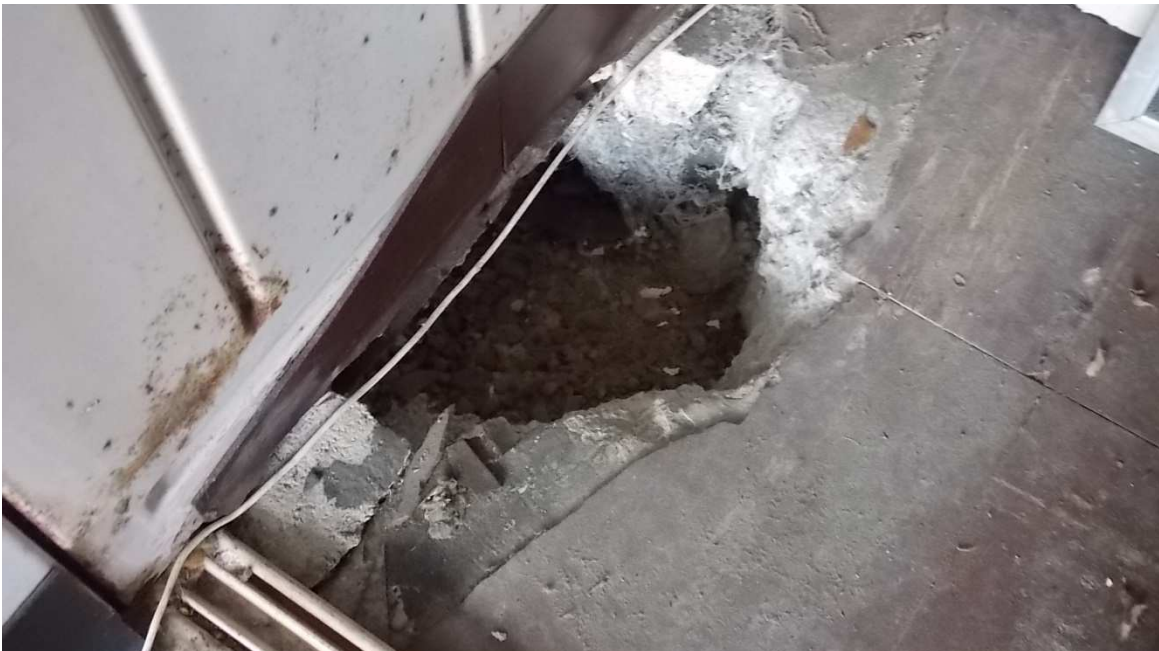
*Fig. 21 – Section of concrete slab-on-grade looking north, which was removed in the Bedroom 2 closet, photo taken June 2017.*

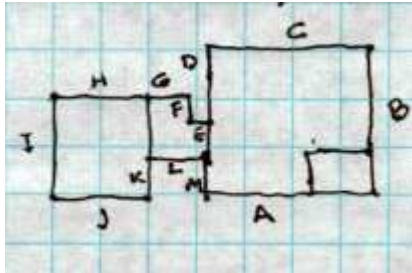
### Kitchen / dining room Façade “A”

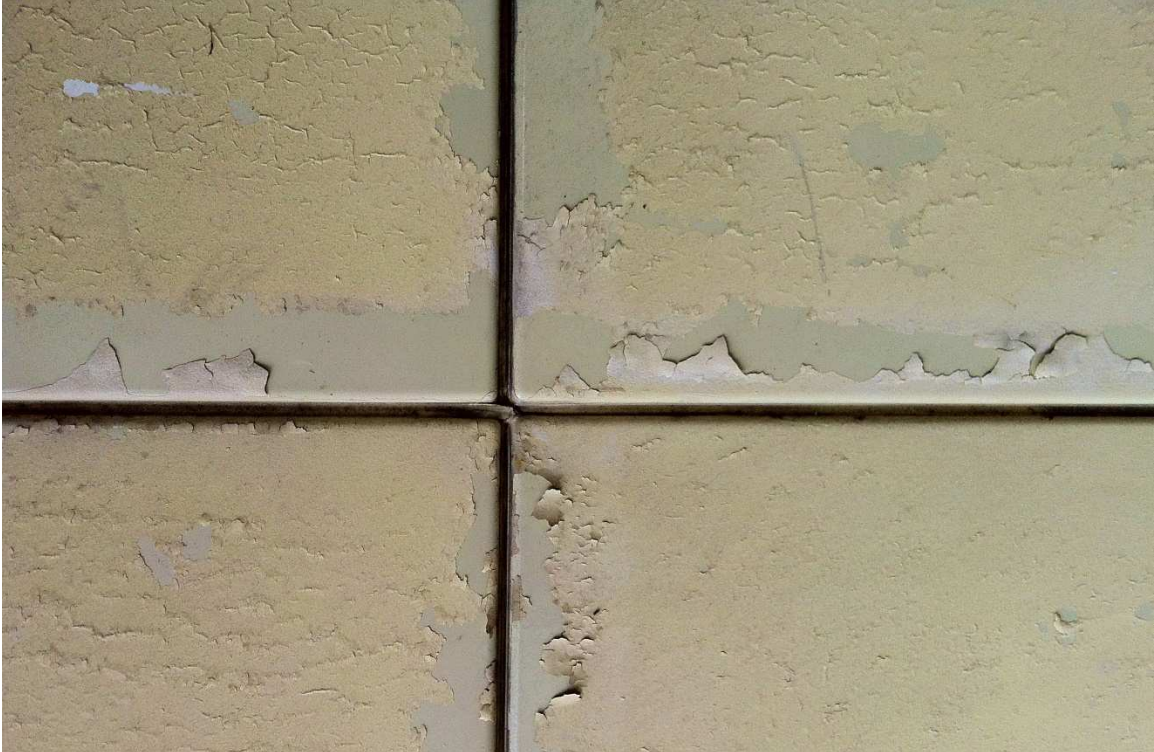
*Fig. 22 – The latex paint which was applied to the exterior wall panels is peeling and should be removed, photo taken June 2017.*

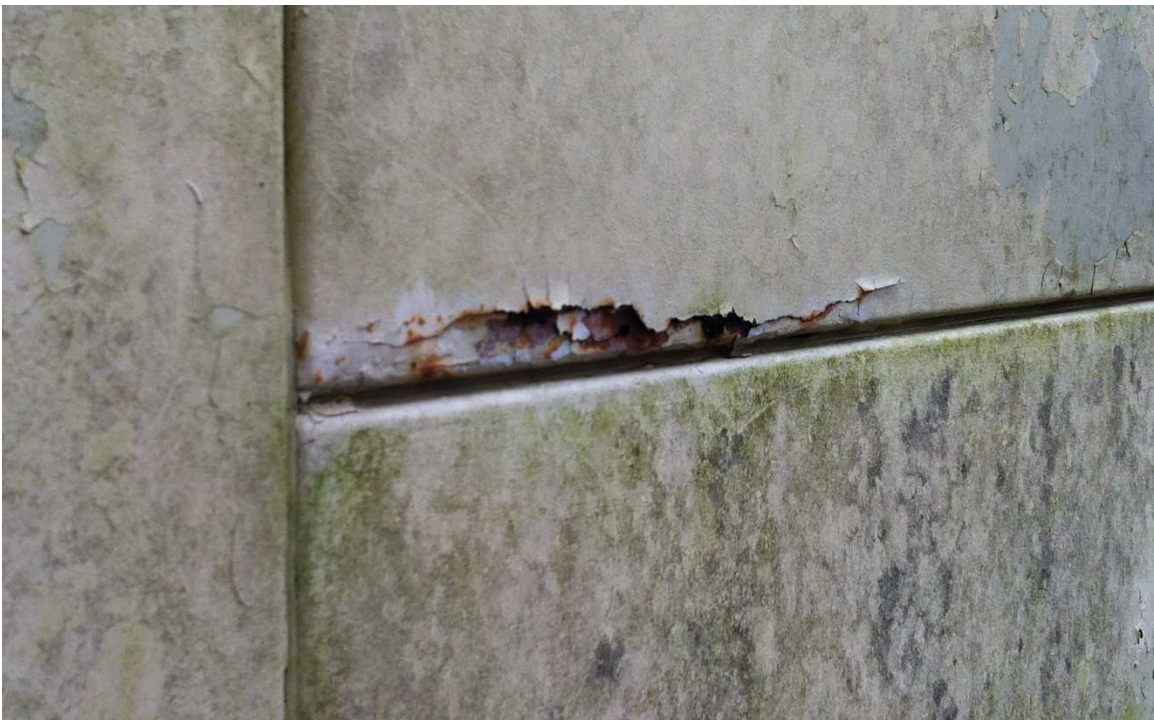
*Fig. 23 – Dirt clings to the latex paint allowing algae and mildew to form. This north east corner panel has rusted through and will need to be repaired, photo taken June 2017.*

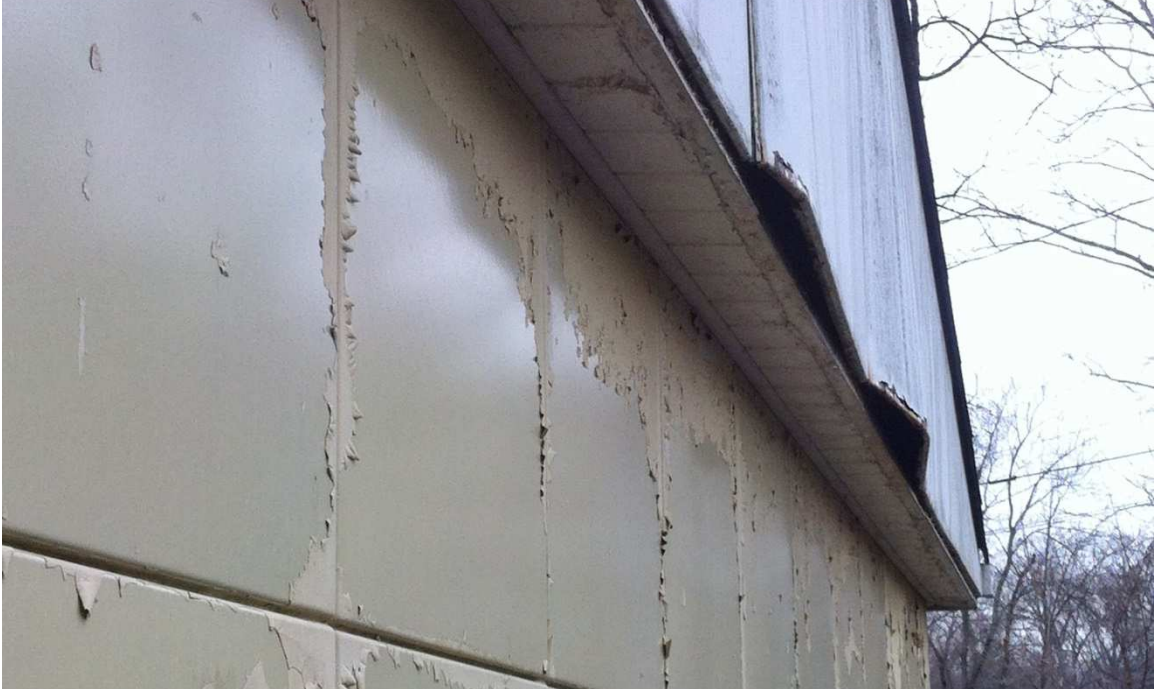
*Fig. 24 – The fascia panels at the west side of the garage gable have been damaged and will need to be removed, straightened, and re-installed. Similar to the “Maize Yellow” panels, the white trim panels were also painted. The white latex paint should likewise be removed and the original finish restored, photo taken March 2017.*

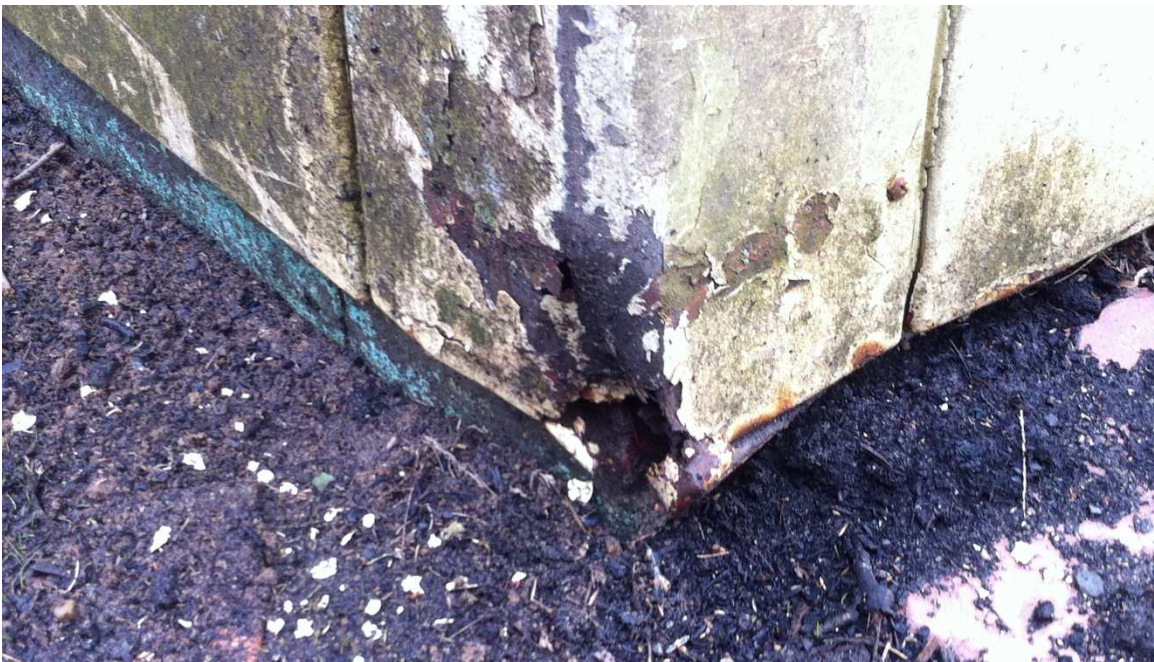
*Fig. 25 –The corner panel at the rear left of the northwest corner of the garage has been damaged and will require repair, photo taken March 2017.*

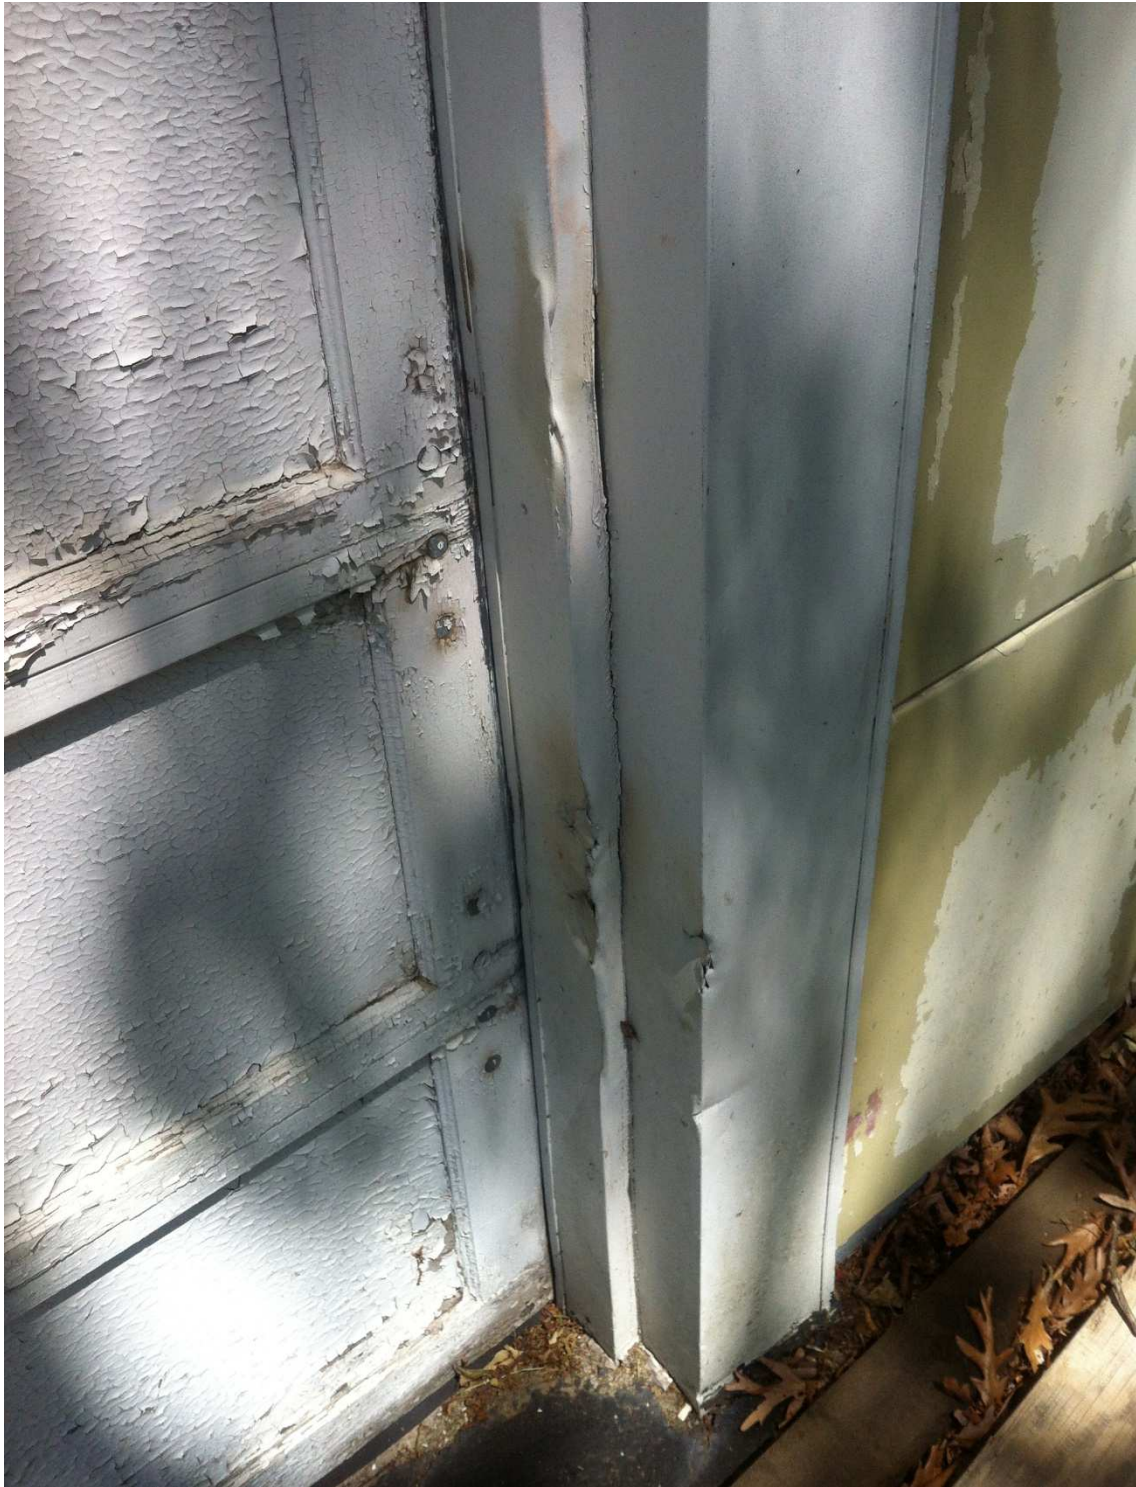
*Fig. 26 –The sheet metal panning on both garage door jambs has been dented through various impacts. This material could be replaced in-kind. Photo taken looking east, June 2017.*

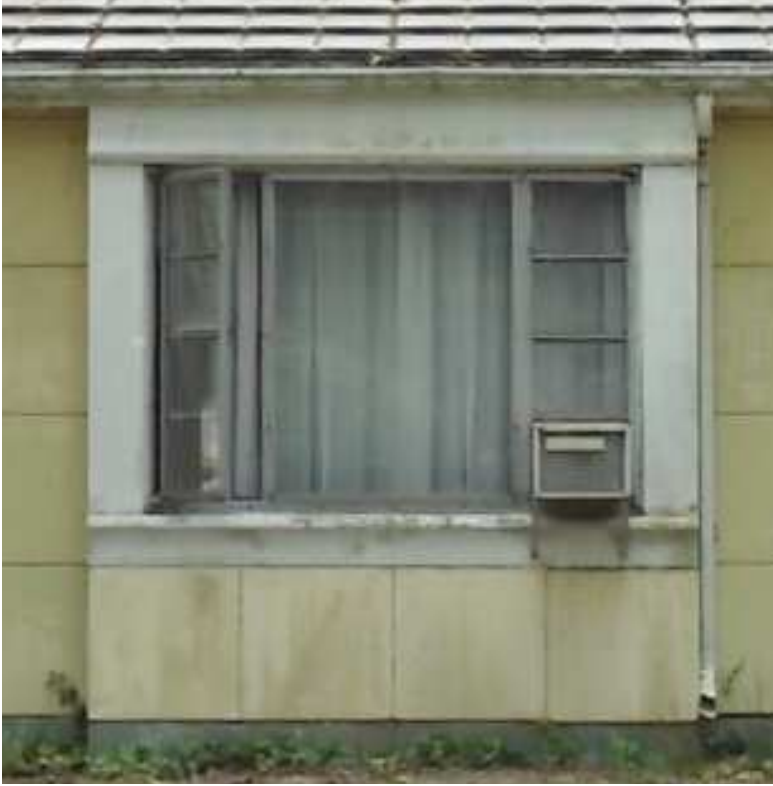
*Fig. 27 –View of the large “Type VI” windows. This window is located in the living room and mounted in a projecting bay. Note the addition of the portable window air conditioner in the lower pane of one casement window. Air-conditioning units were installed in each of the large windows, at the Dinette, Living Room, and both bedrooms, plus in one of the breezeway windows. Photo taken looking west, June 2017*

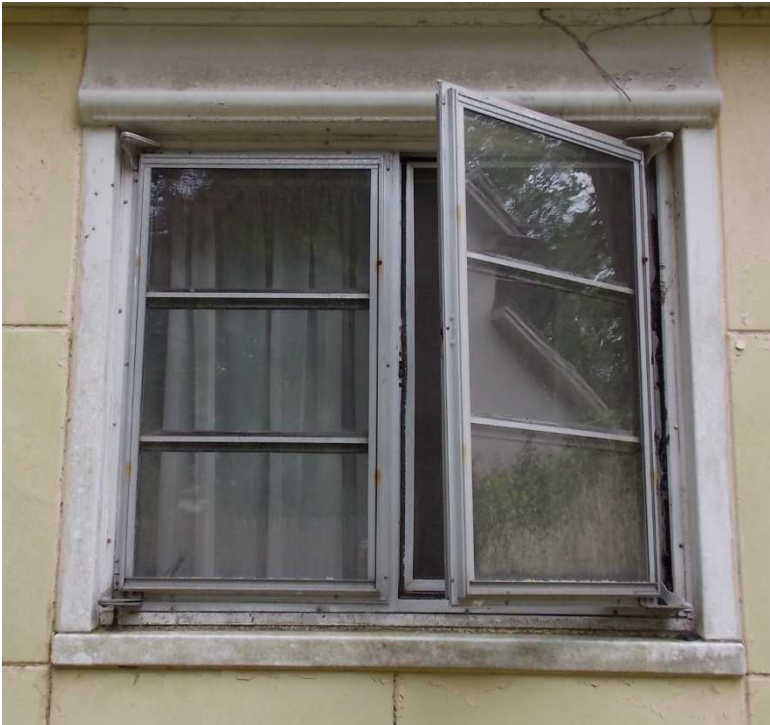
*Fig. 28 –View looking south of the “Type VII” window installed at Bedroom No.1, photo taken June 2017.*

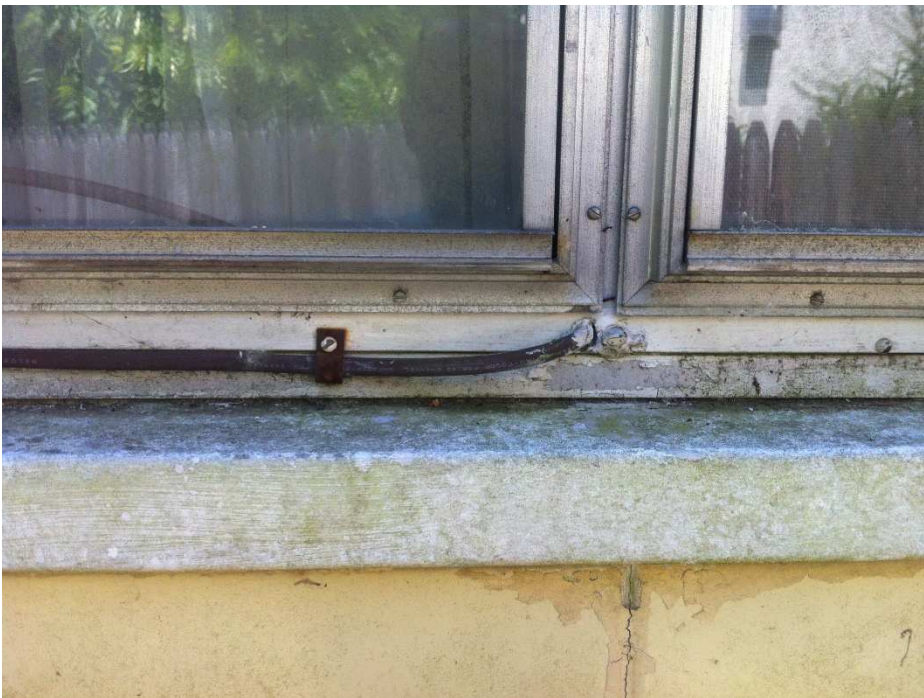
*Fig. 30 –The attachment of this wire with a steel clip has caused galvanic action between the steel and the aluminum. Any attachment must isolate dissimilar metals. This should be replaced with an aluminum clip, photo taken June 2017.*

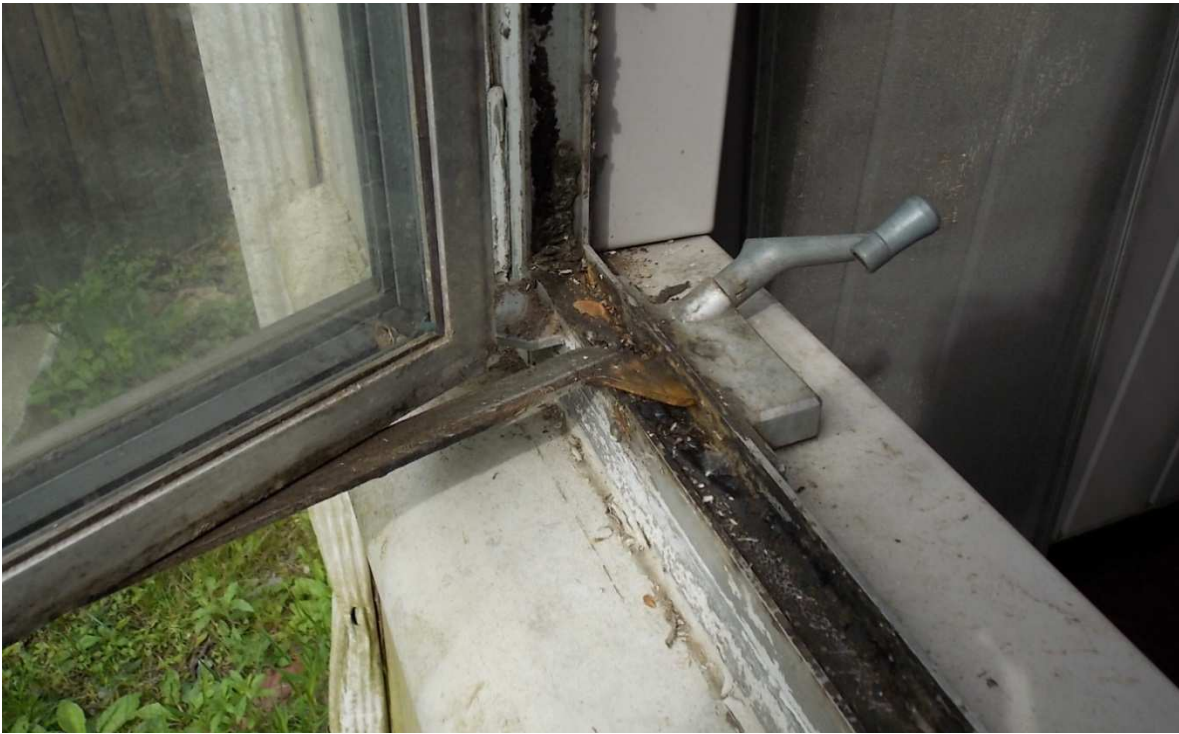
*Fig. 31 – An accumulation of dirt and grime has made operation of the windows difficult on the west wall, photo taken June 2017.*

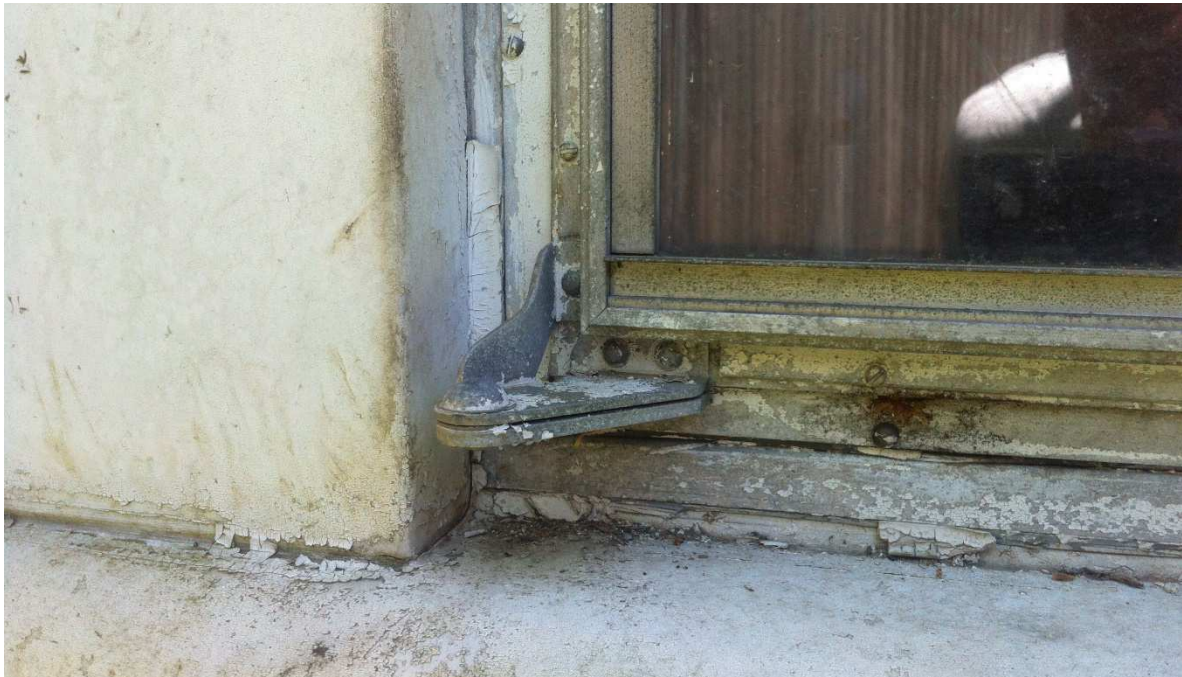
*Fig. 32 –This window has had joint sealant installed at the perimeter of the steel panels. It has failed and should be removed, photo taken looking south June 2017.*

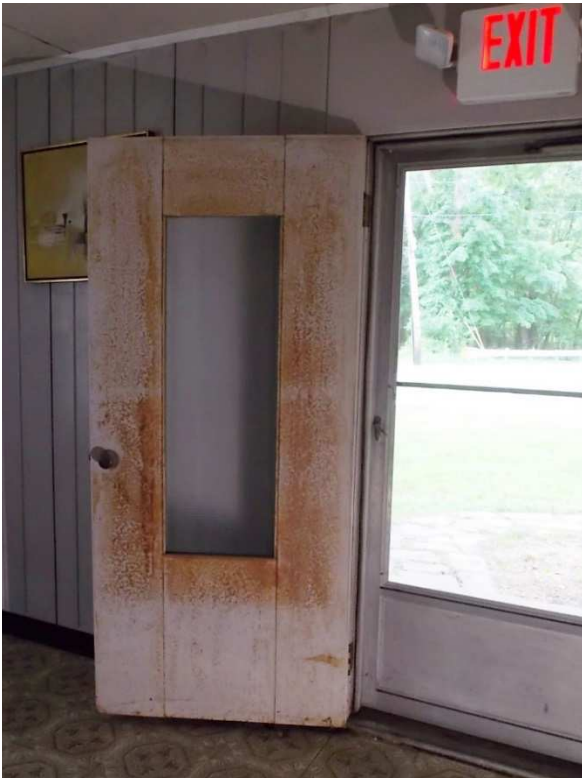
*Fig. 33 –The front entry door is badly rusted and its finish should be restored.*

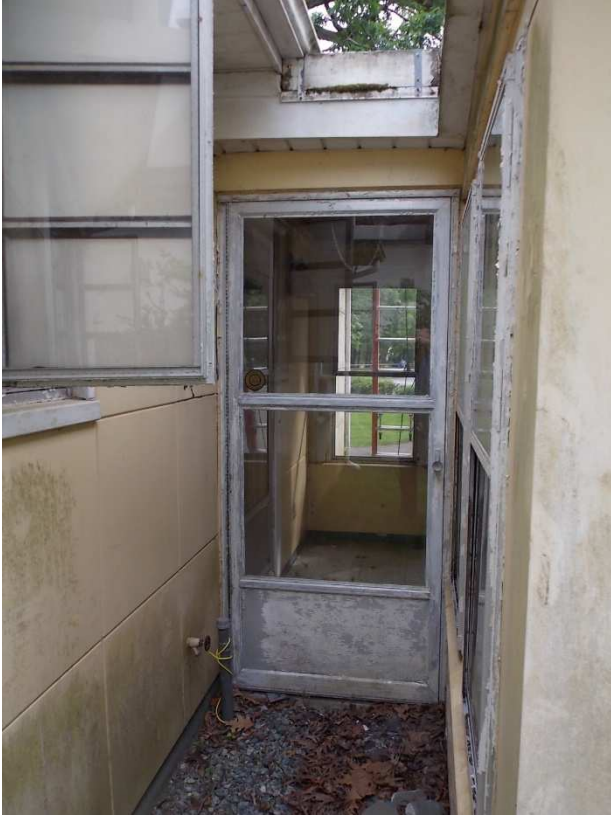
*Fig. 34 –The rear breezeway door no longer opens completely due to the location of a new utility pipe. The pipe should be relocated. Photo taken looking south, June 2017*

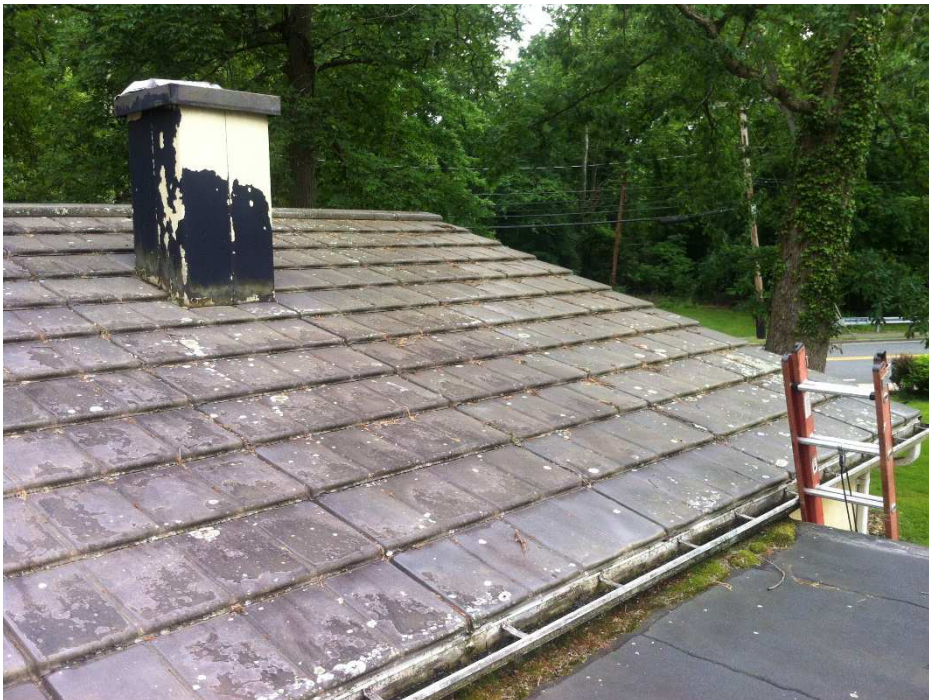
*Fig. 36 – Much of the paint which was applied to the roof panels circa 1990s has worn off, there is still a rougher texture than the original porcelain enamel which catches dirt and debris allowing lichen to form. Looking south, note the paint on the chimney casing, photo taken June 2017*

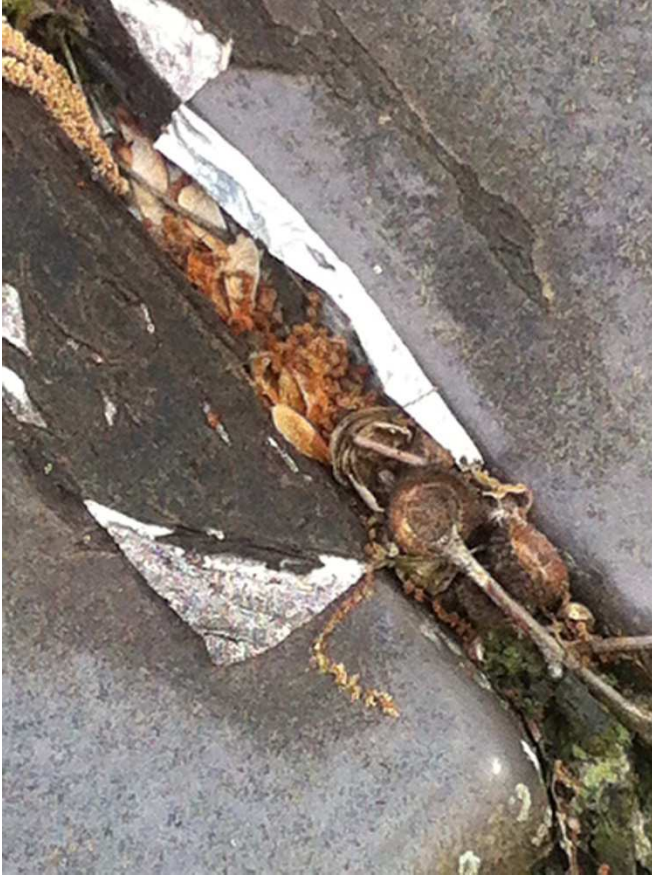
*Fig. 37 – A make-shift roofing repair of metal foil and asphaltic roof coating likely covers a rust hole. The seams where the panels overlap every four feet are deeper and tend to collect leaves, twigs, and other debris which holds moisture against the panels for prolonged periods. Photo taken June 2017 looking east.*

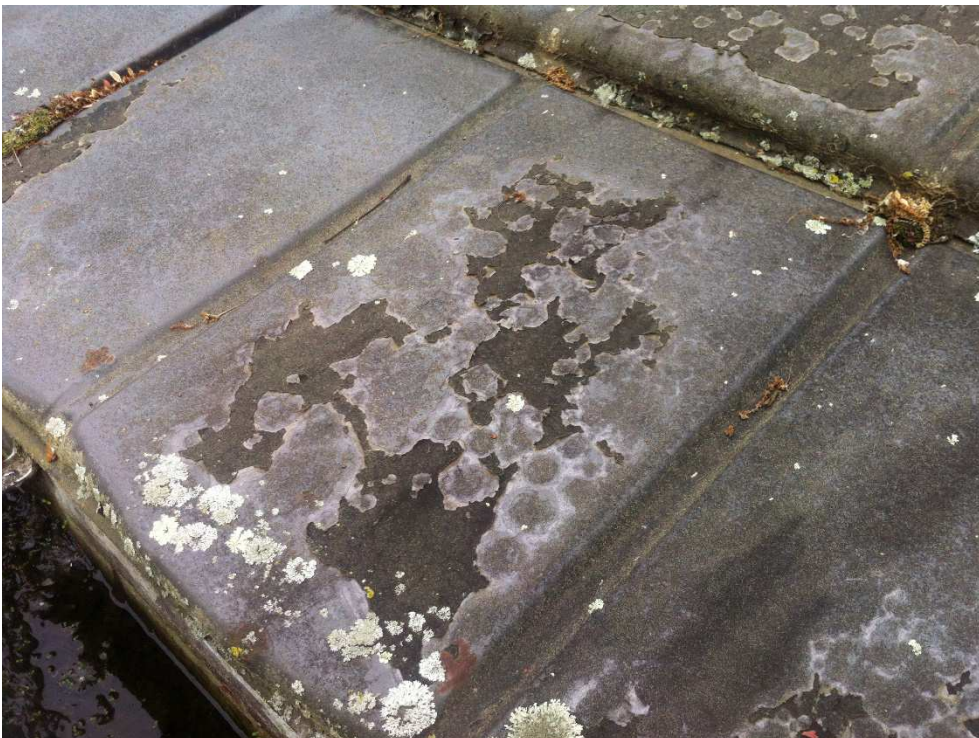
*Fig. 38 – Close-up view of lichen growth on the house roof, looking east, photo taken June 2017.*
