# Harold Hess Lustron House

Closter, New Jersey

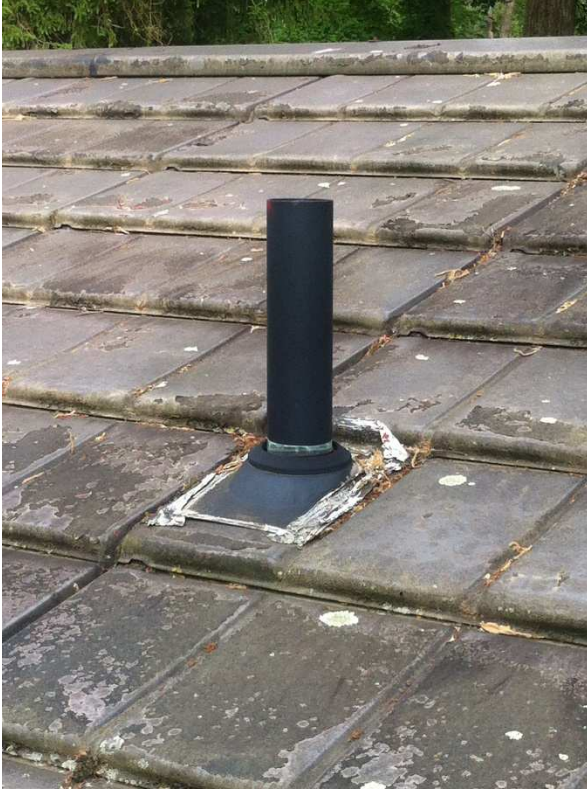
*Fig. 39 – The original porcelain enamel plumbing vent has been replaced. The original is stored in the attic of the house. Photo taken June 2017 looking east.*

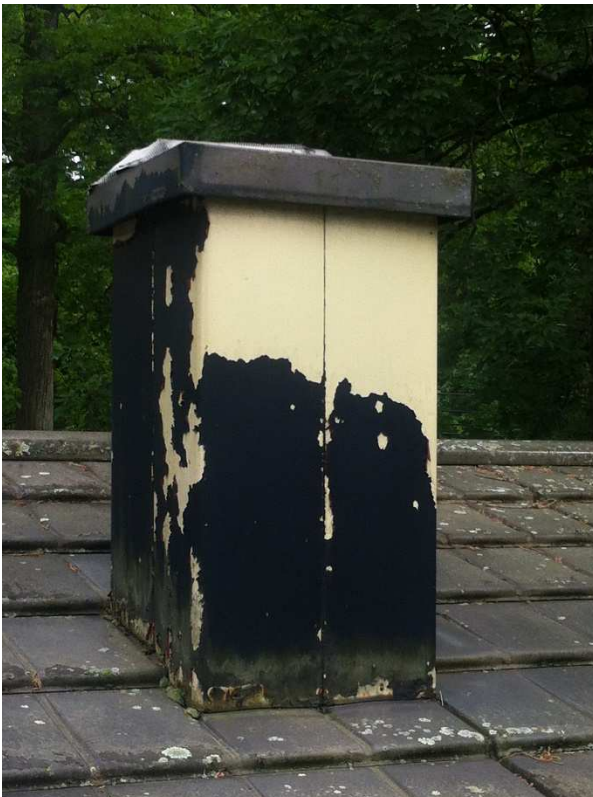
*Fig. 40 – The chimney casing should have the remaining black latex paint removed and repairs made to the rust at its base. Photo taken June 2017 looking east.*

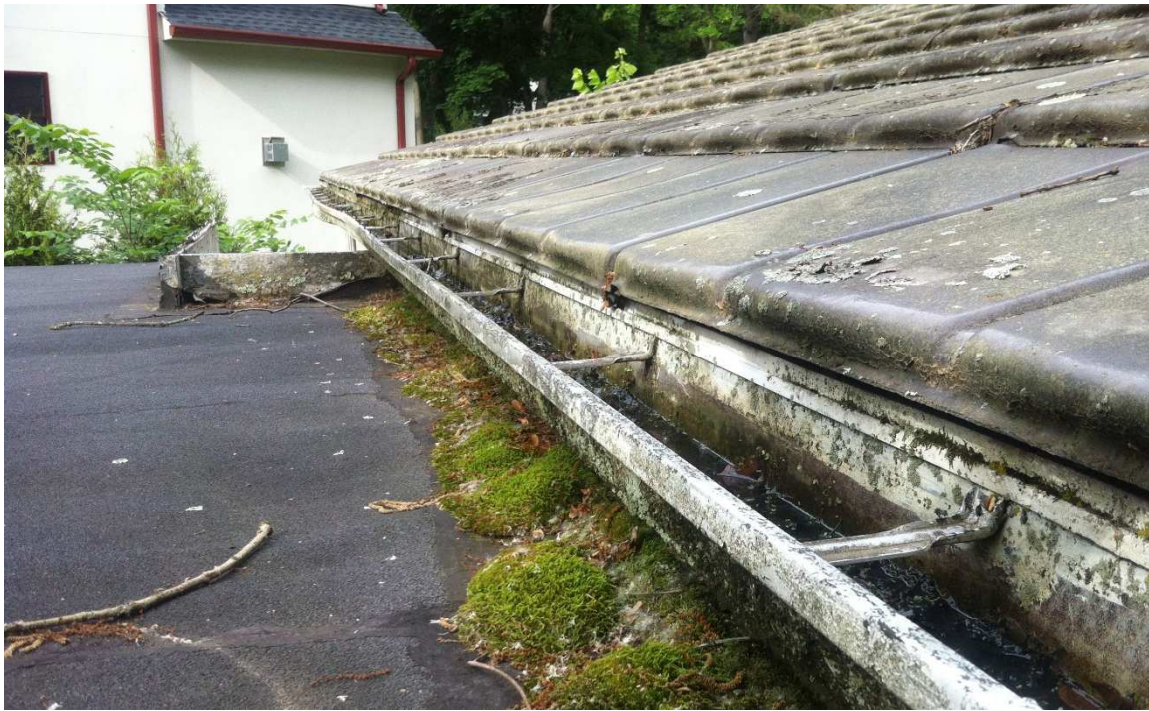
*Fig. 41 – View of the breezeway roof adjacent to the house shows constant moisture has enabled moss growth. There is water damage in the breezeway ceiling below this area, photo taken June 2017 looking north.*

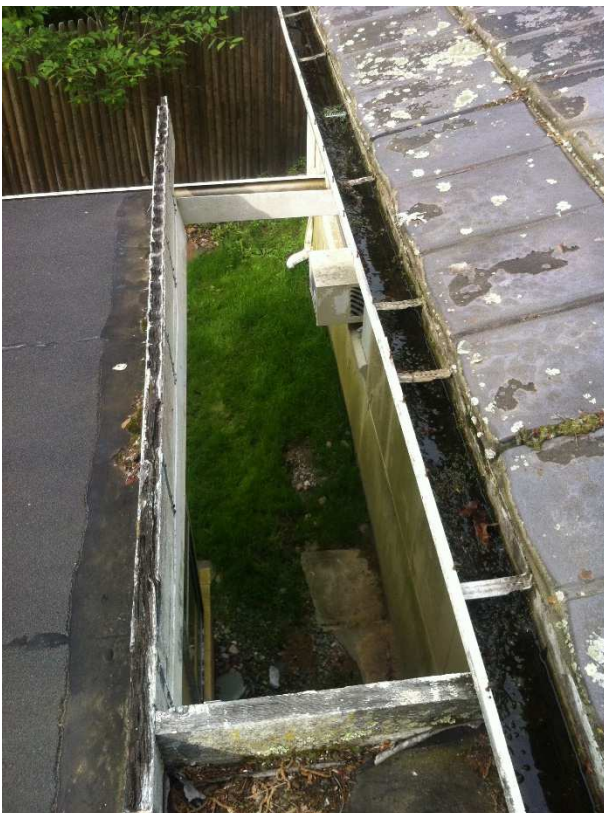
*Fig. 42 and 43 – This area between the breezeway and the house was covered with a white corrugated translucent fiberglass roofing panel. A section remains stored in the breezeway. The wood trim which supported it is seen at left and below. Photo taken June 2017 looking north.*

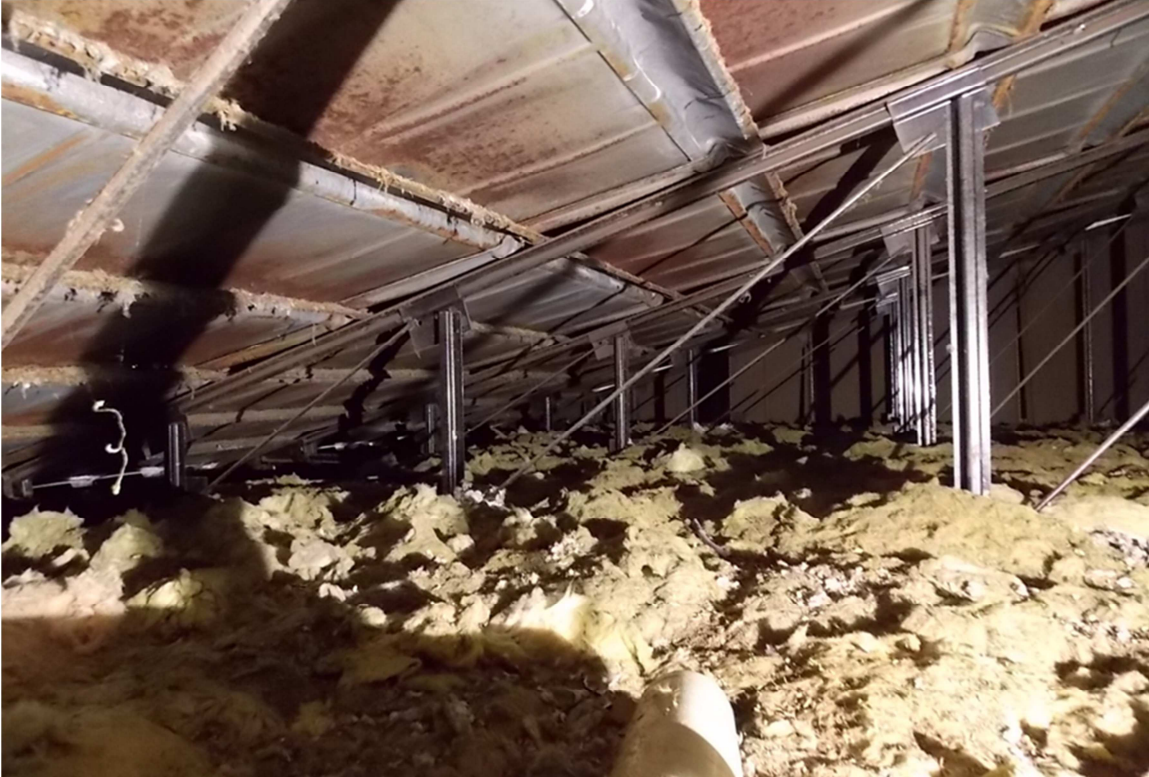
*Fig. 44 – The underside of the roof panels have surface rust. The panels need to have an anti-corrosive coating reapplied to protect them from further deterioration. Photo taken June 2017 looking north.*

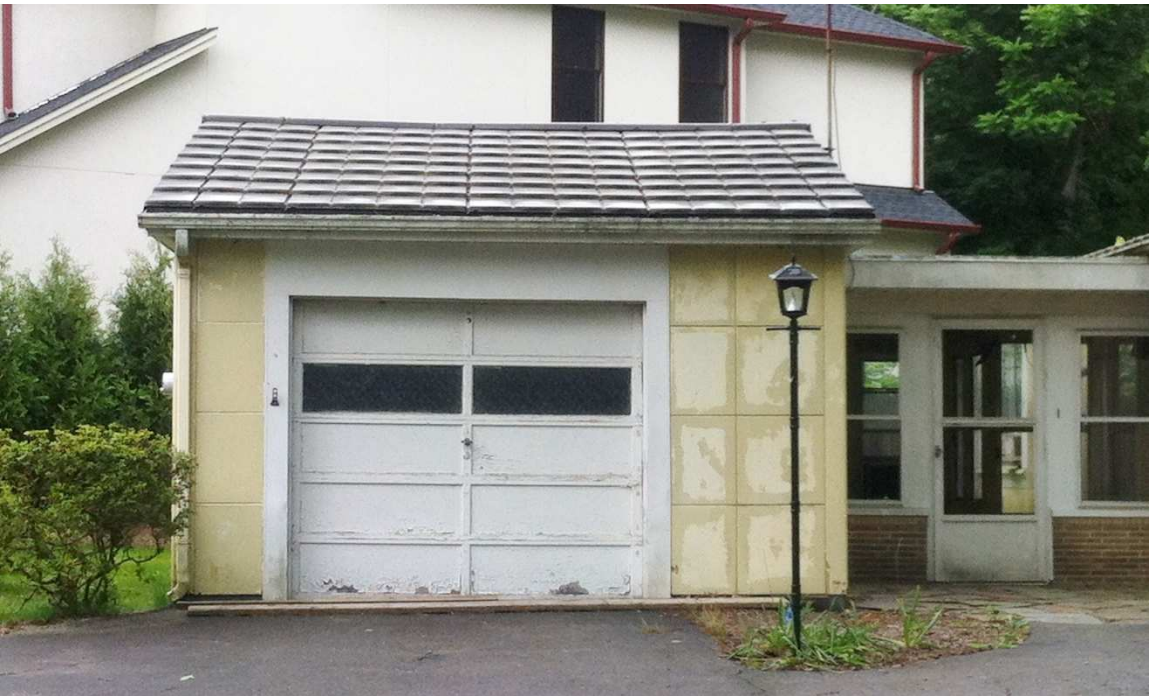
*Fig. 45 – The garage roof sags at the center, photo taken June 2017 looking north.*

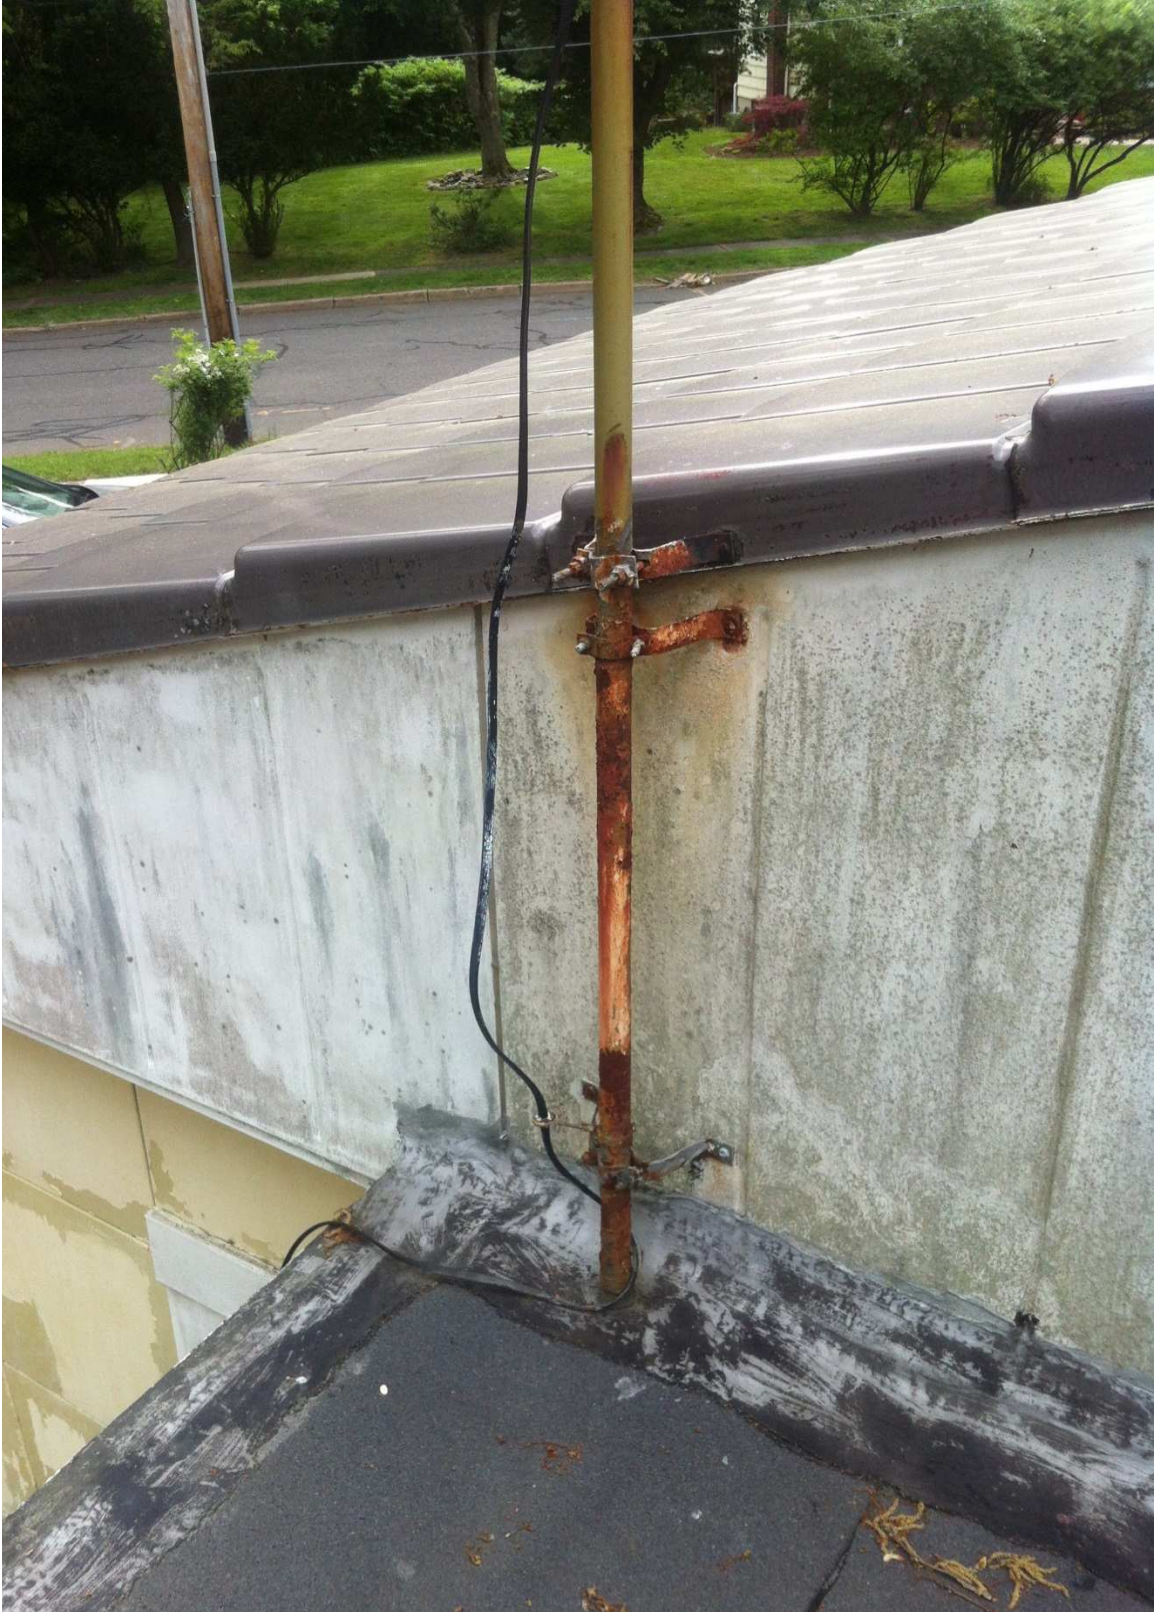
*Fig. 46 – The television antennas at the garage and house are rusted. These features are important to interpret post-World War II life in America and should be retained and restored. Photo taken looking south, June 2017.*

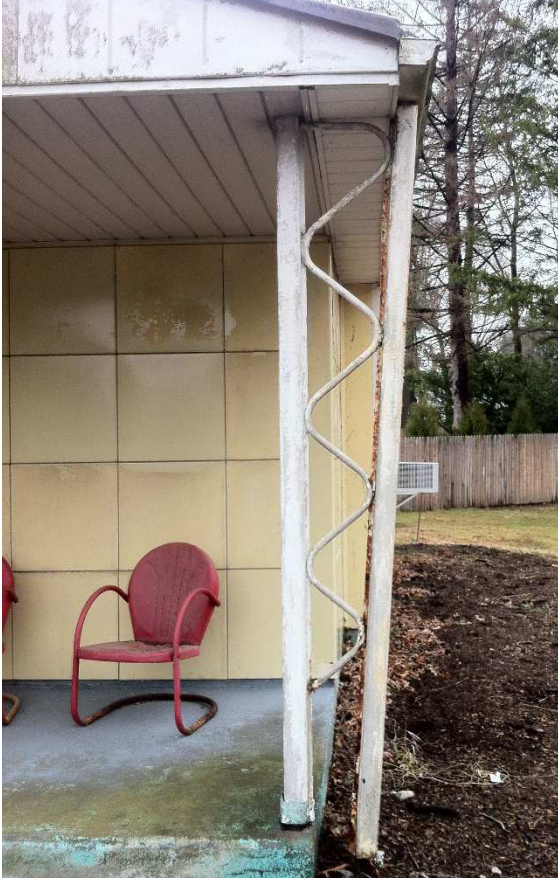
*Figs. 47 (looking north), 48 (looking east), 49 (looking north) – Images of the original remaining serpentine downspout at the front porch. The angled downspout is supported by the vertical post on the porch by a serpentine tube. The seam at the backside of the downspout is rusted and there is a chip in the porcelain enamel finish. The tube is rusted where it connects to the downspout and the base of the post is rusted. Photos taken March/June 2017.*

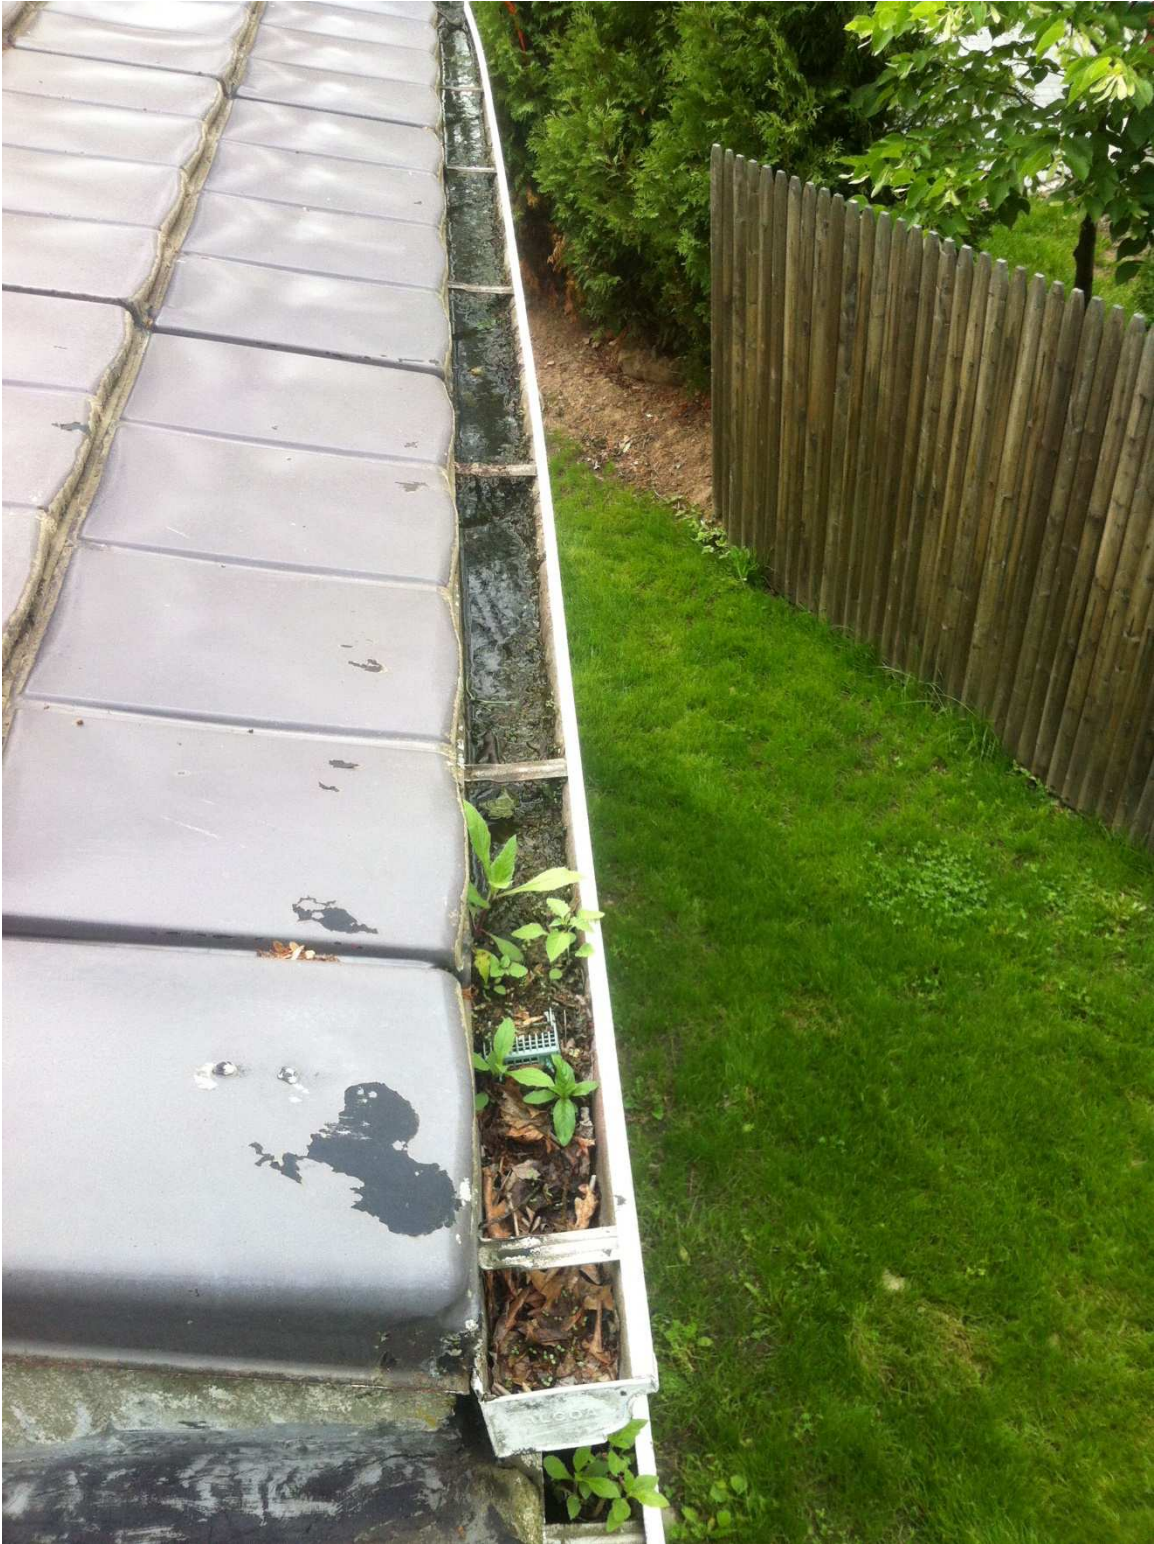
*Fig. 50 – The gutters and downspouts require periodic maintenance to keep them clear, photo taken looking west, June 2017.*

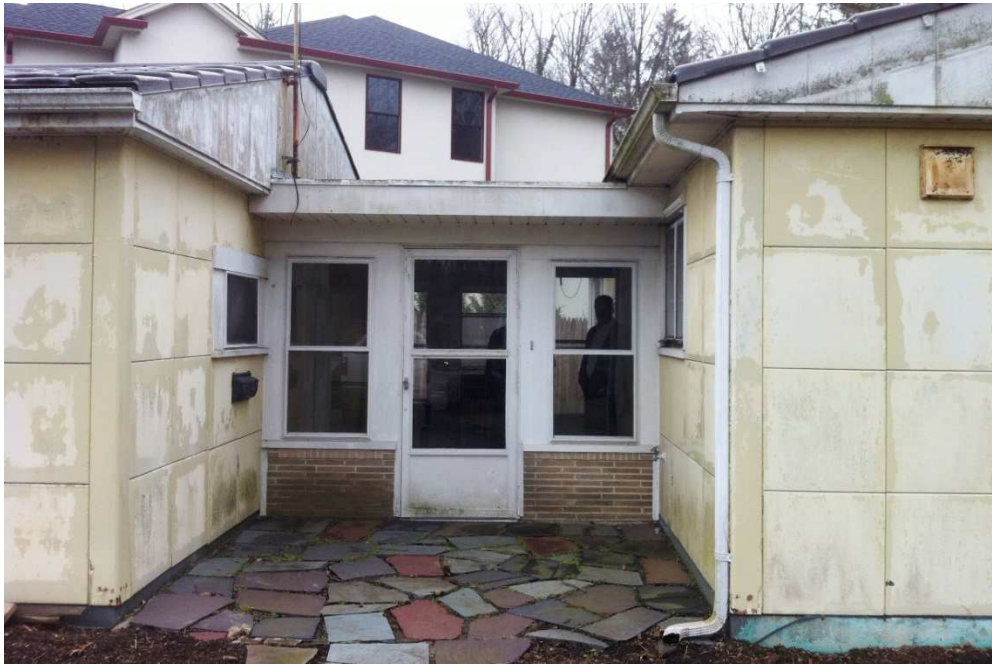
*Fig. 51 – View of breezeway front, photo taken looking north, March 2017.*

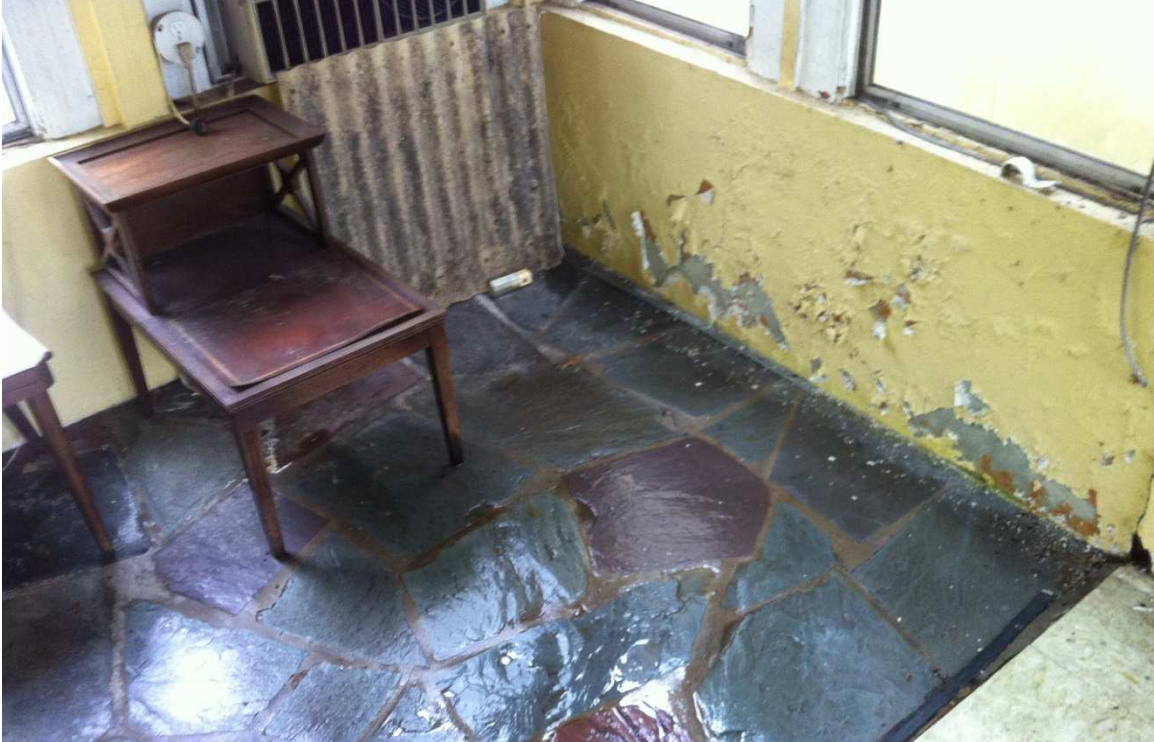
*Fig. 53 – View enlarged area of breezeway. The floor is wet from active roof leaking. Note the corrugated fiberglass roof panel stored in the corner of the room which was formerly above the rear door of the breezeway. Photo taken looking east, June 2017.*

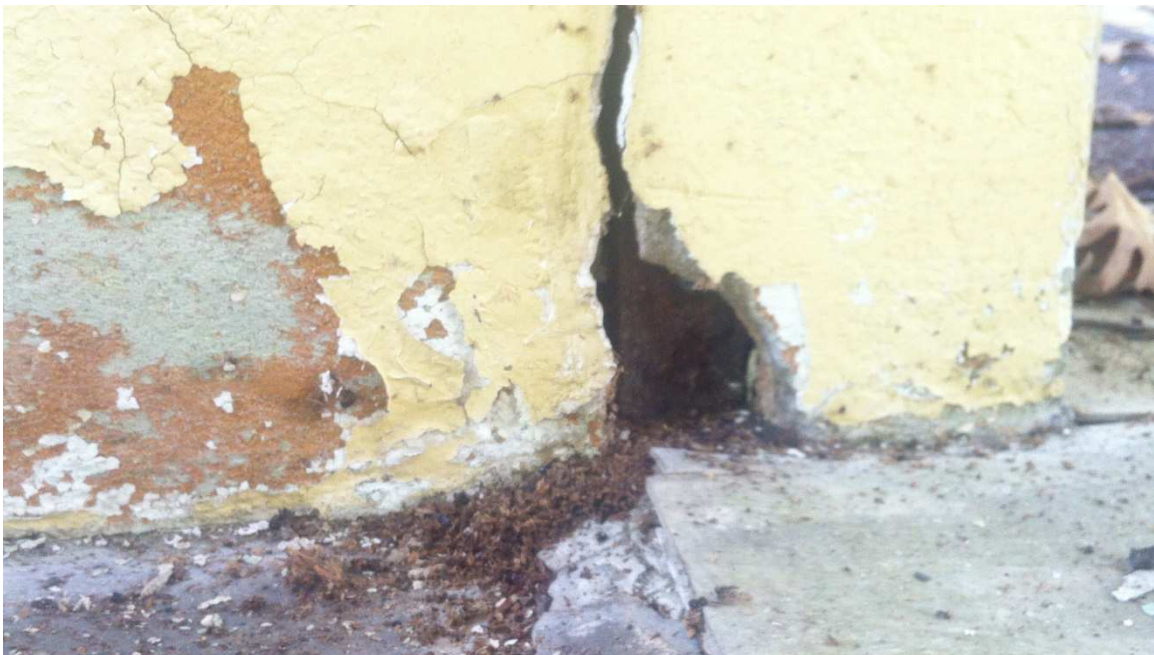
*Fig. 54 – View of the base of the post adjacent to rear door of breezeway. The crack in the wall is from settlement of the rear concrete slab-on-grade. The brown material on the floor is from the base of the post inside the wall. Photo taken looking east, June 2017.*

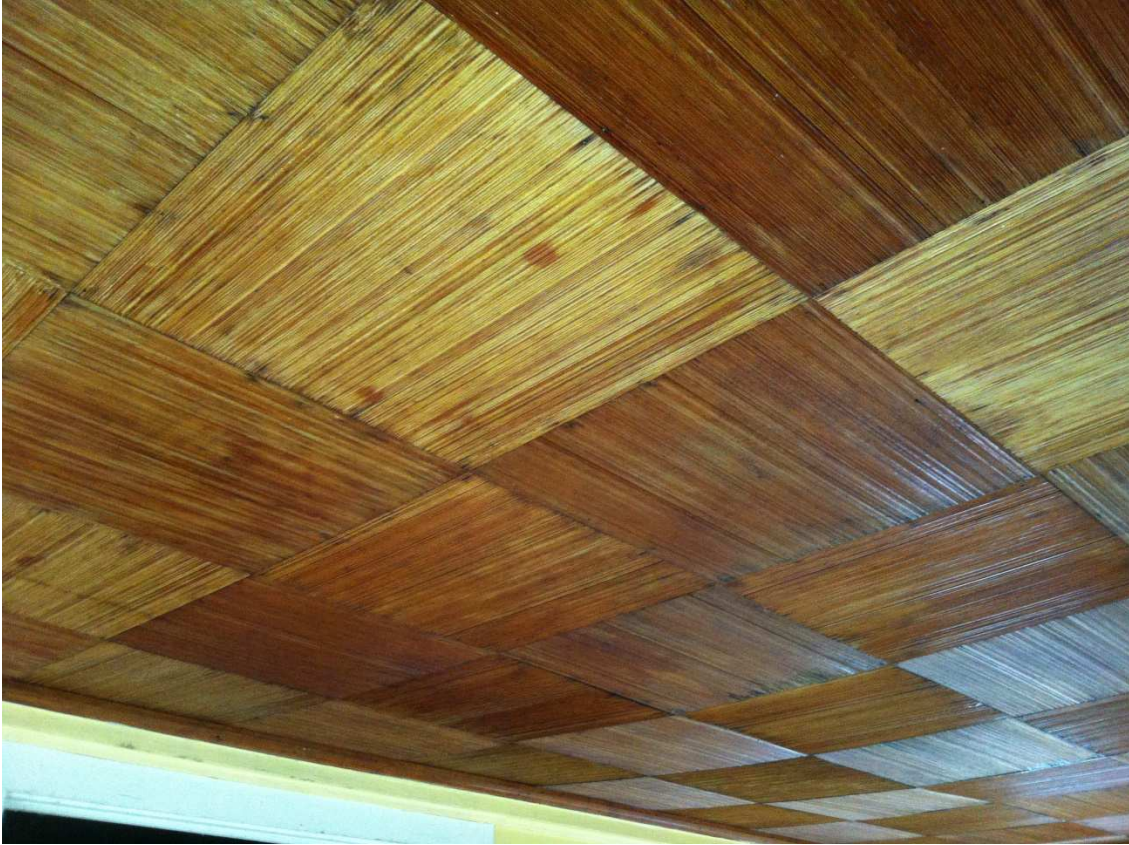
*Fig. 55 – View of breezeway ceiling, photo taken looking east, June 2017.*

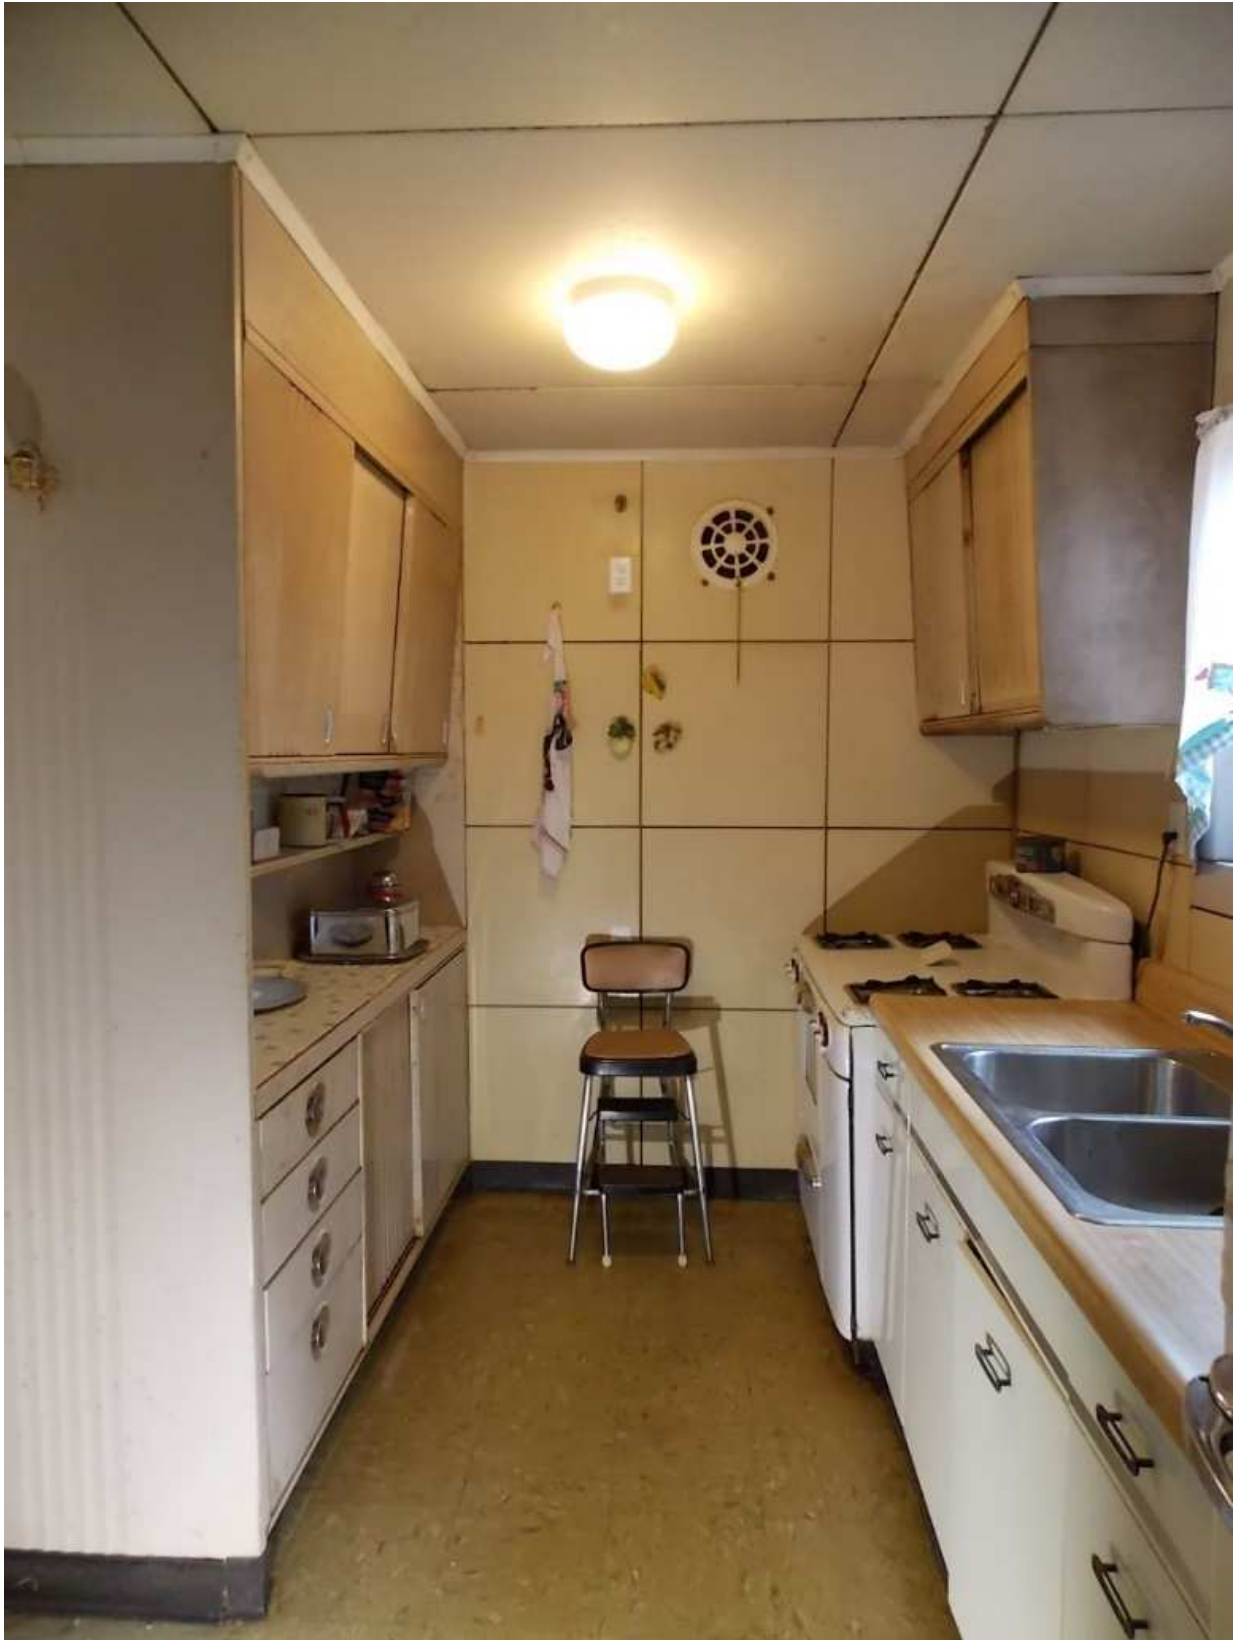
*Fig. 58 – View of Kitchen looking from Utility Room, photo taken looking south, June 2017.*

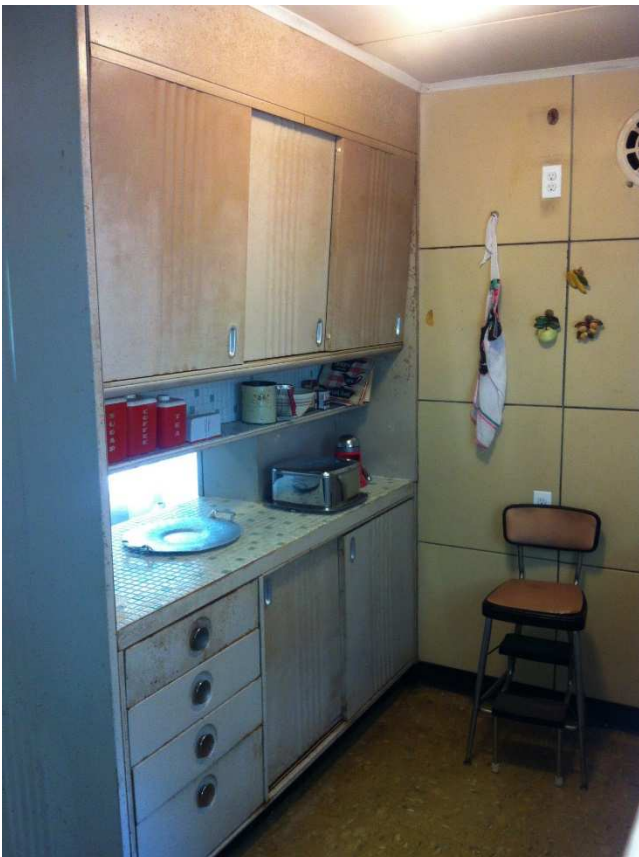
*Fig. 60 – View of Kitchen / Dinette pass-through china cabinet. Note the surface rusting of cabinet finish. Photo taken looking south, June 2017*

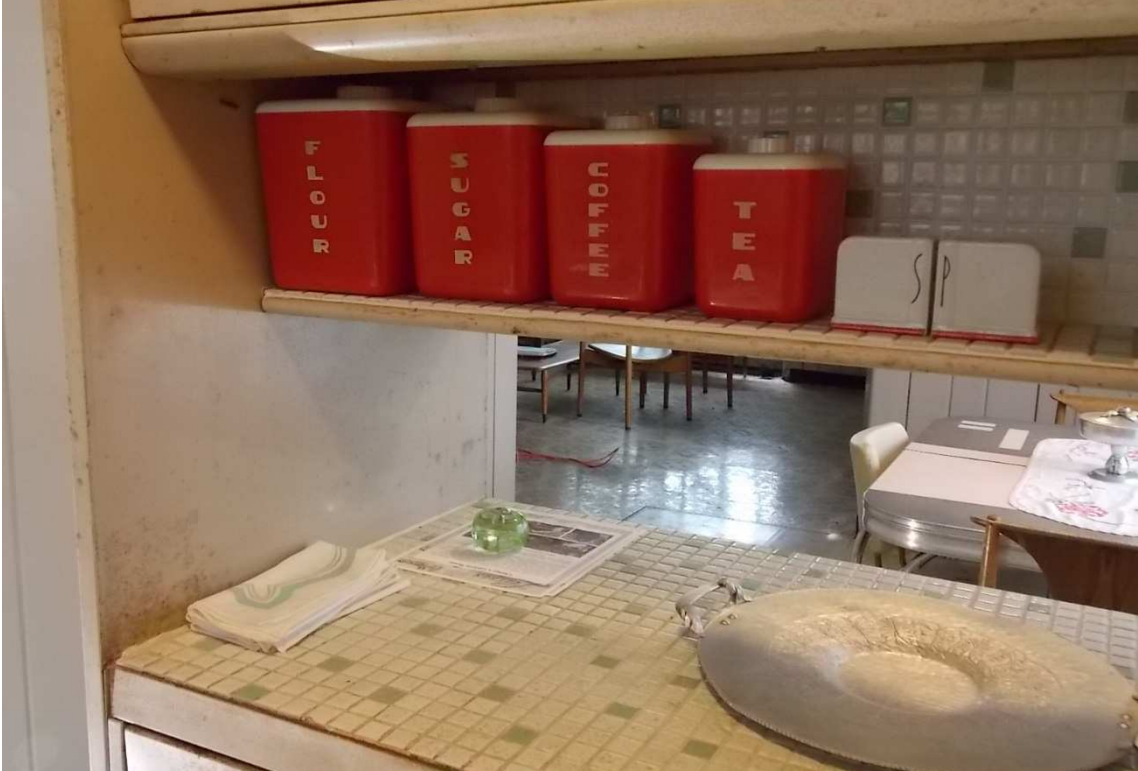
*Fig. 61 – View of pass-through looking east, showing early tile finish added by the Hess family, photo taken June 2017*

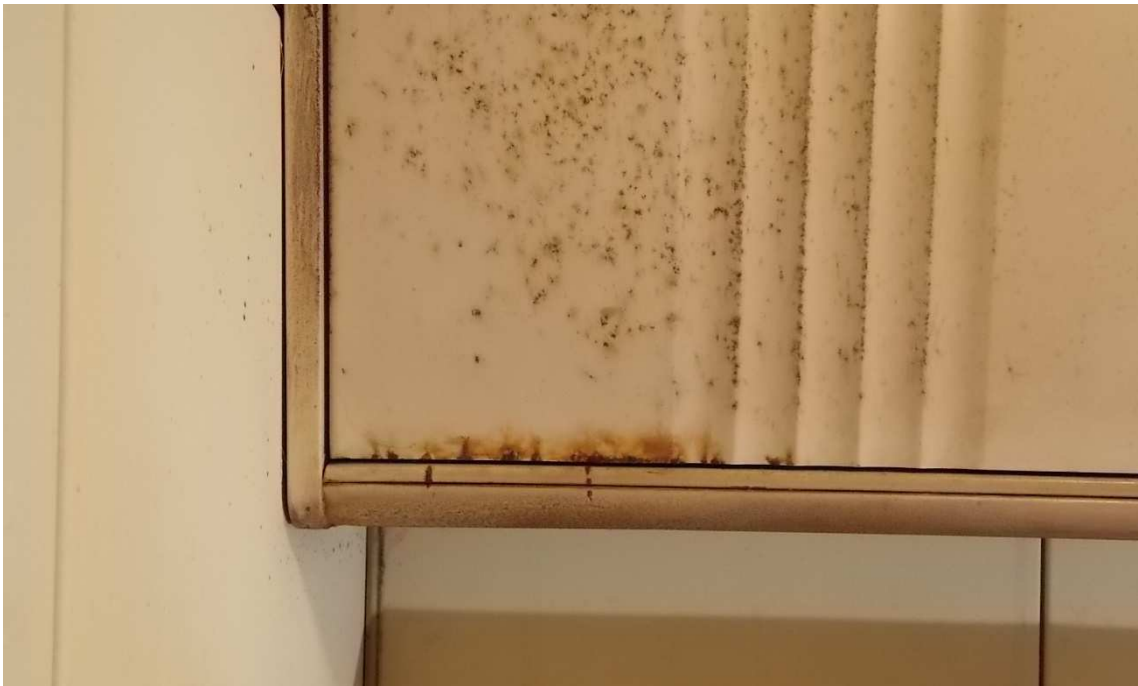
*Fig. 62 – View of typical rust damage to cabinetry and closets. This is the kitchen cabinet above the stove, photo taken June 2017.*

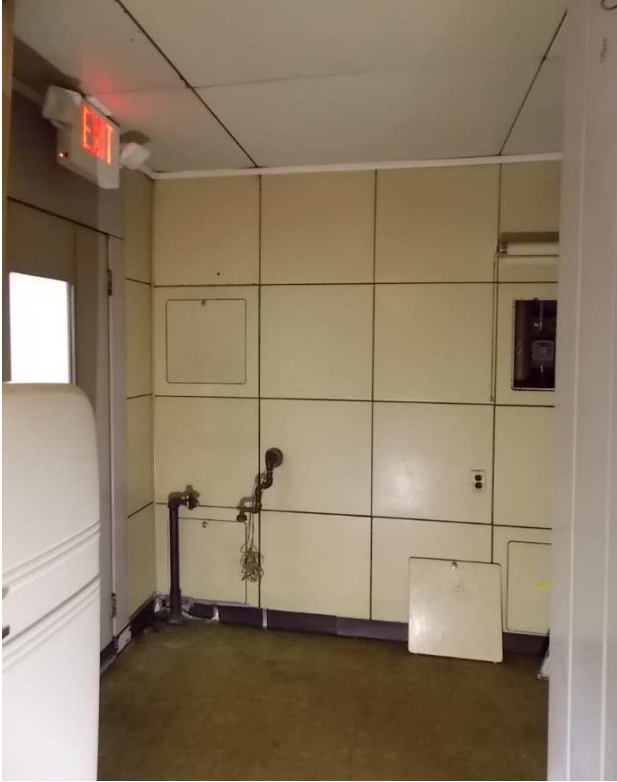
*Fig. 63 – View of utility wall from Kitchen looking north, photo taken June 2017.*

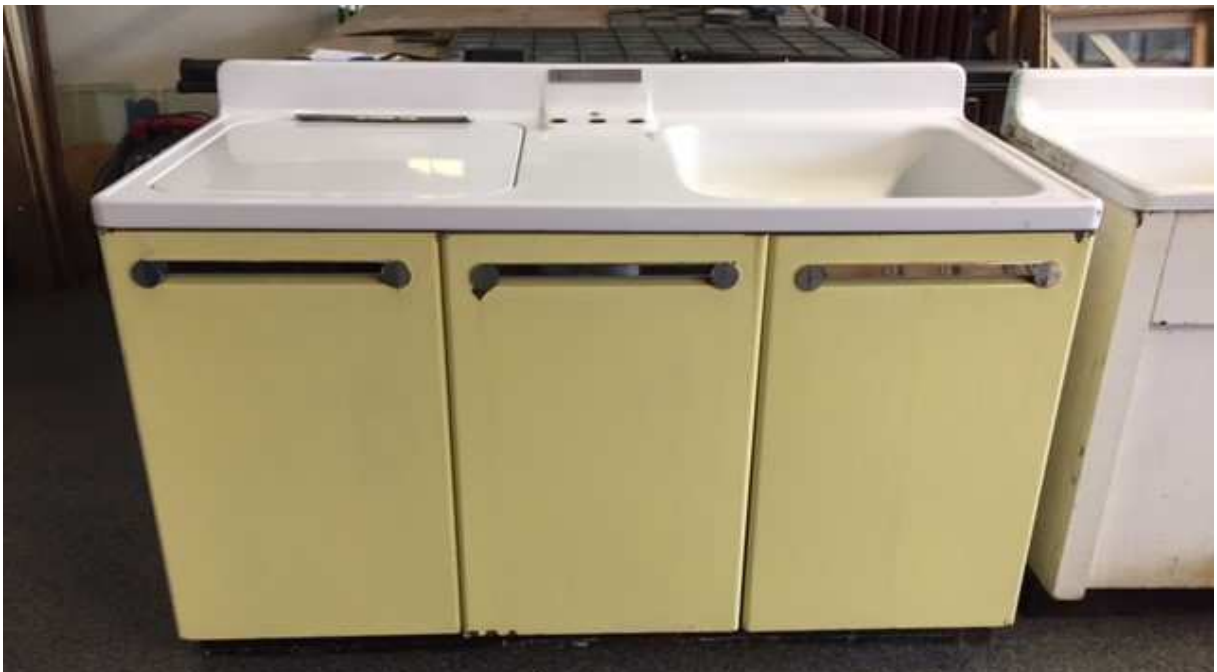
*Fig. 66 – View of potential replacement unit for the missing combination clothes and dishwasher with sink unit for the Harold Hess Lustron House. Where original elements are missing, replacement parts from other dis-assembled Lustron houses may be possible.*

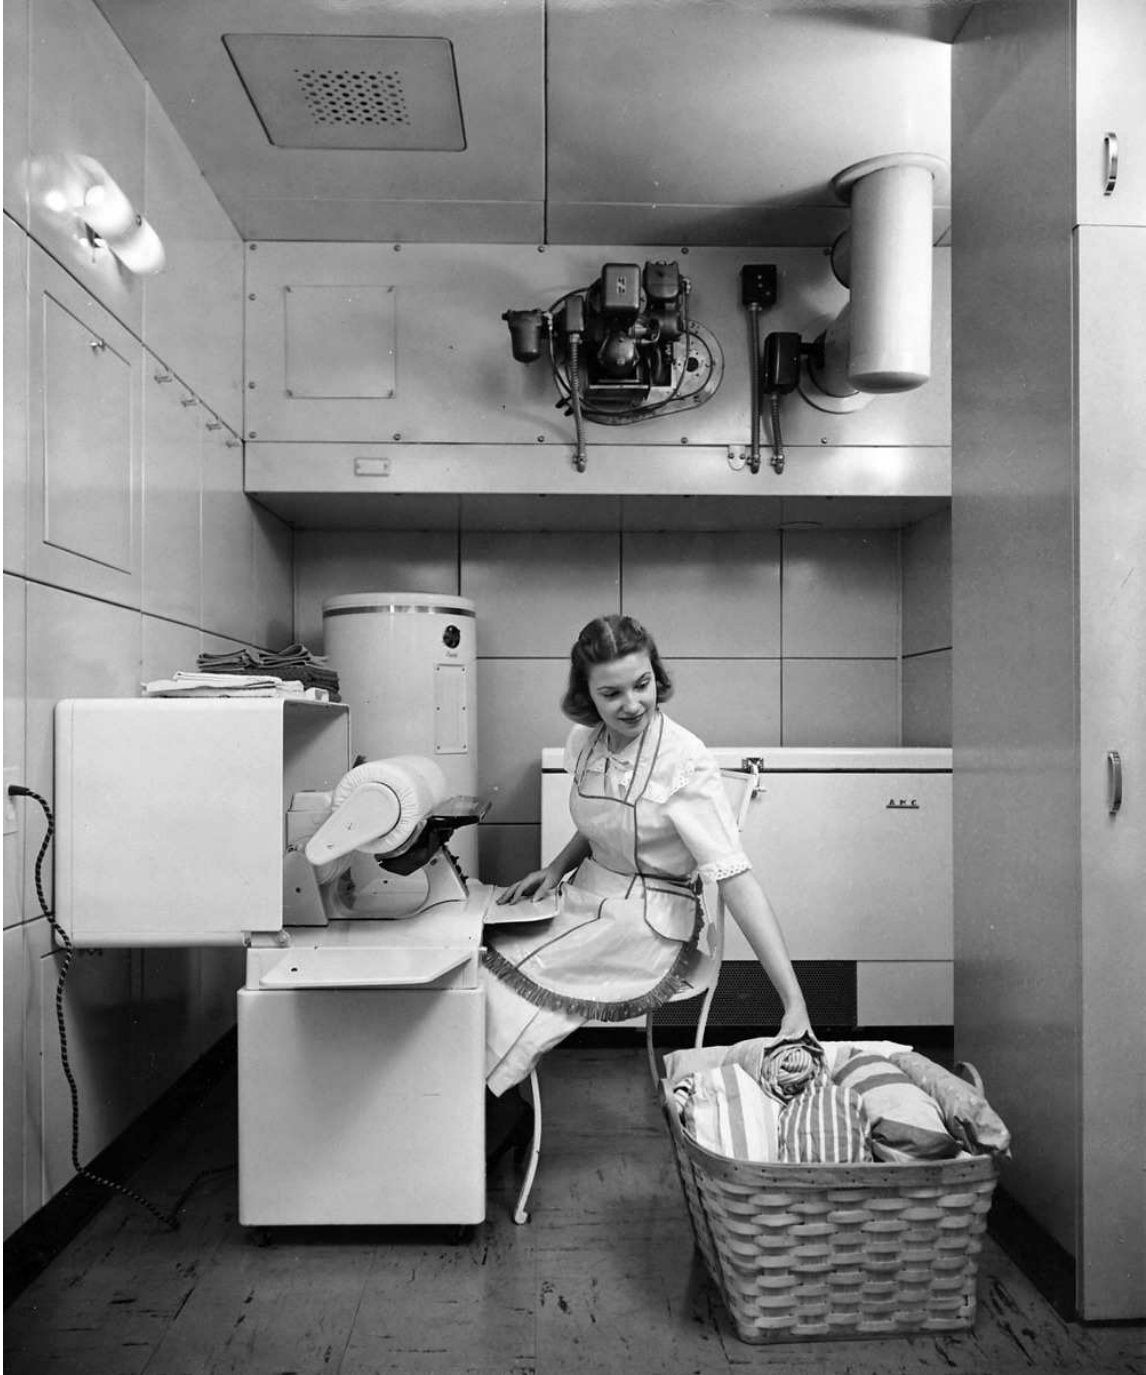
*Fig. 67 – View of Utility Room as depicted in Lustron Home brochure republished on Ohio Historical Society website. The enclosure below the ceiling at the rear wall contained the furnace which supplied hot air to the radiant ceiling plenum system. Also note the perforated roof scuttle ceiling panel. This item is not currently in the Harold Hess Lustron House.*

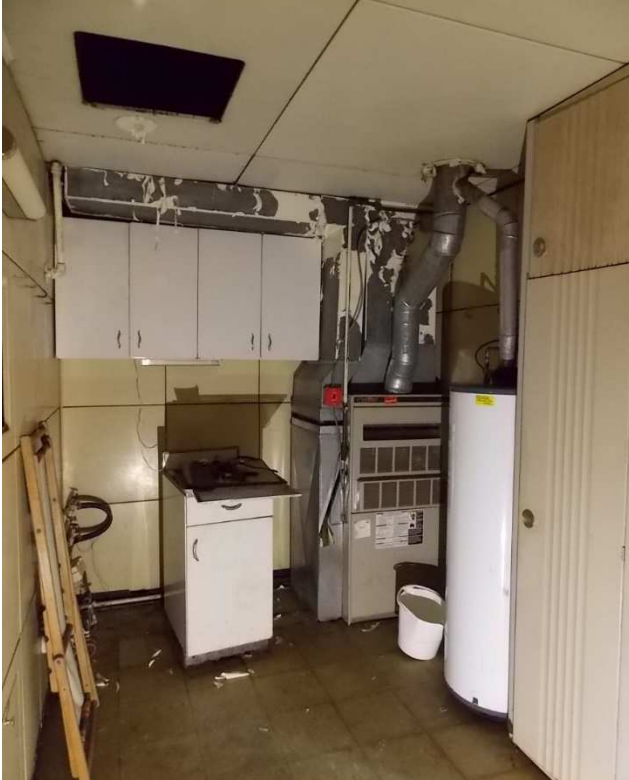
*Fig. 68 – View of Utility Room looking east. Note the floor mounted furnace, exposed ductwork, non-original laundry cabinets and missing scuttle at ceiling. Photo taken June 2017*

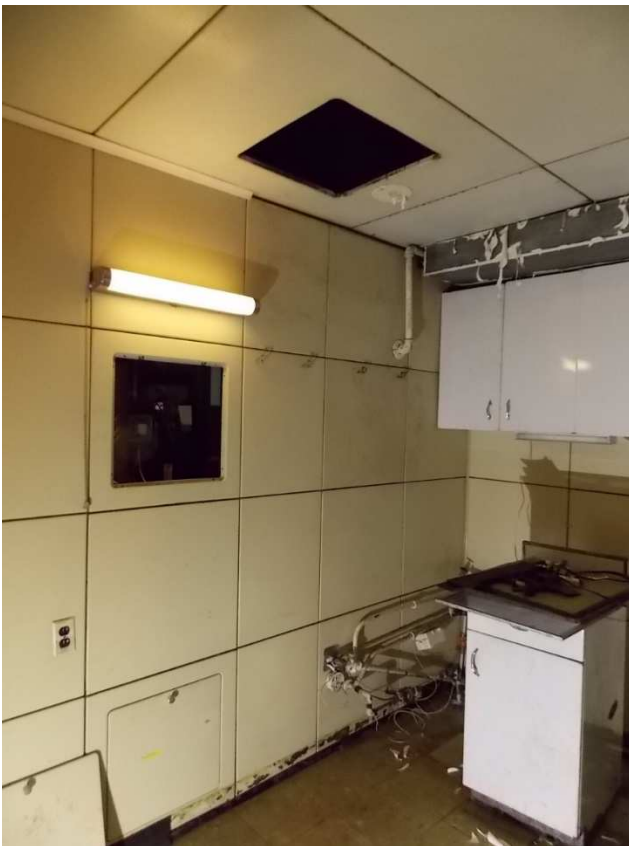
*Fig. 69 – View of utility wall in the Utility Room, looking east. Note the original light fixture over the removed access panel. Also note the plumbing piping added for the washing machine which the Hess family had installed here. Photo taken June 2017.*

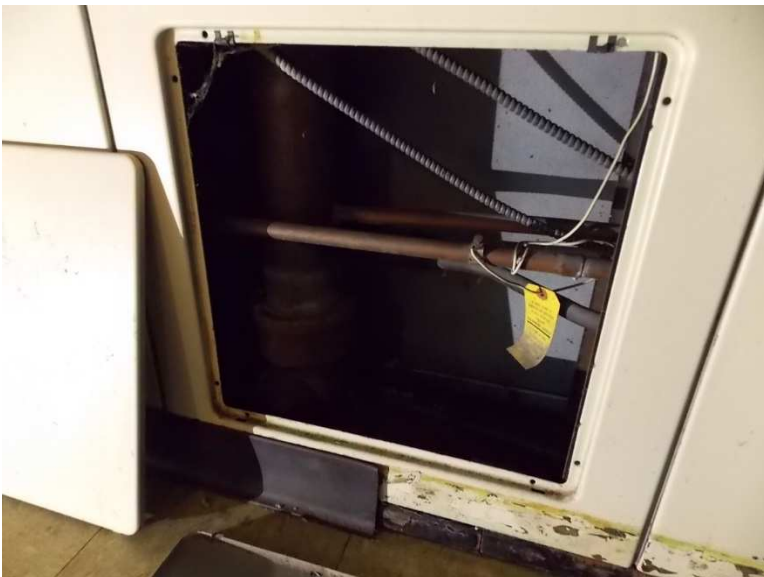
*Fig. 71 – One of the access panels located in the utility wall between the Kitchen and Utility Room and the Bath. Access is provided for both plumbing connections and the electrical panel. Several sections of base are missing or damaged. Photo taken looking north, June 2017.*

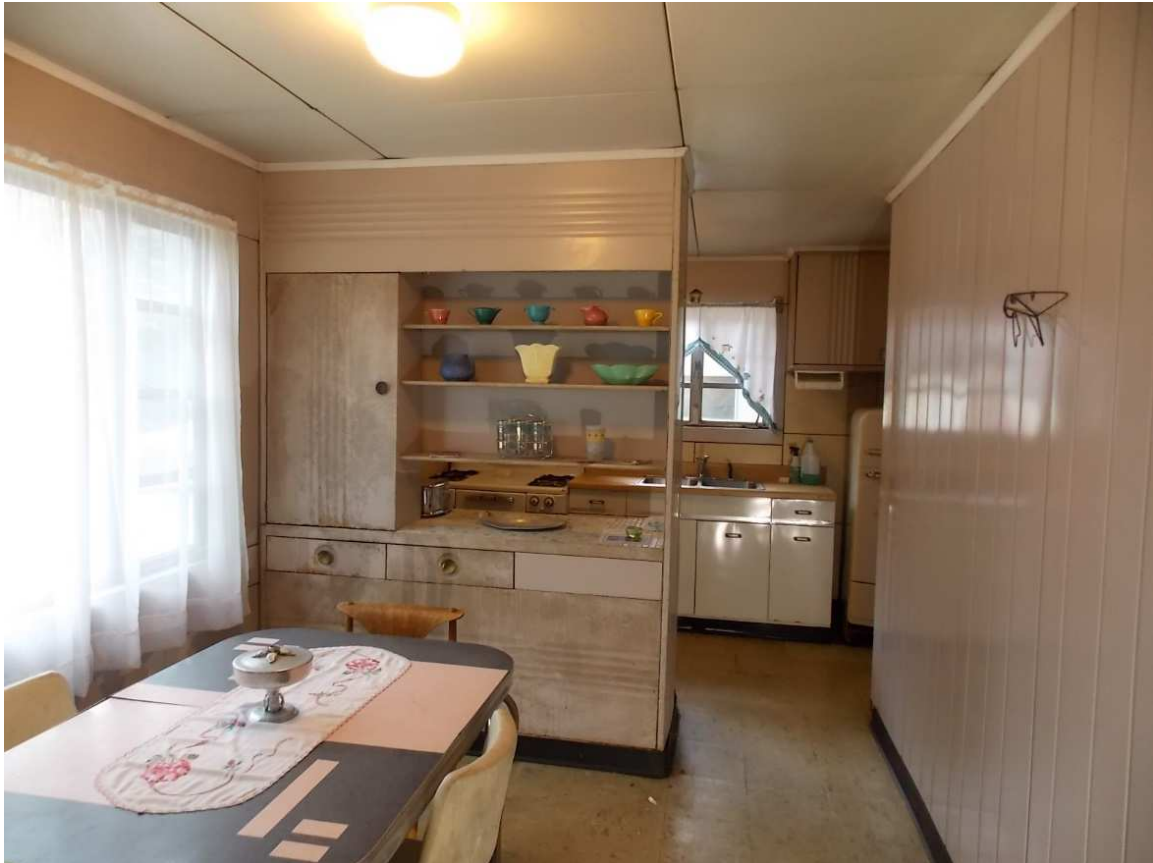
*Fig. 72 – View of Dinette looking west toward Kitchen. Note the China Cabinet with pass-through, a distinctive feature of the Lustron House, photo taken June 2017.*

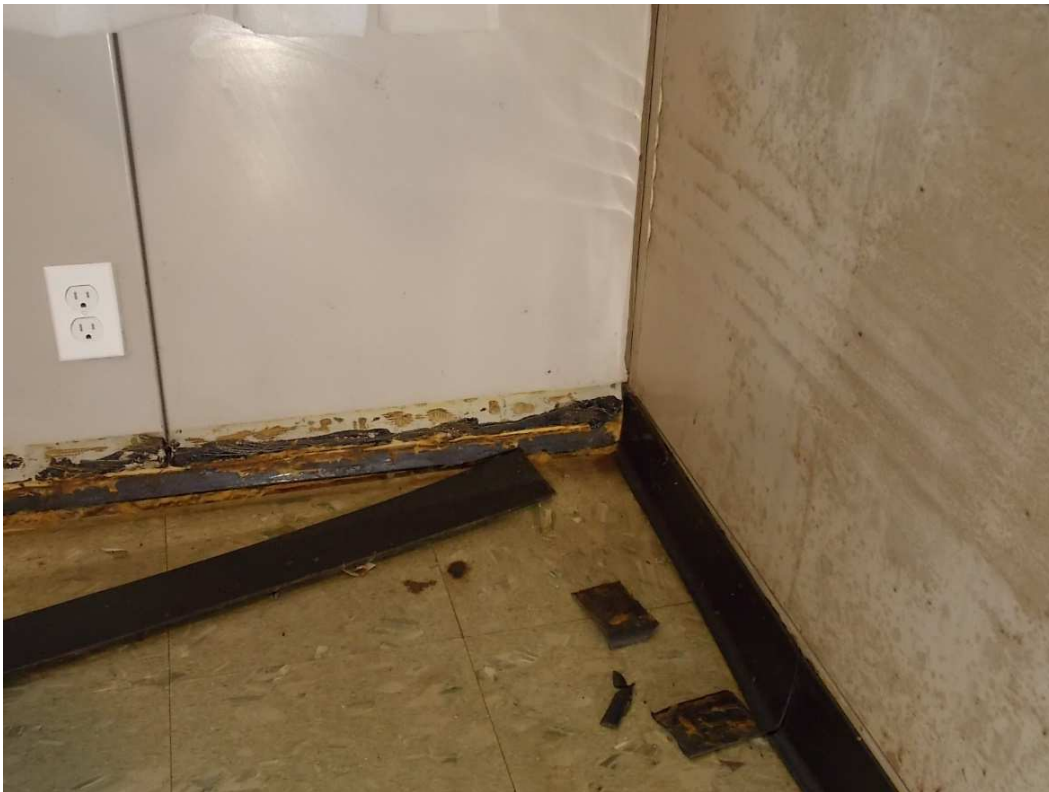
*Fig. 73 – The adhesive securing the base to the wall panels has failed in many areas causing the base to fall off. These sections should be reinstalled. Missing or damaged sections should be replaced with new base that matches the original. Also note the surface rusting of the China Cabinet at right and the modern white receptacle at the exterior wall. Photo taken looking south, June 2017.*
