# Harold Hess Lustron House

Closter, New Jersey

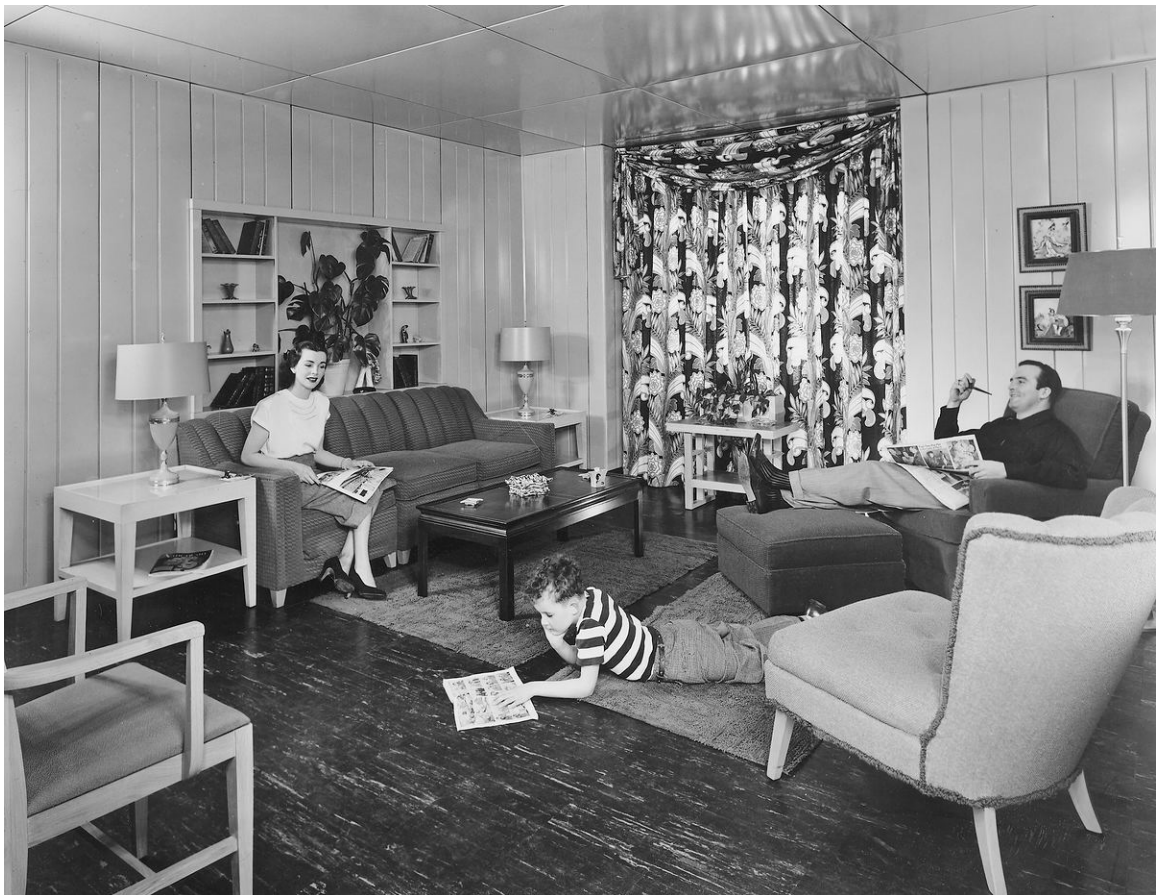
Fig. 74 – View of a Lustron House Living Room from a Lustron advertisement circa 1949. Image from the National Trust of Historic Places website.

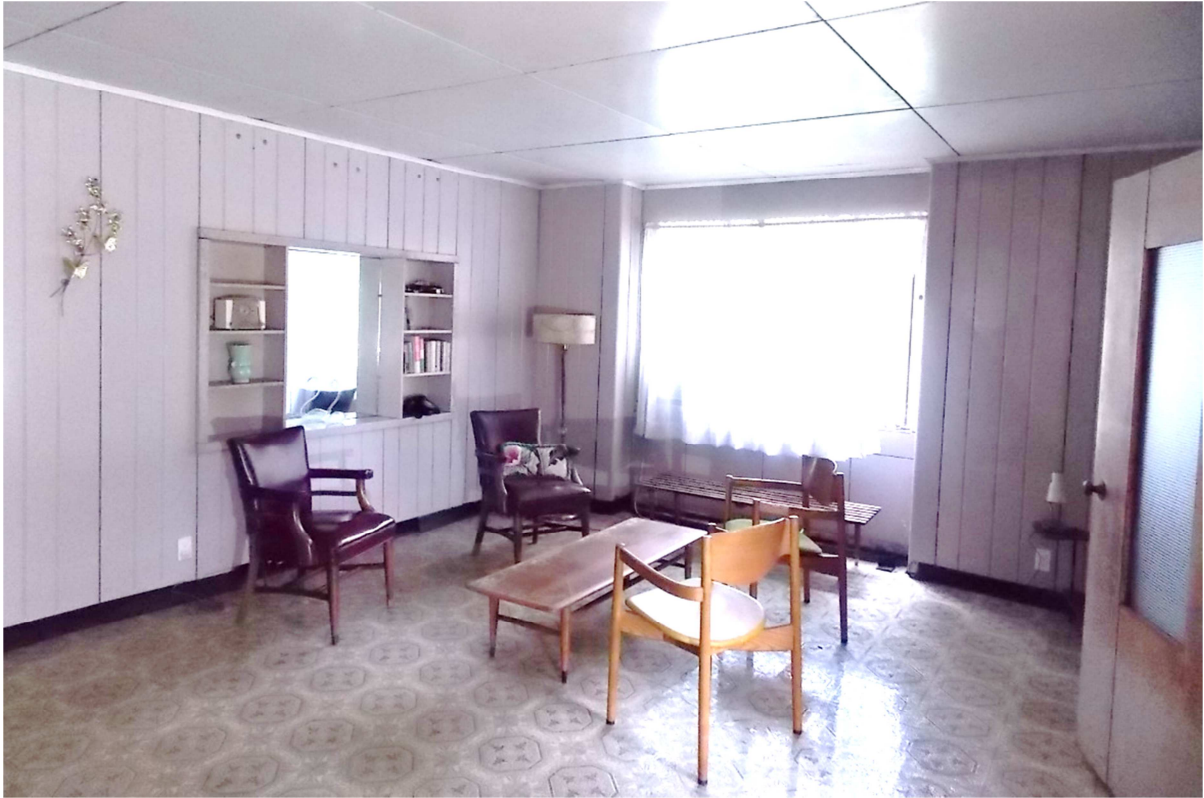
*Fig. 75 – View of Living Room looking east from the Dinette, photo taken June 2017.*

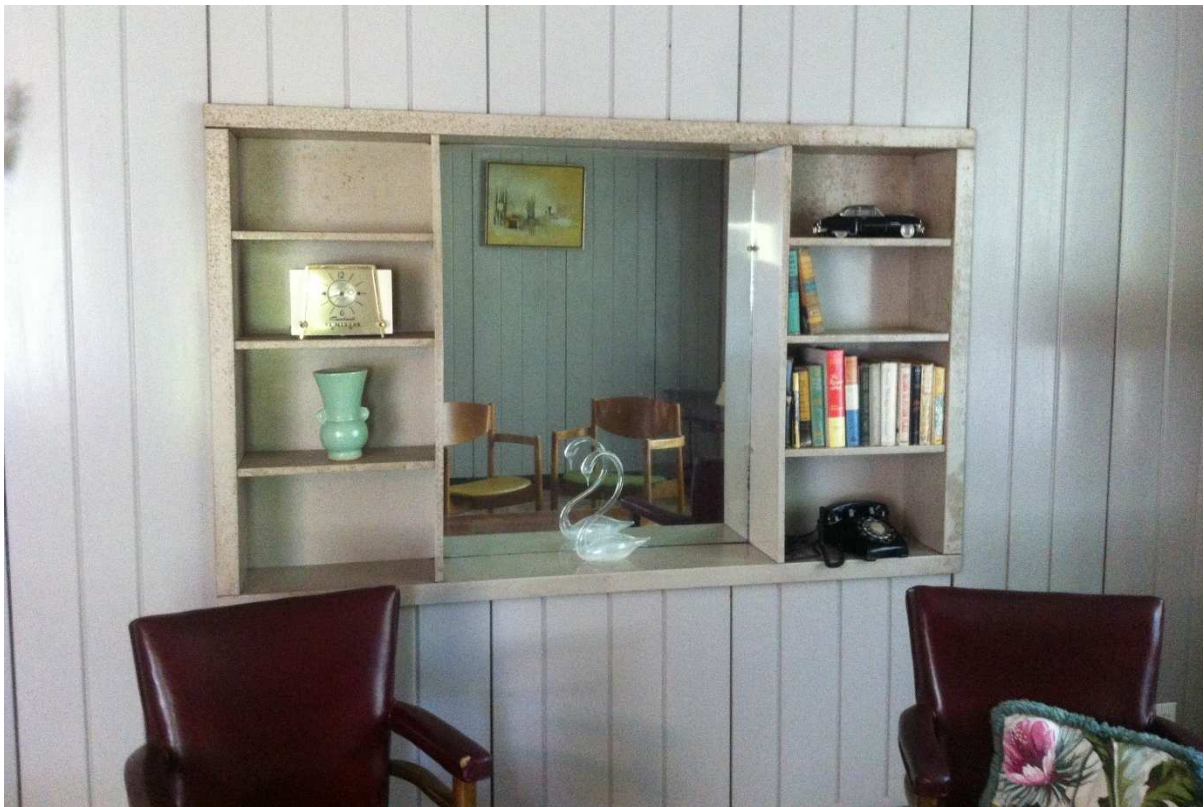
*Fig. 76 – View of Living Room bookcase unit, photo taken looking north, June 2017. Note the surface rust and added mirror.*

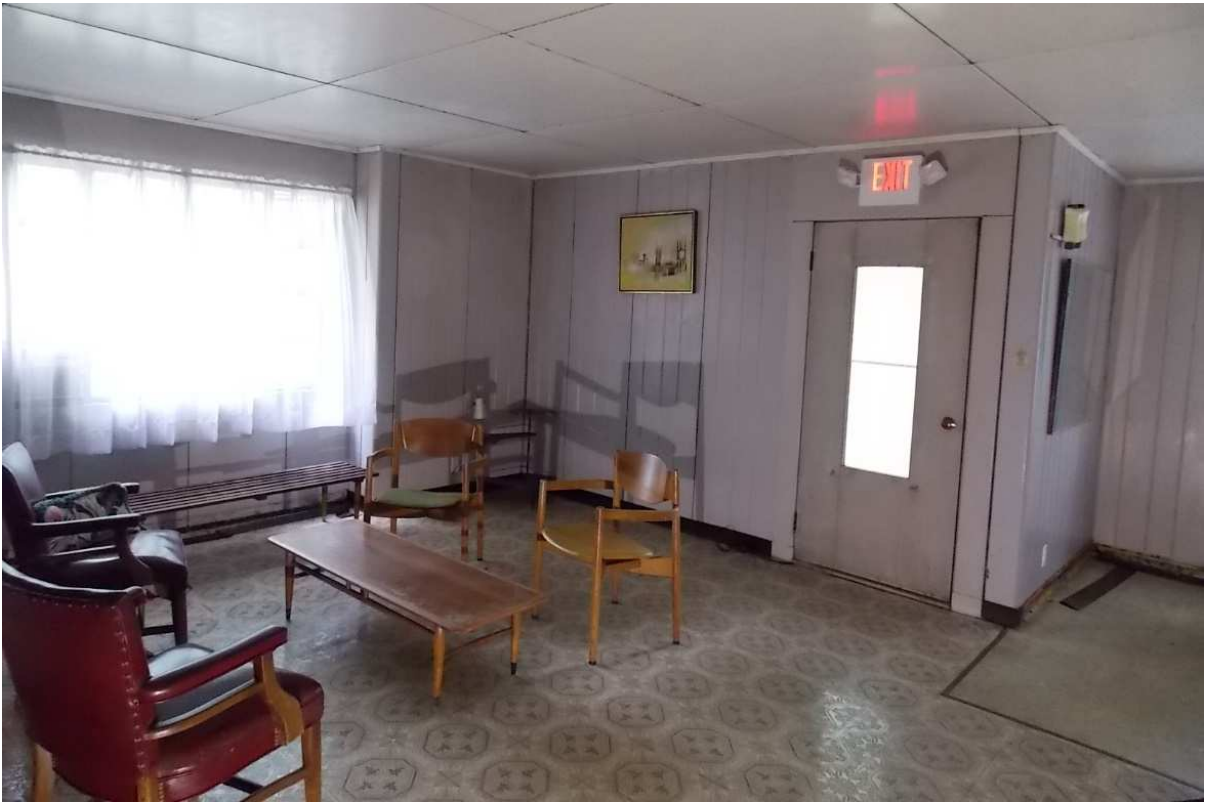
Fig. 77 – View of Living Room looking south from the Hallway, photo taken June 2017. Note the new Exit / Emergency lighting.

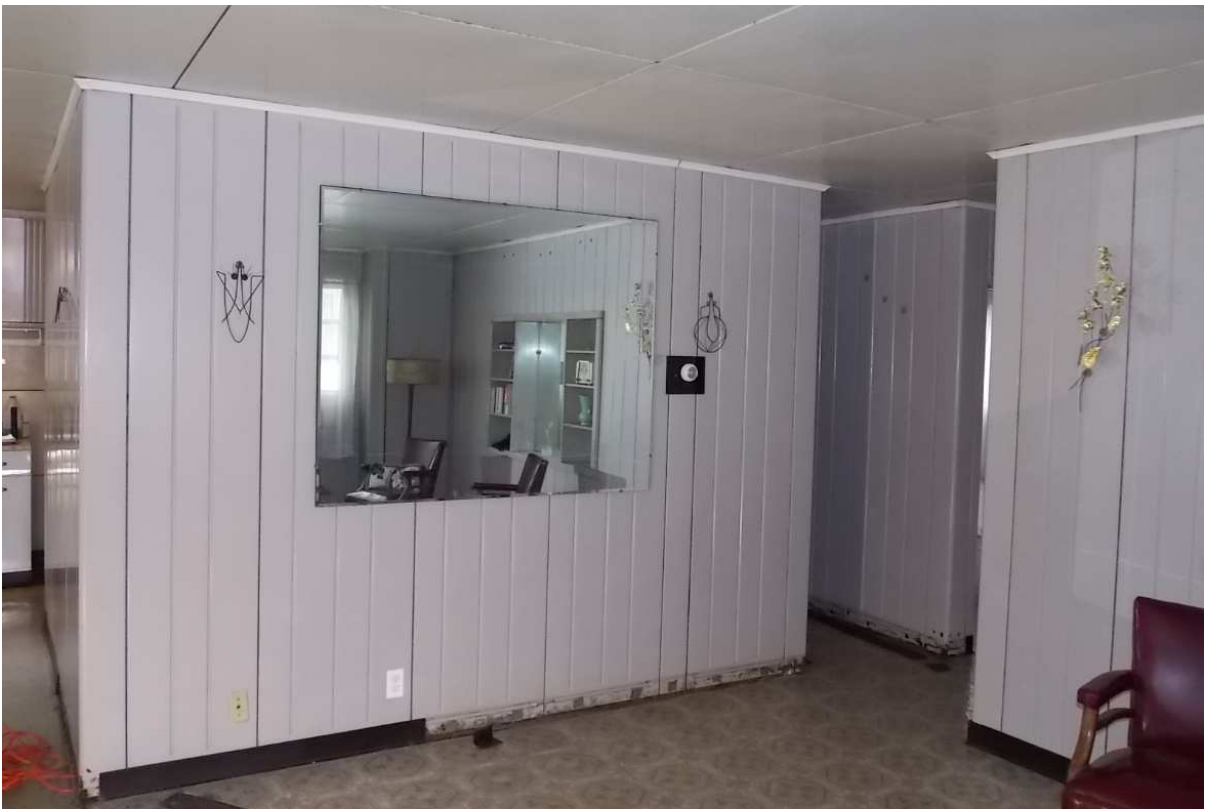
Fig. 78 – View of Living Room looking west toward the Hallway, photo taken June 2017. Note the missing section of base.

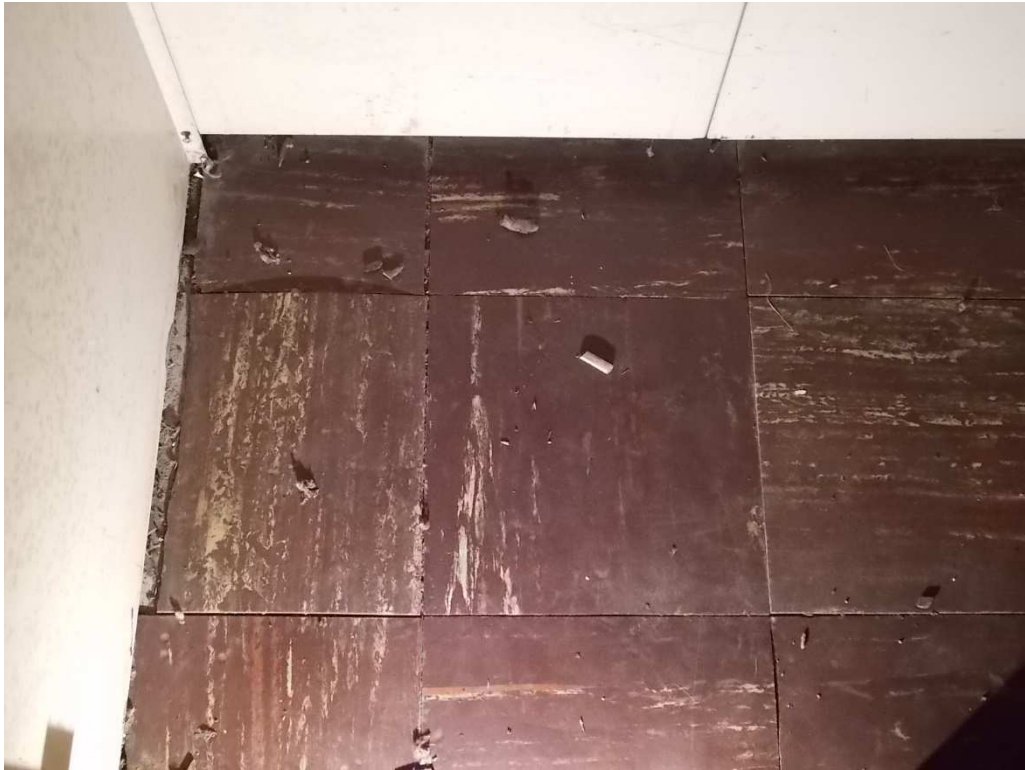
*Fig. 79 – Original dark brown vinyl floor tiles located in the guest closet of the Hallway. Some need to be re-adhered. Photo taken looking south, June 2017*

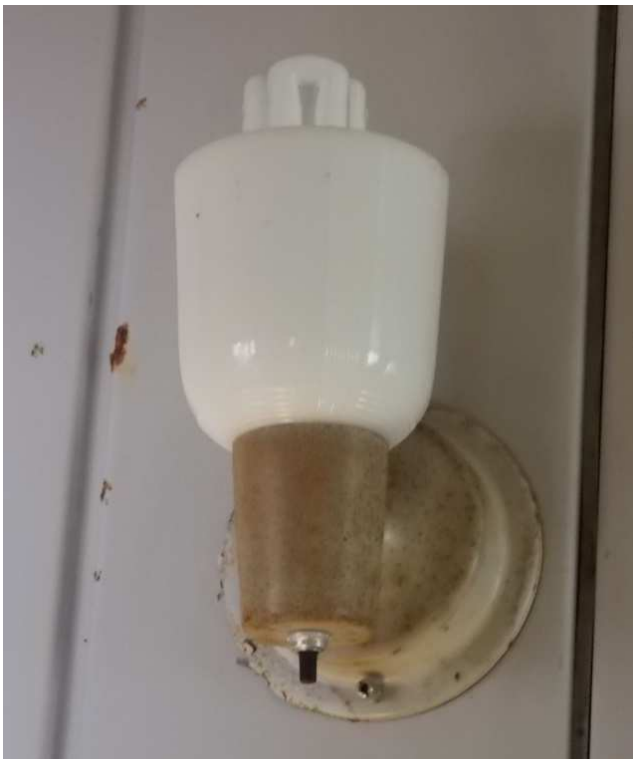
*Fig. 81 – Original wall-mounted light fixture in Hallway, photo taken looking east, June 2017. Note surface rust of finish and compact fluorescent lamp that extends past the shade.*

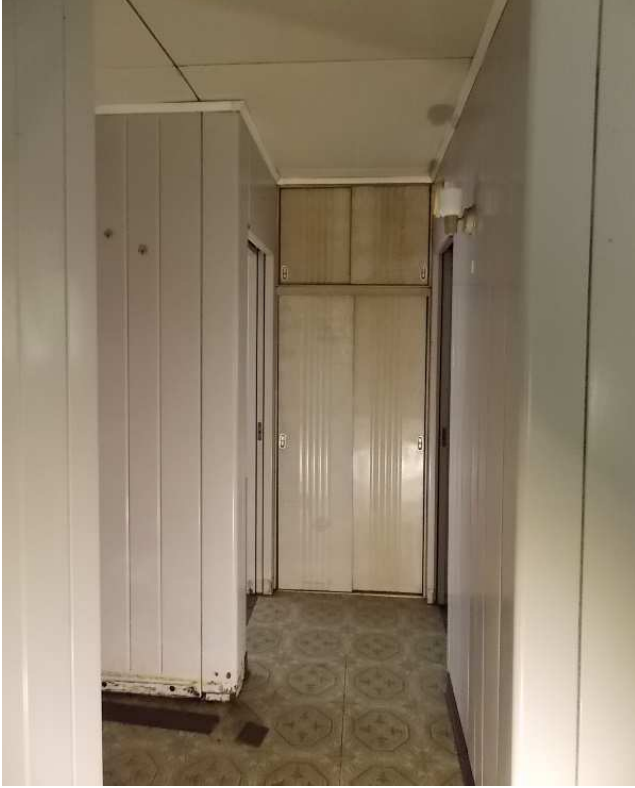
*Fig. 82 – View of Hallway looking north with linen closet doors closed, photo taken June 2017.*

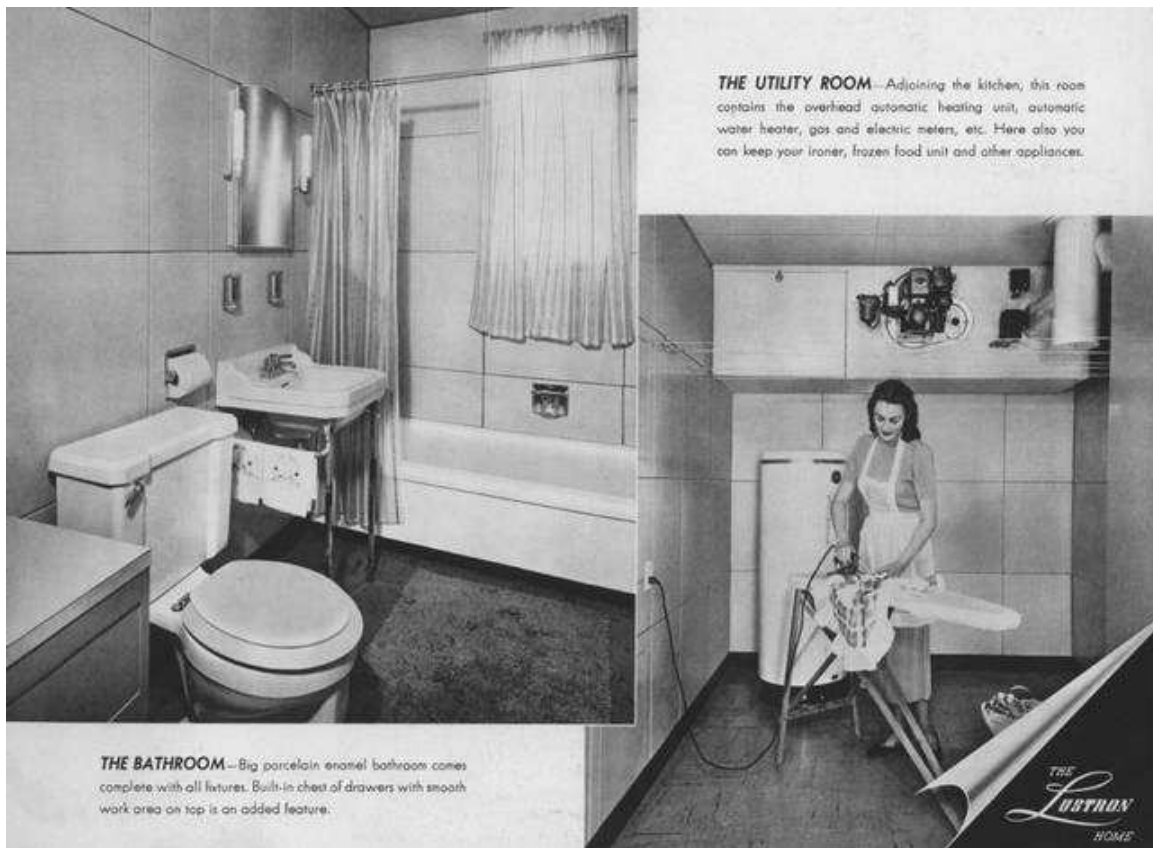
Fig. 84 – Lustron Corporation brochure depicting the Bathroom and Utility Room circa 1949.

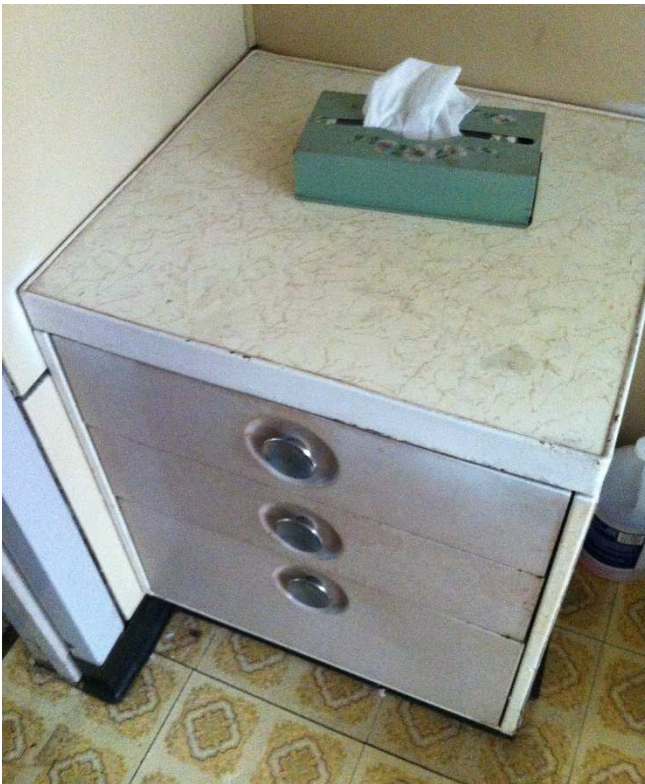
*Fig. 85 – Original bathroom vanity. The top no longer has its original painted enamel finish, photo taken looking south, June 2017. Note the replacement floor tiles.*

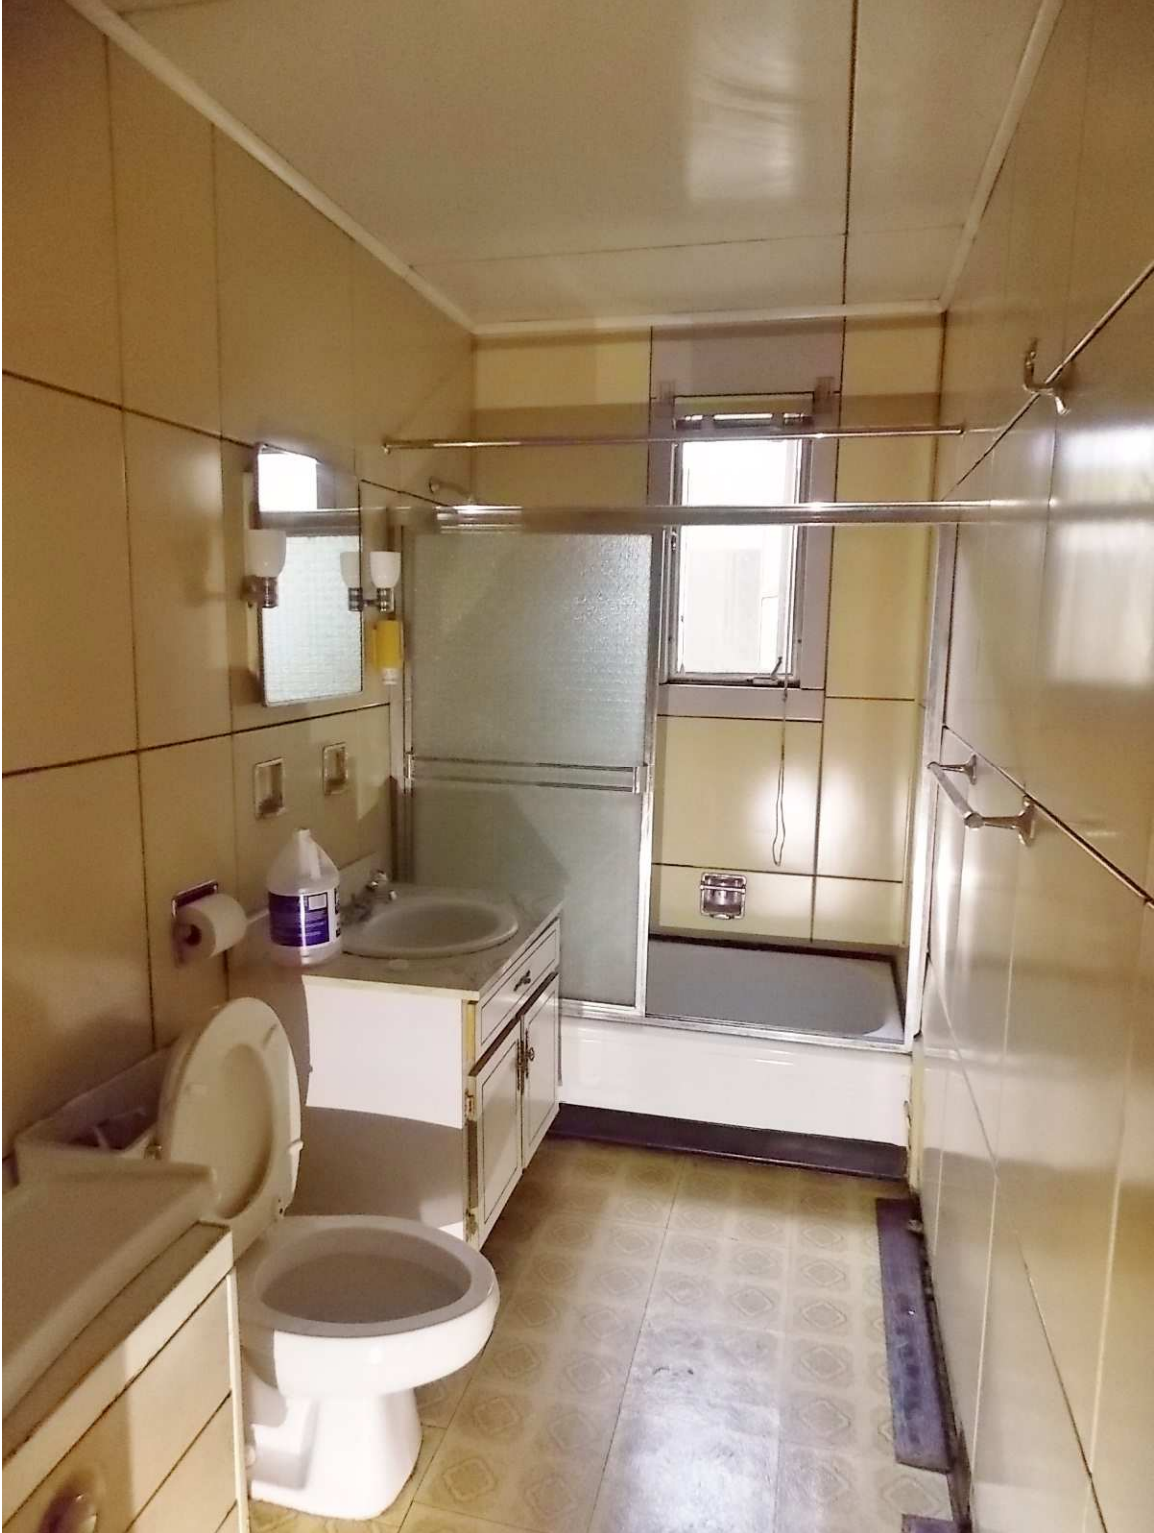
*Fig. 86 – View of Bathroom looking west from Hallway, photo taken June 2017. Note the glass shower doors which have been added.*

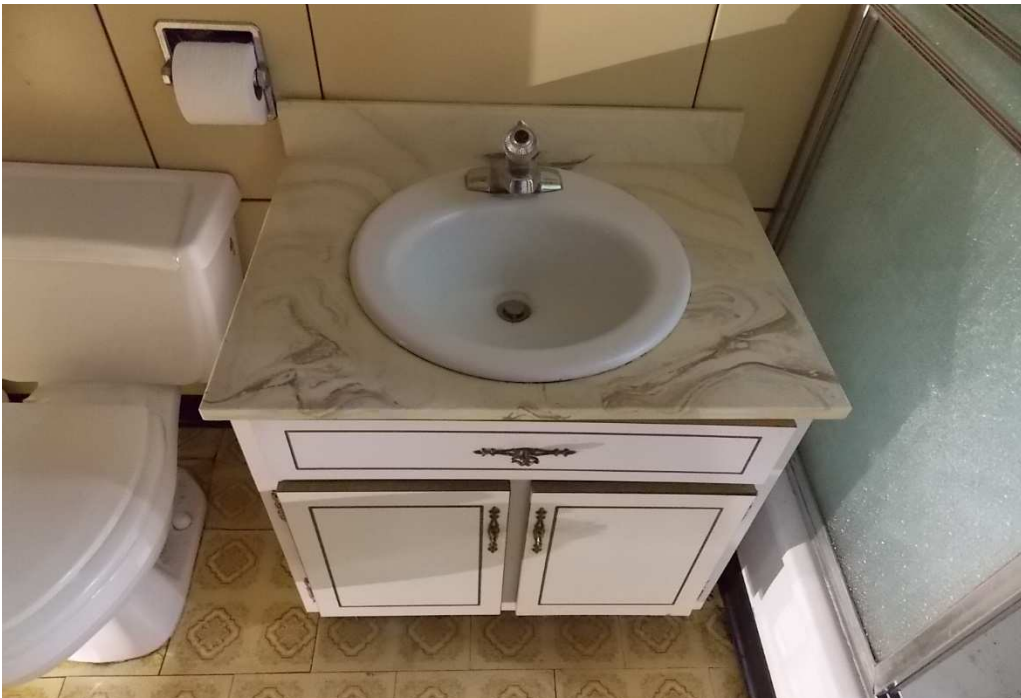
*Fig. 89 – Replacement vanity sink, photo taken looking south, June 2017. See Figure 84 on page 104 for view of an original lavatory.*

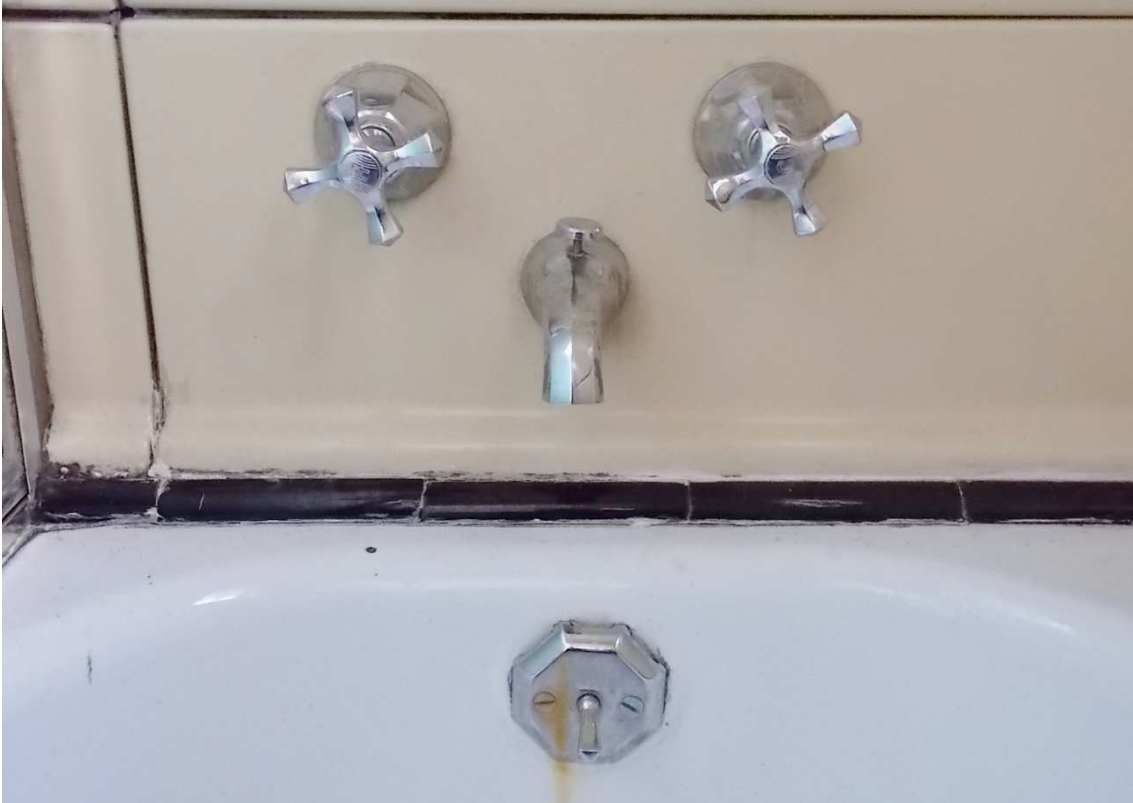
*Fig. 90 – Original faucets, knobs, and cleanout. The black ceramic tile was added later, probably to conceal rust damage. Photo taken looking south, June 2017.*

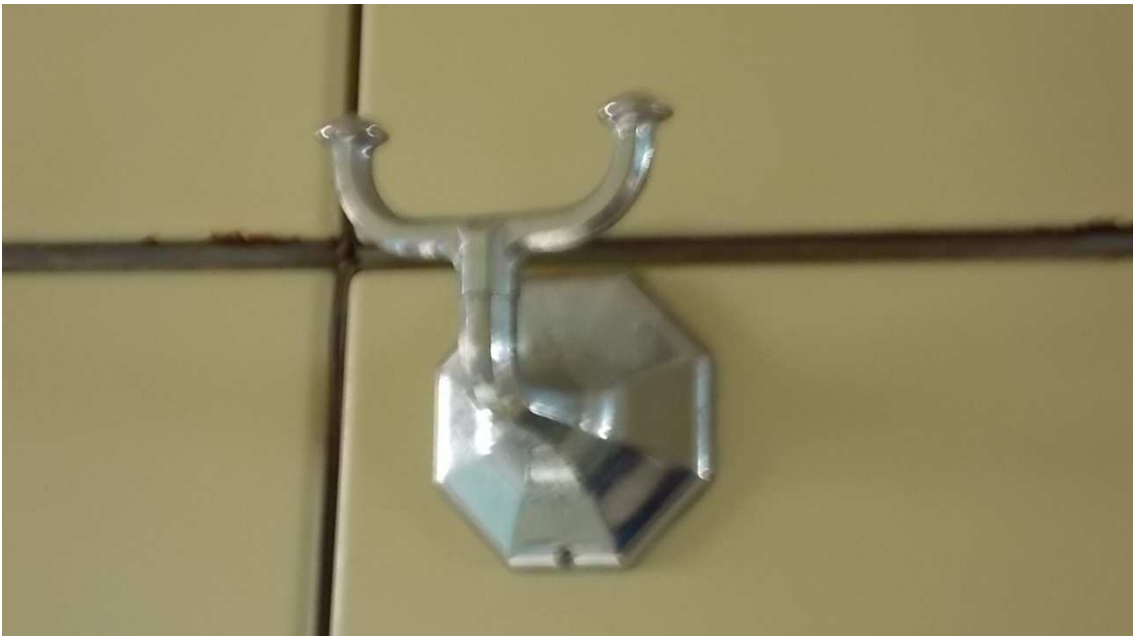
*Fig. 91 – Original double robe hook, photo taken looking north, June 2017.*

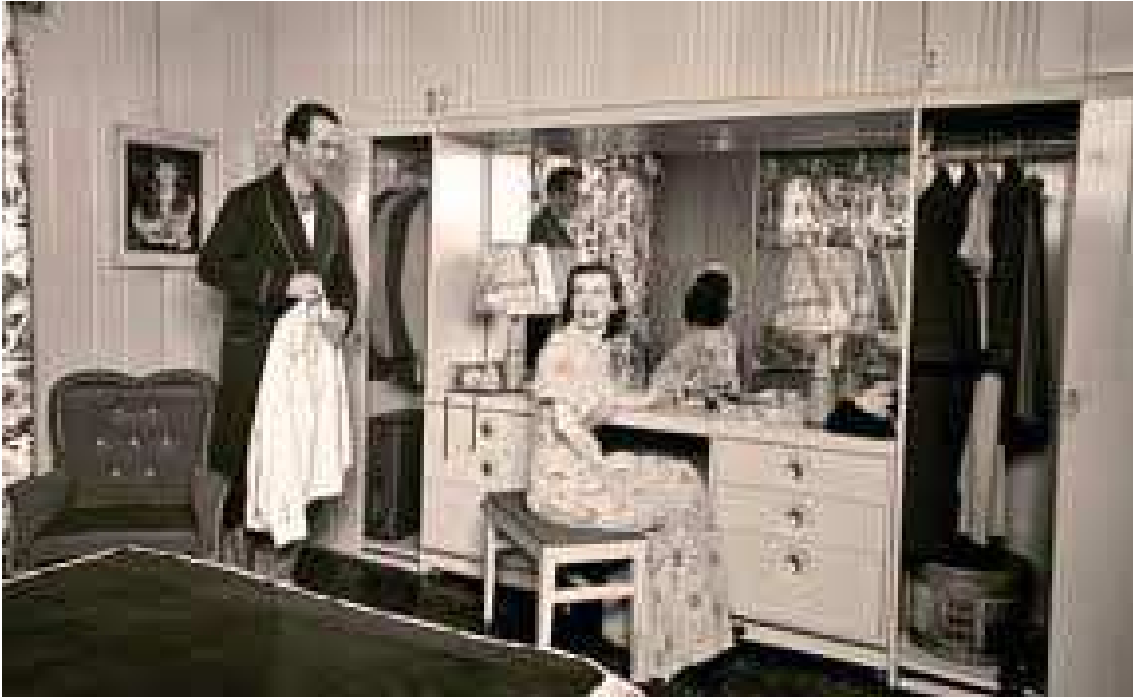
*Fig. 94 – Lustron Corporation advertisement showing Bedroom No. 1 circa 1949.*

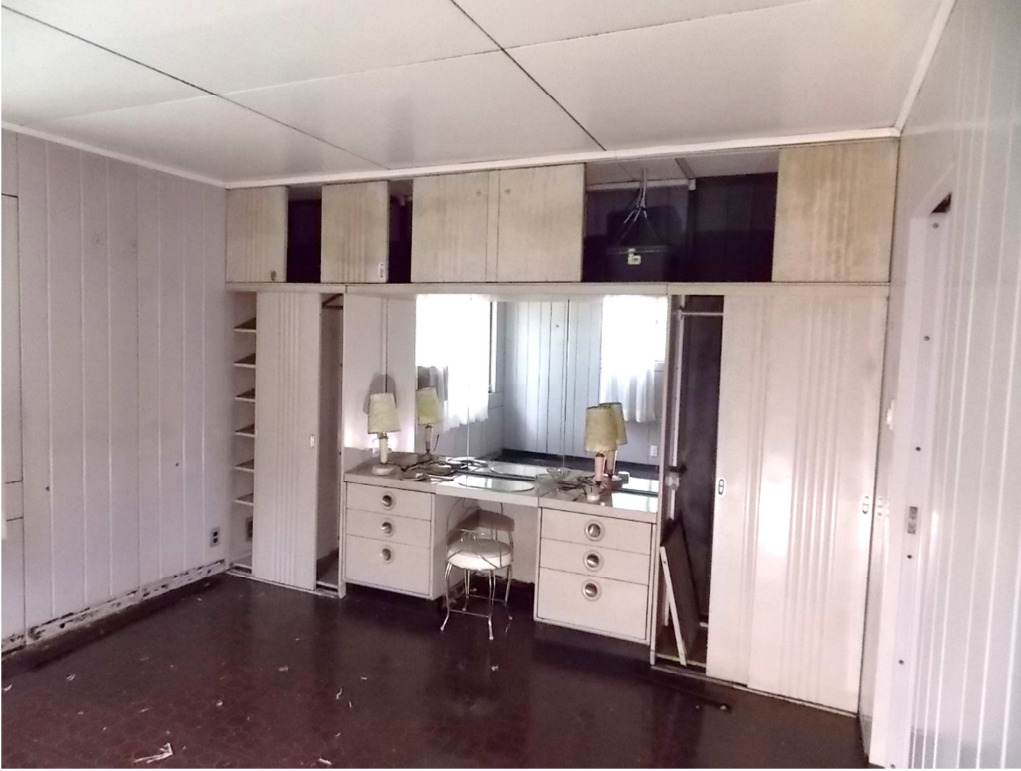
*Fig. 95 – View of vanity and closets in Bedroom No. 1, photo taken looking south, June 2017. Note the missing doors.*

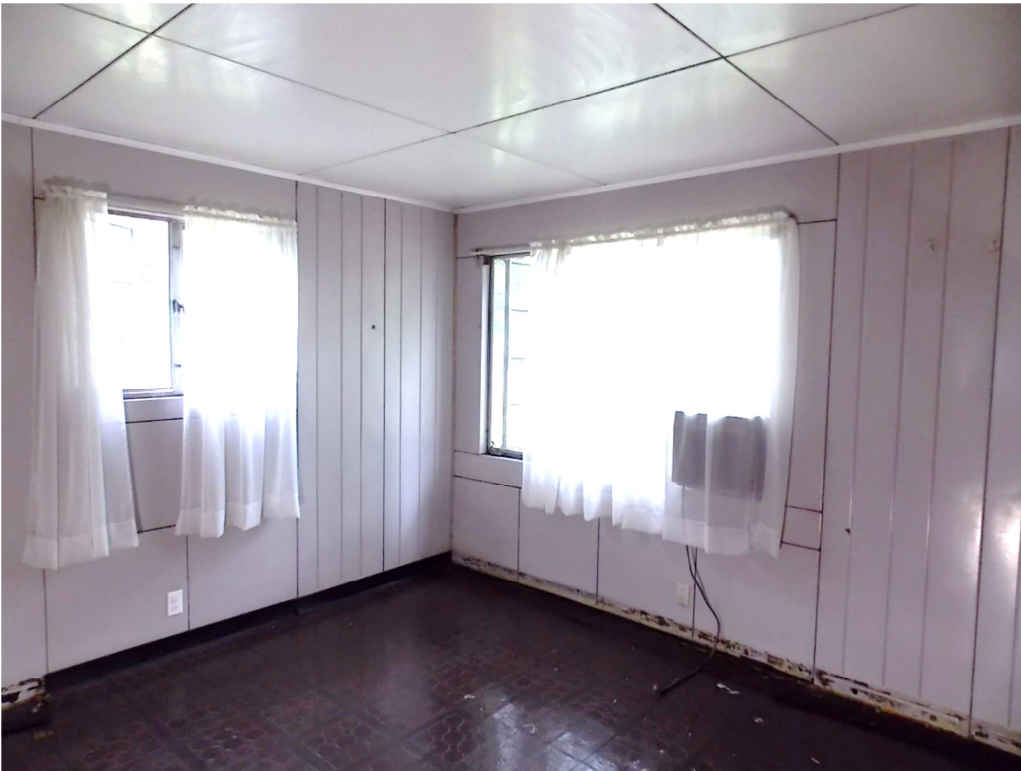
*Fig. 96 – View of Bedroom No. 1, photo taken looking east, June 2017. Note the un-adhered base and shiny vinyl flooring.*

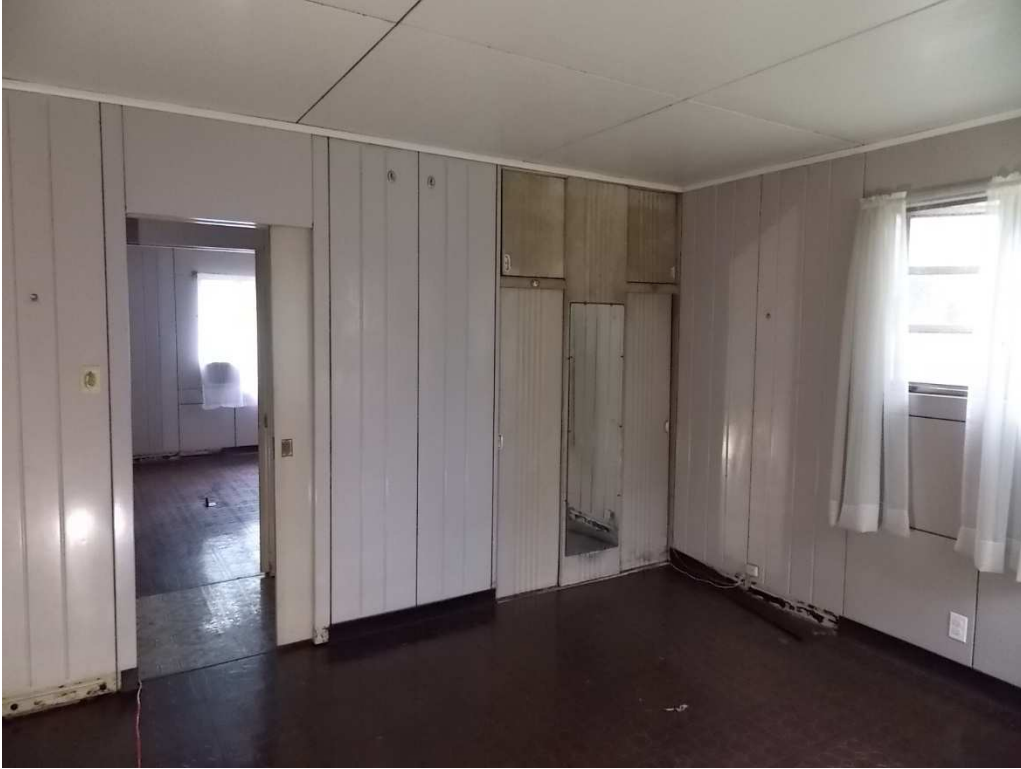
*Fig. 97 – View of Bedroom No. 1 looking west toward Bedroom No. 2, photo taken June 2017. Note the deteriorated finish on the closet.*

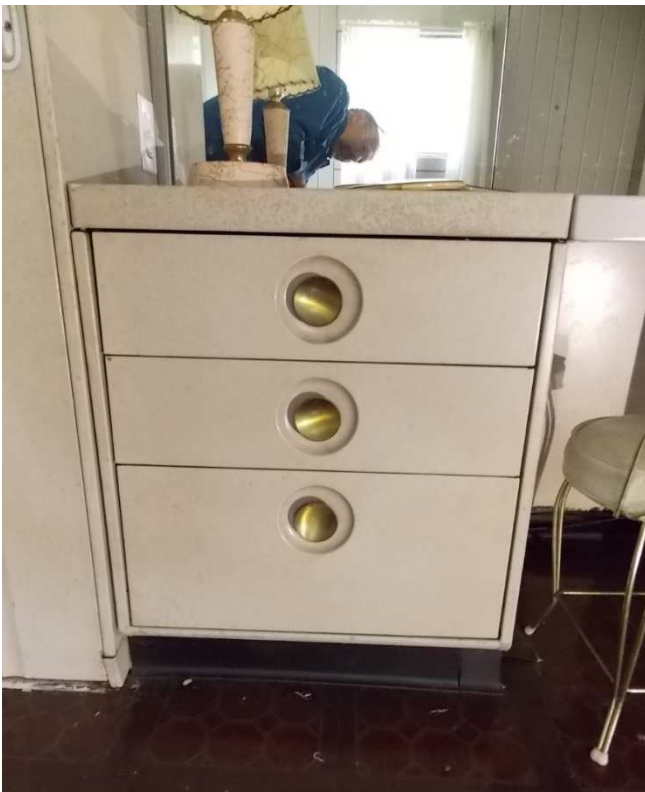
*Fig. 98 – Vanity drawer unit, photo taken looking south, June 2017.*

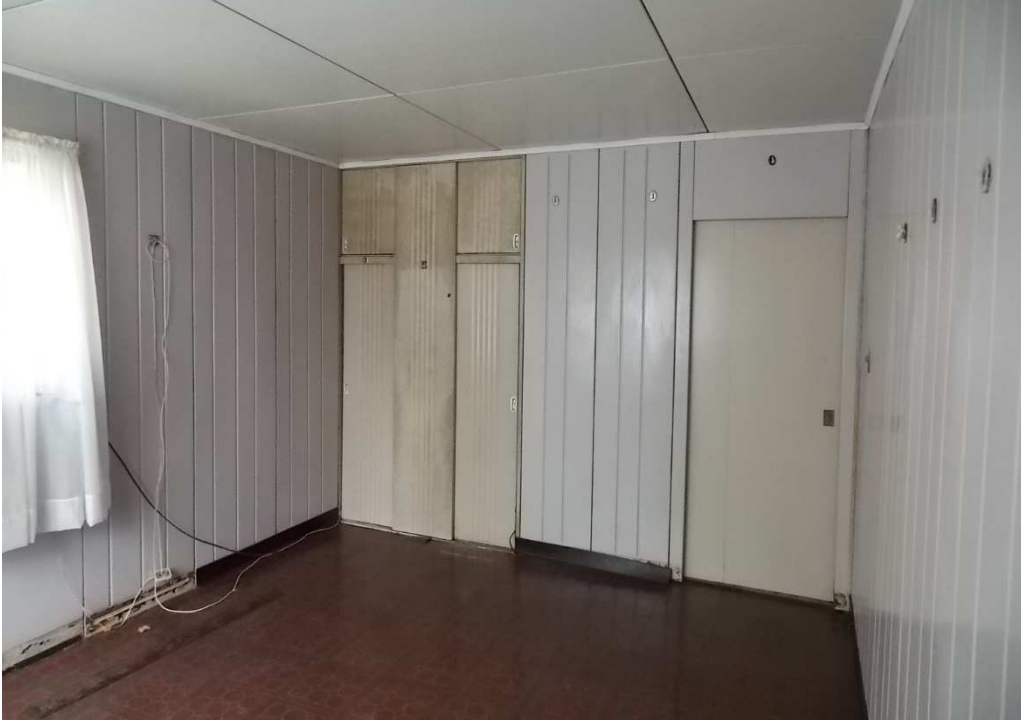
*Fig. 102 – View of Bedroom No. 2, photo taken looking east, June 2017. Note the rusting of the closet and entry door.*

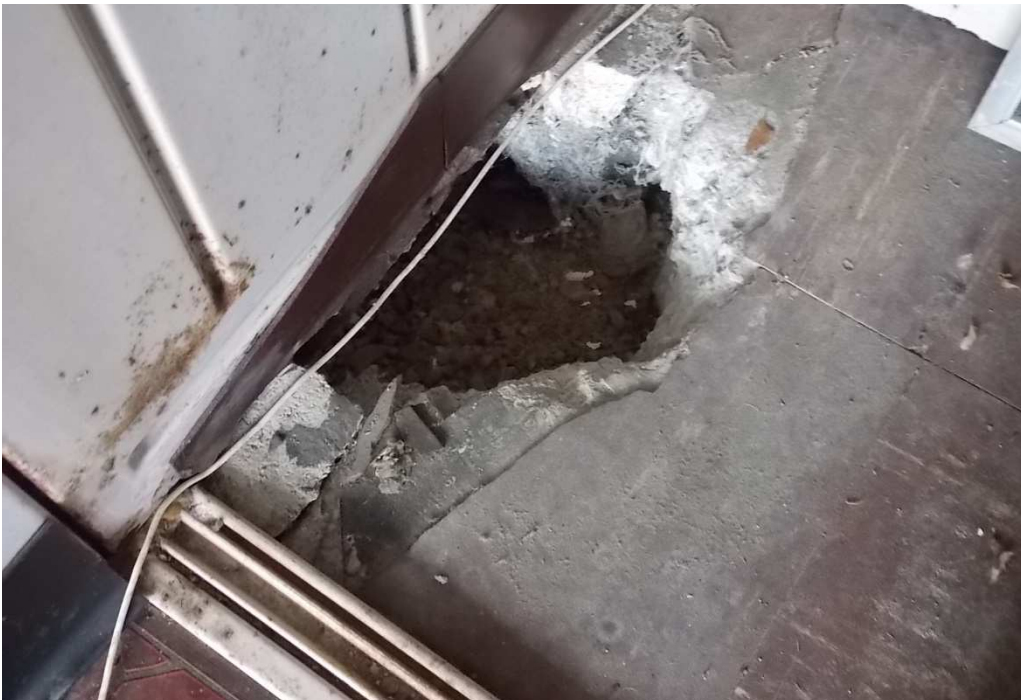
*Fig. 103 – The closet retains its original brown vinyl floor tile except where a hole has been cut through the concrete foundation and floor slab, photo taken looking north, June 2017.*

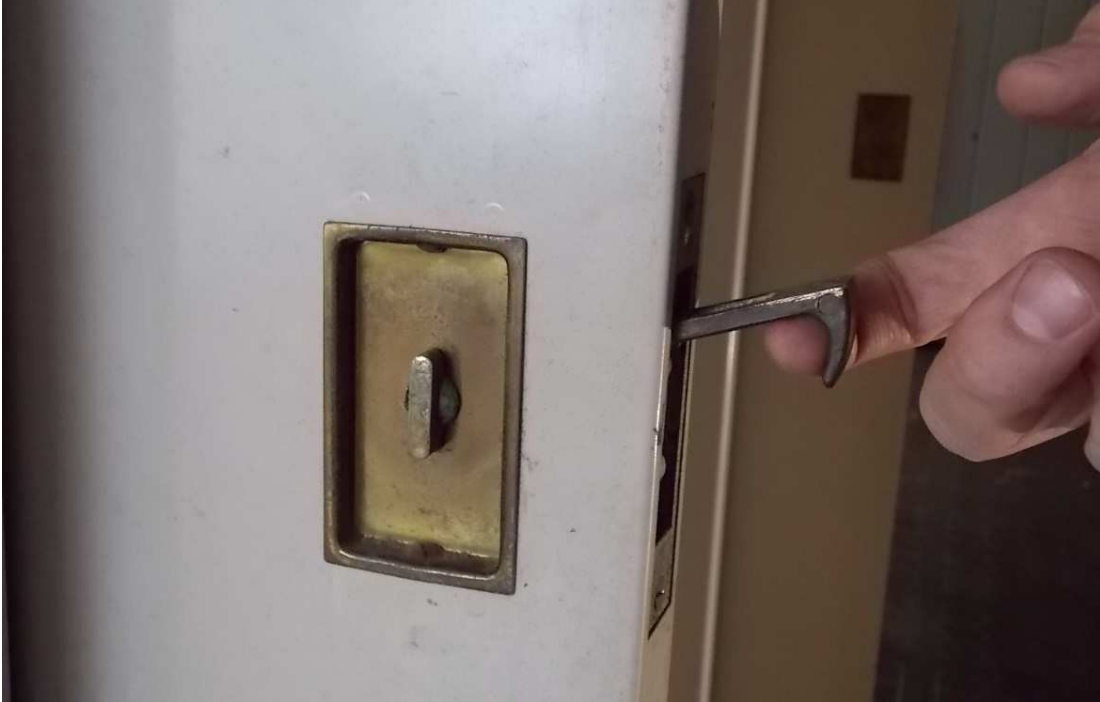
*Fig. 104 – Typical latch and finger pull for internal communicating doors, photo taken looking east, June 2017.*

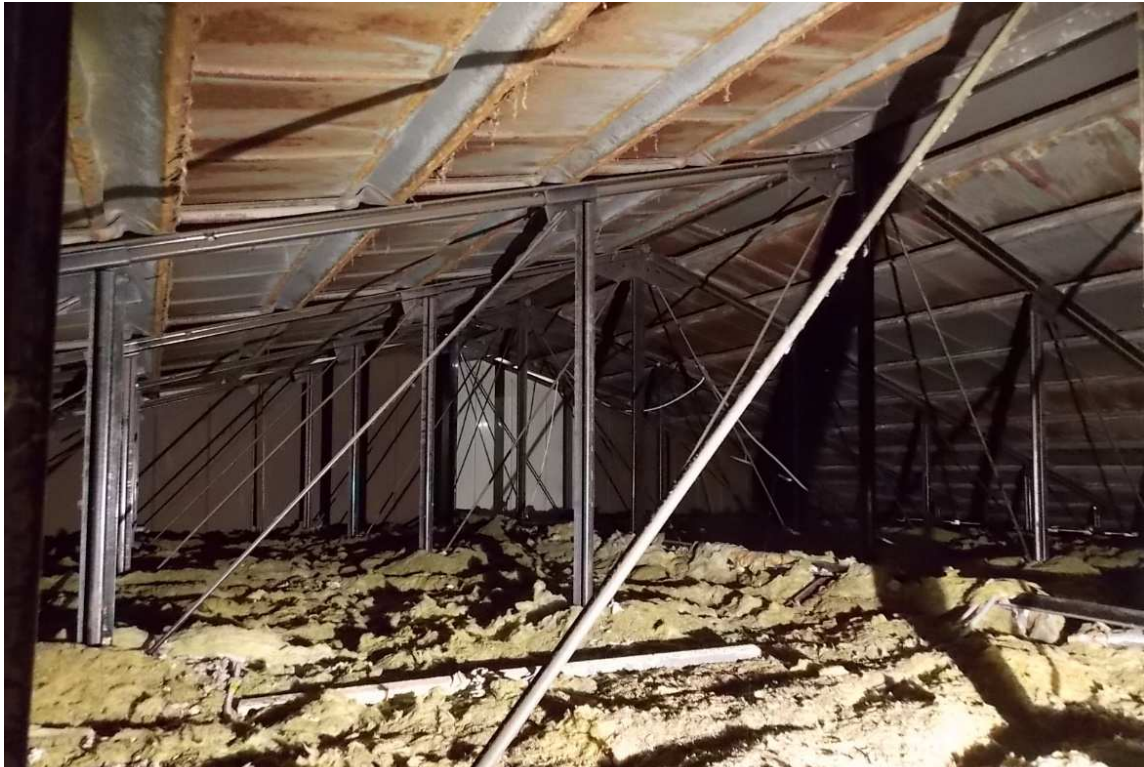
*Fig. 108 – View of the attic from the scuttle location looking north, photo taken June 2017.*

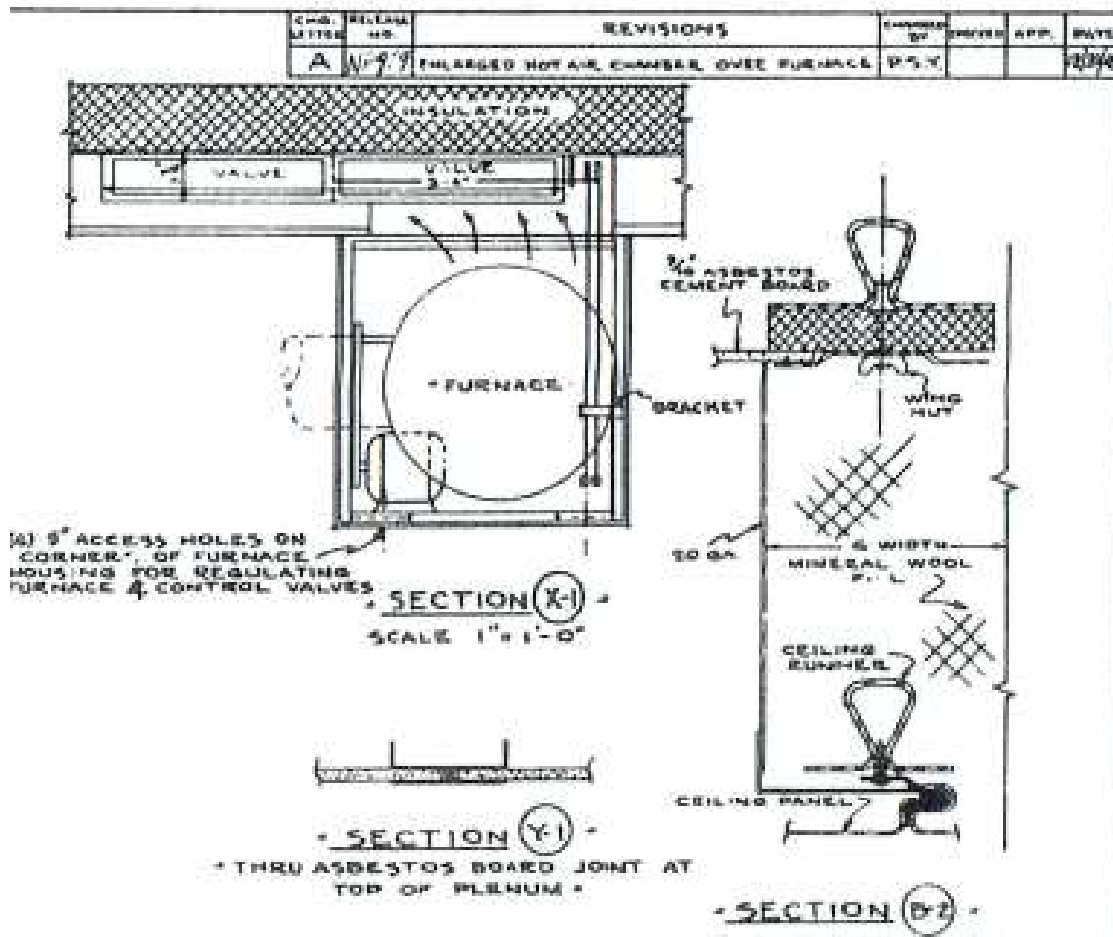
Fig. 109 – Detail from Lustron drawing AP2-J-100 included in the Lustron Corp. Architectural Plans – Model 02 Home Appendix to this report. Note the asbestos cement board which forms the top of the plenum chamber. The insulation between the board and the bottom of the roof trusses is called out as “Corrugated Asbestos Insulation”.

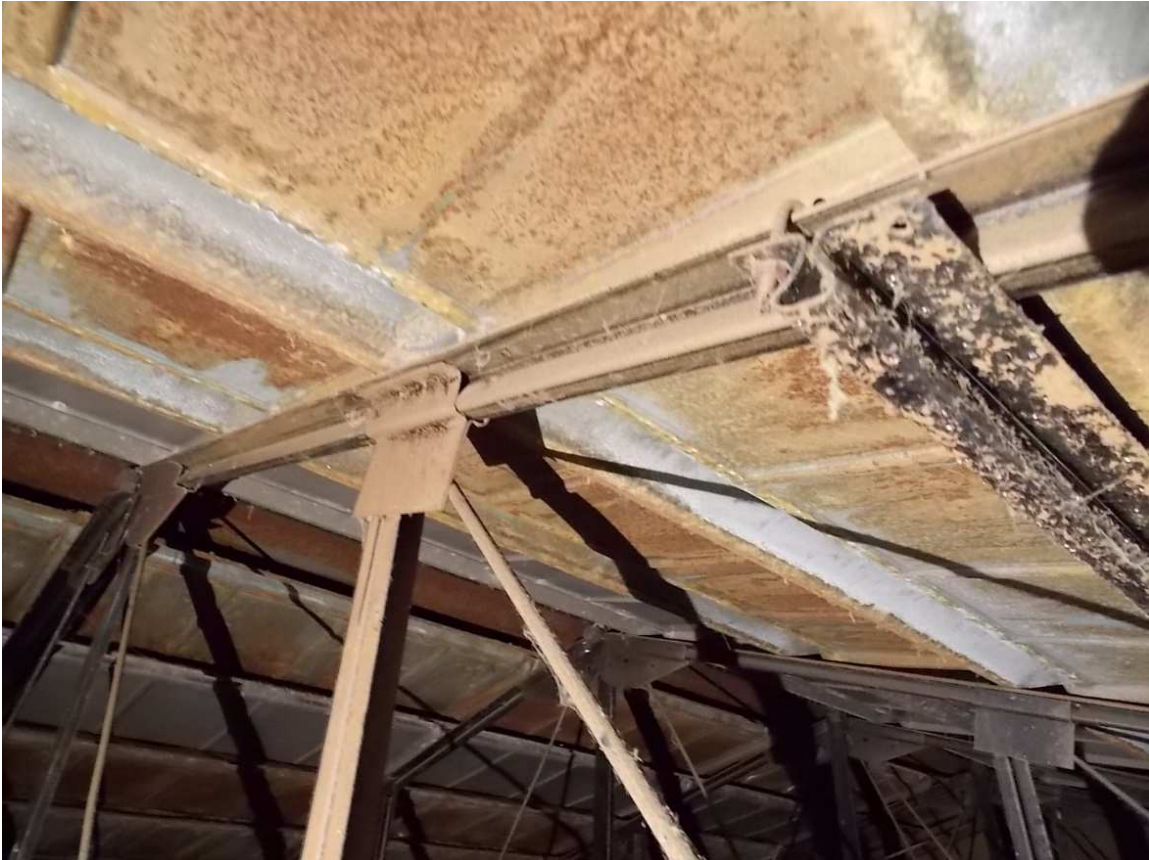
*Fig. 110 – Surface rusting is exhibited on the underside of roof panels and the roof trusses.*

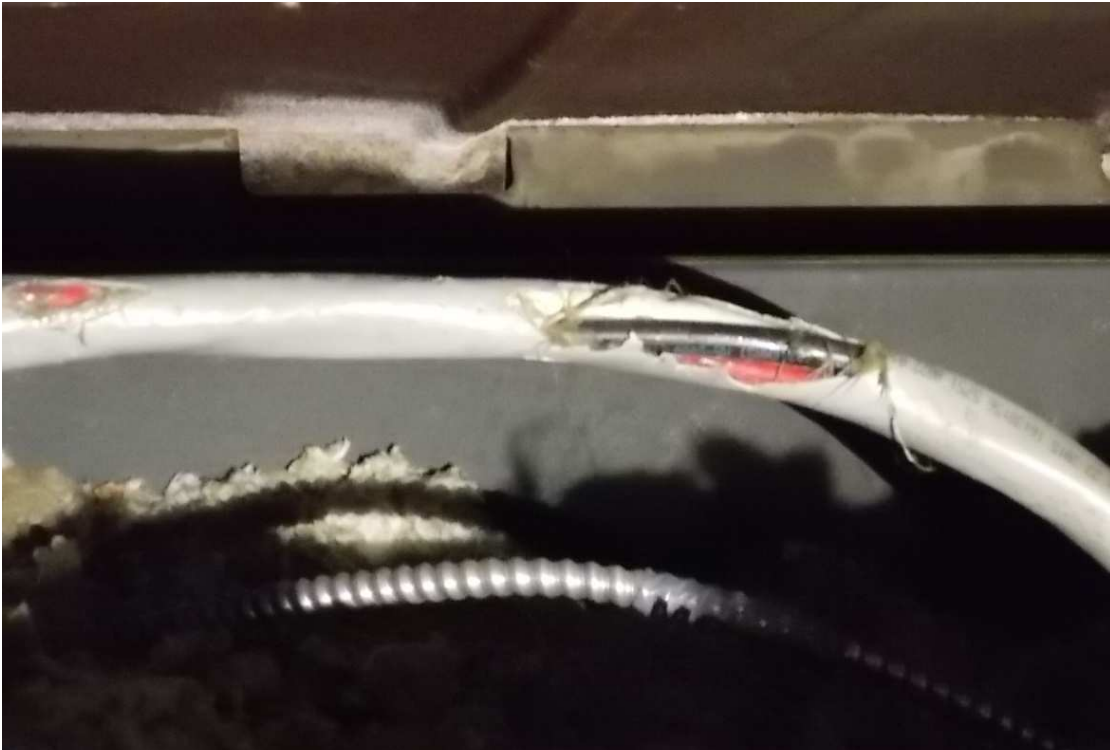
*Fig. 111 – Raccoon or rodent chewed wiring, photo taken June 2017.*
