# Harold Hess Lustron House

Closter, New Jersey

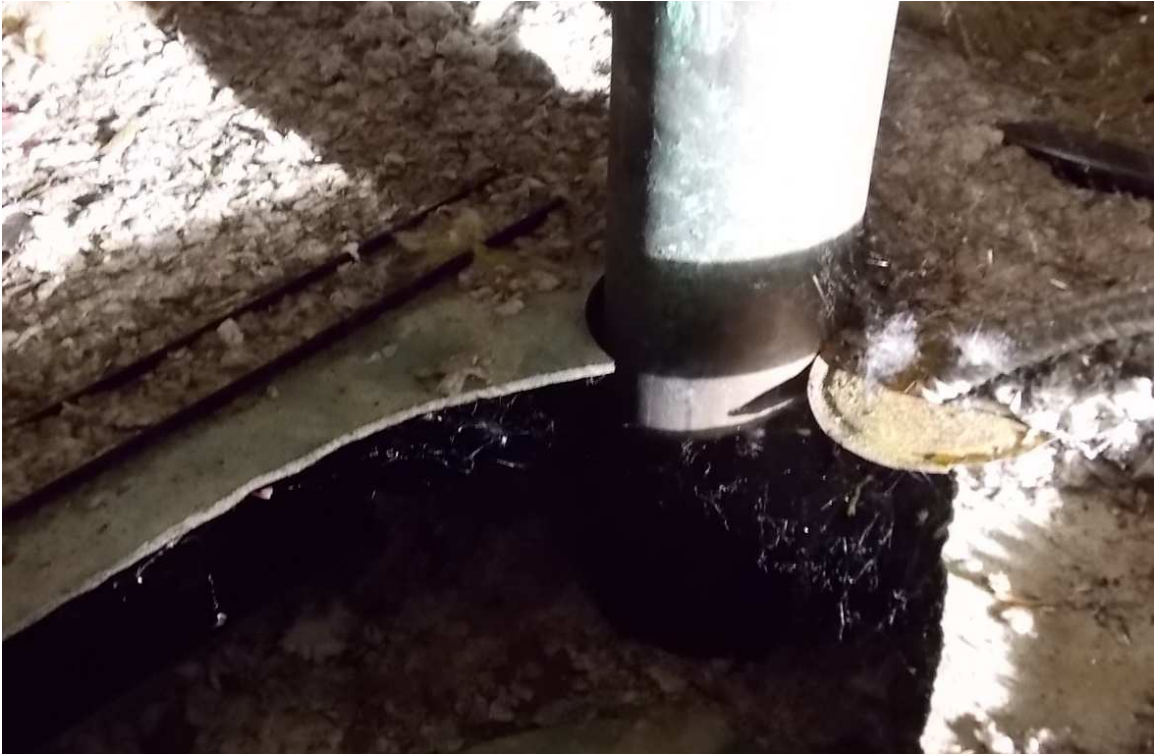
*Fig. 113 – Broken cement-asbestos panel in top of plenum, photo taken June 2017.*

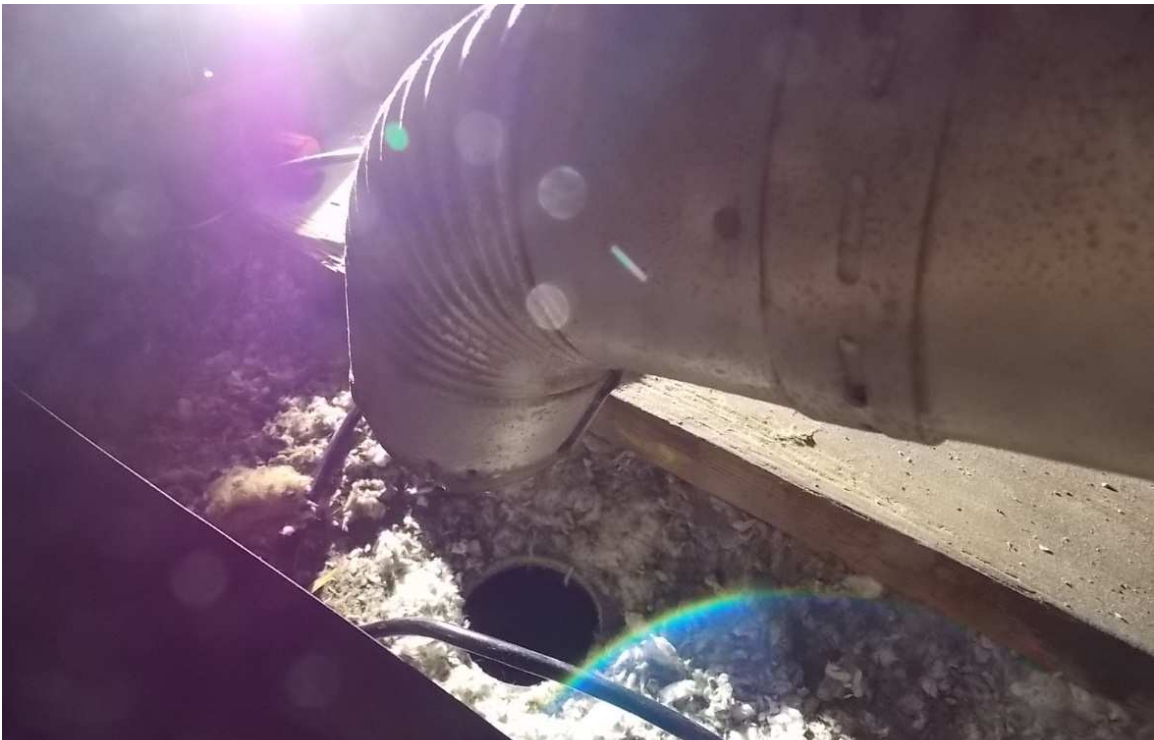
*Fig. 114 – Original hole in Utility Room attic for water heater has been plugged but flue remains in attic, photo taken June 2017.*

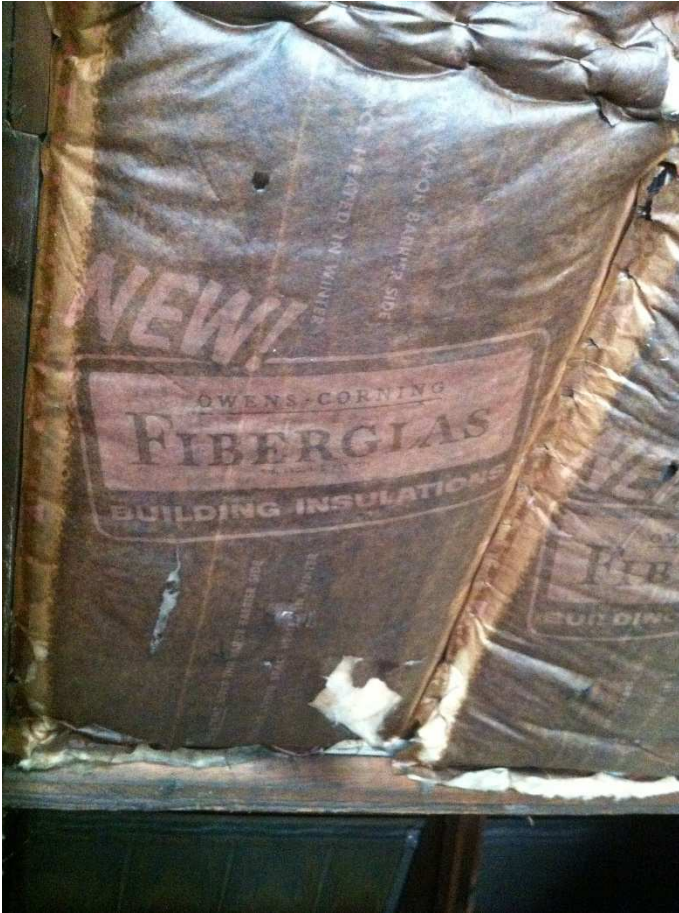
*Fig. 116 – Fiberglas batt insulation which appears to date from the mid-20<sup>th</sup> century, photo taken June 2017.*

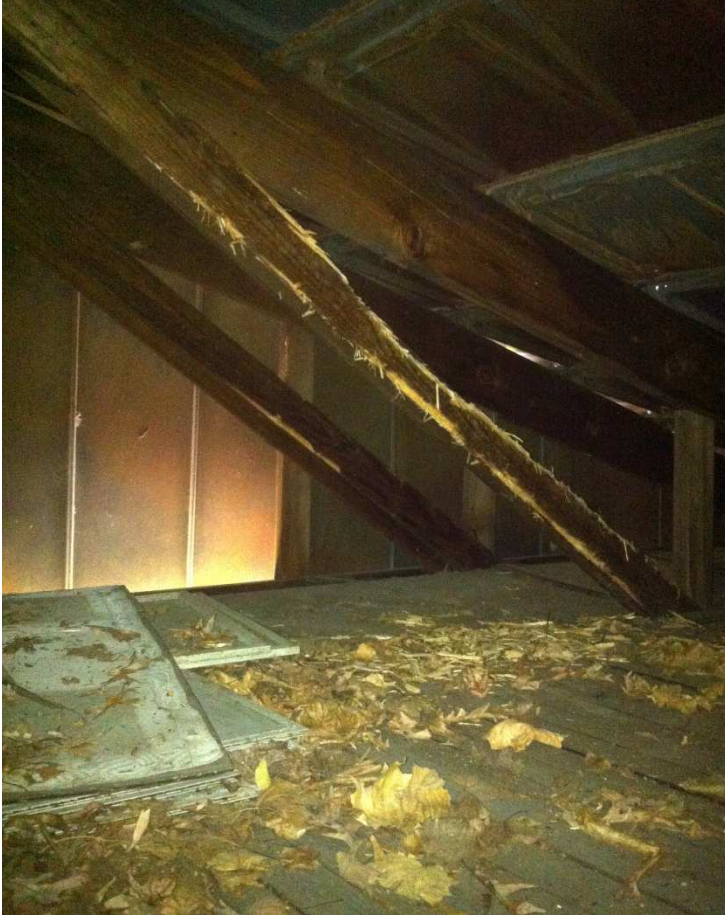
*Fig. 118 – One of the truss members has been damaged by raccoon or rodent gnawing, photo taken looking west, June 2017.*

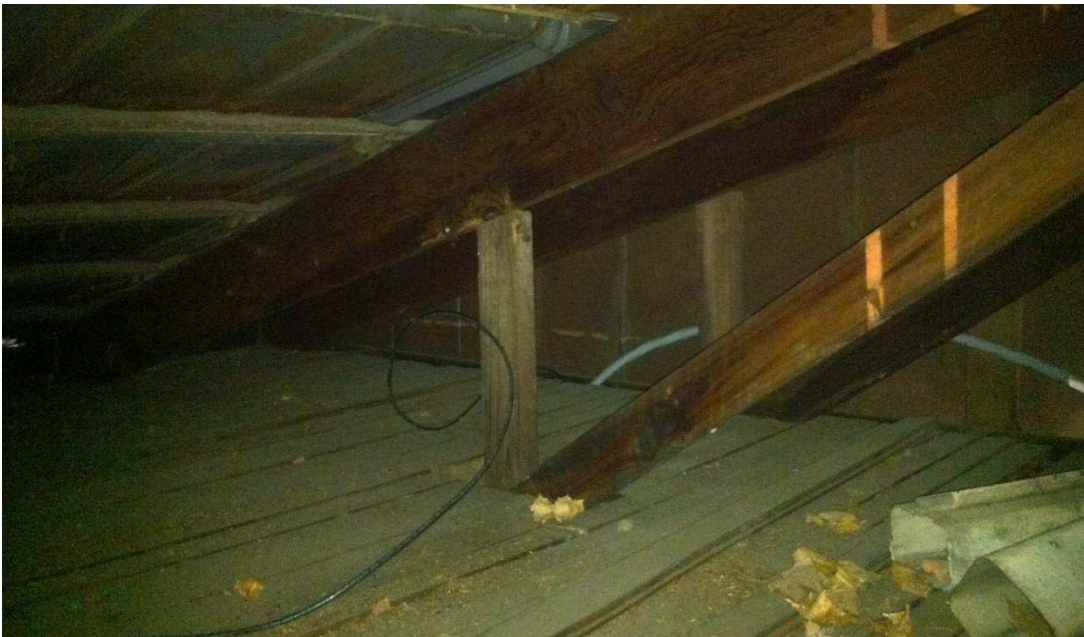
*Fig. 119 – Jacking of the roof trusses to straighten the ridge should not be attempted, photo taken looking west, June 2017. Note the original downspouts stored in the garage attic.*

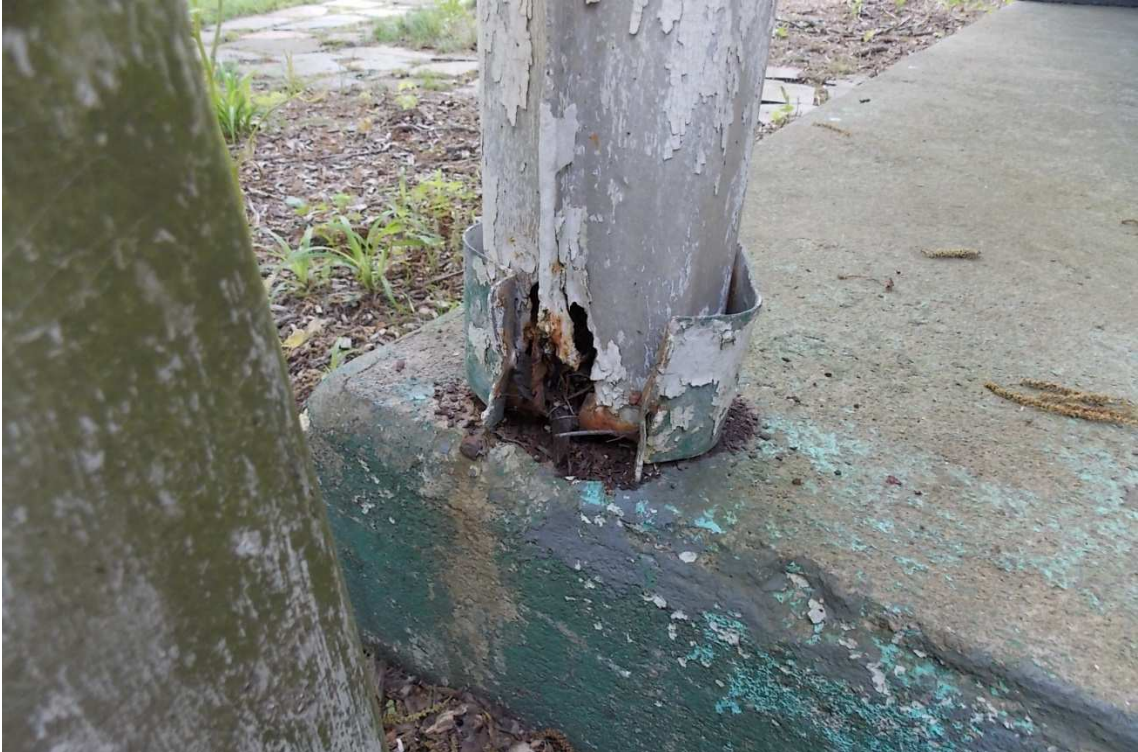
*Fig. 122 – The base of the porch column is rusted and requires repair, photo taken looking west, June 2017.*

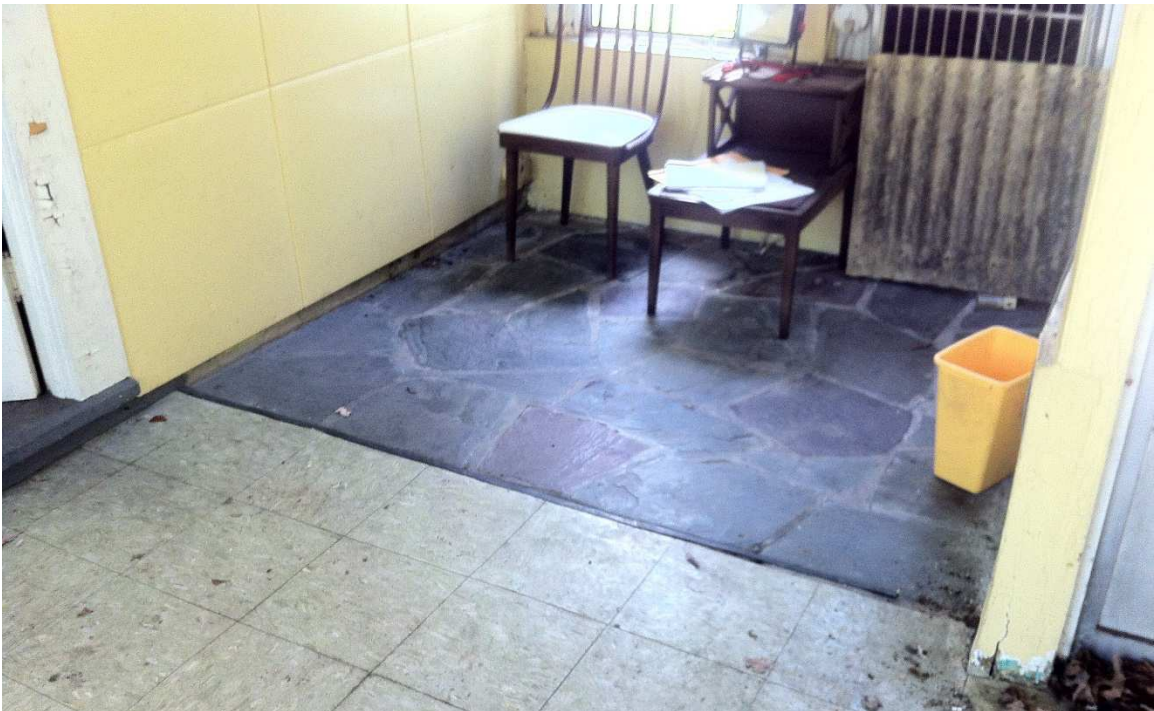
*Fig. 123 – The concrete floor slab in the breezeway expansion has settled toward the rear wall, photo taken looking north, June 2017.*

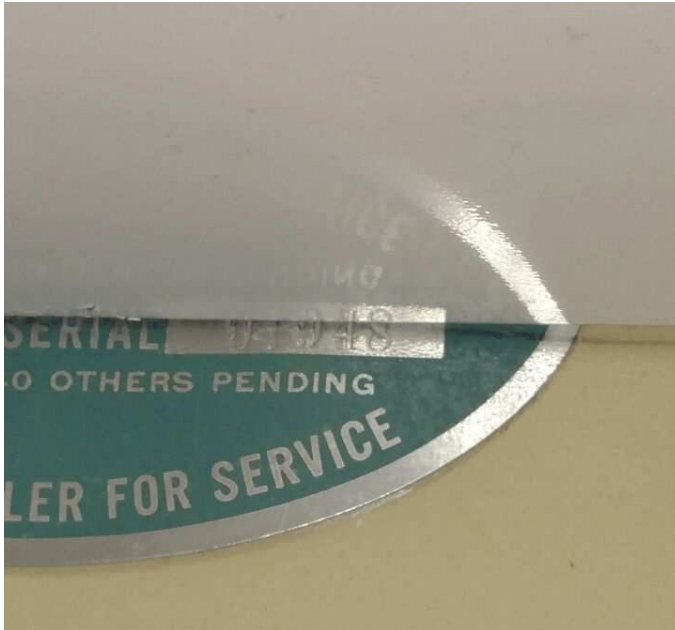
*Fig. 124 – View of the Lustron Serial Number tag installed looking east in the Utility Room of the Harold Hess Lustron House. Photo courtesy of Jennifer Rothschild.*

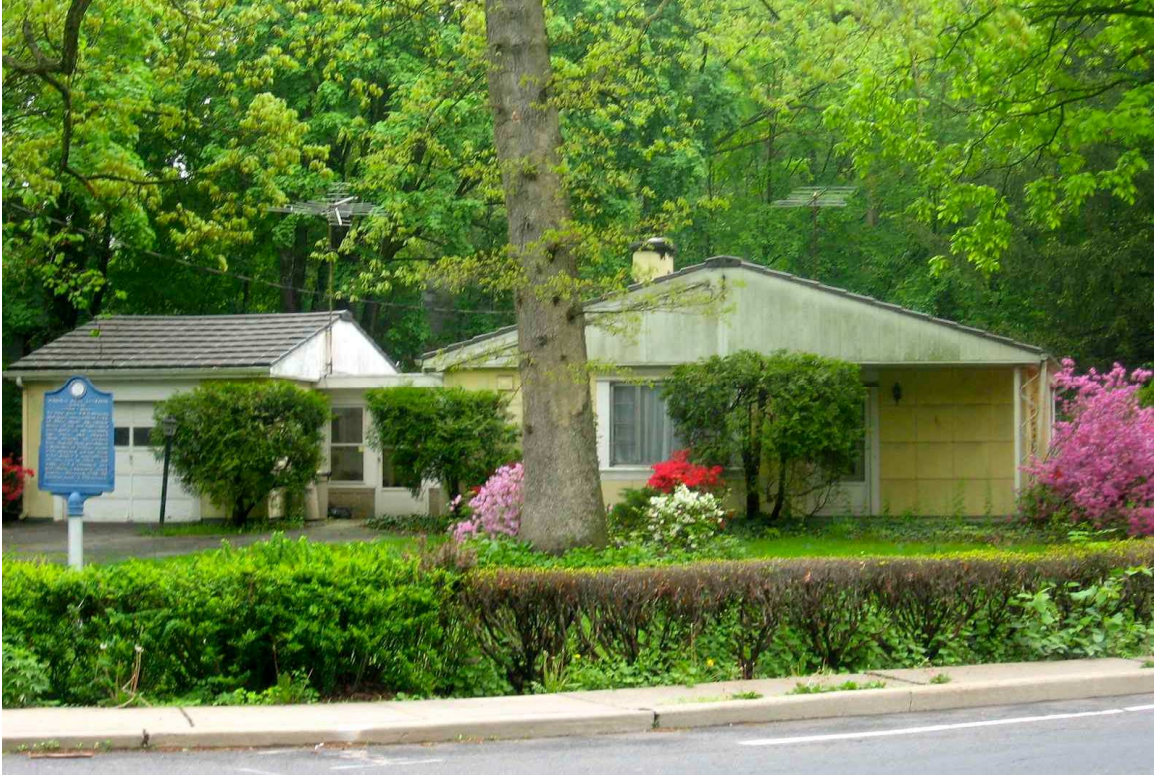
*Fig. 125 – View of the Harold Hess Lustron House as it appeared with landscaping in Spring 2009. Photo courtesy of Jennifer Rothschild.*

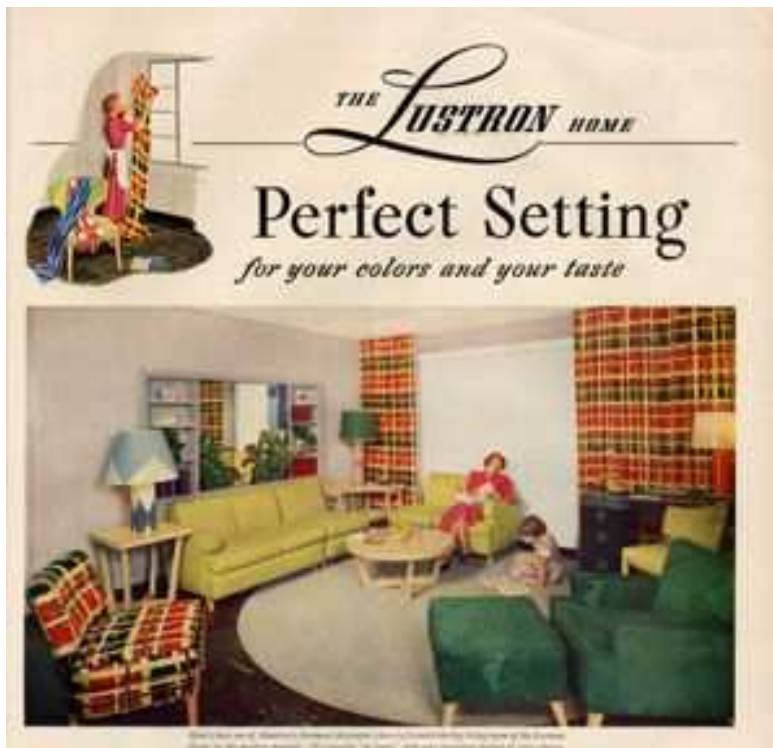
Fig. 126 – Lustron Corp. advertisement circa 1949

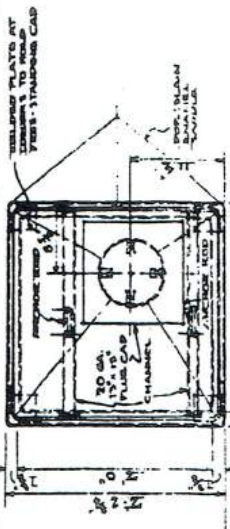
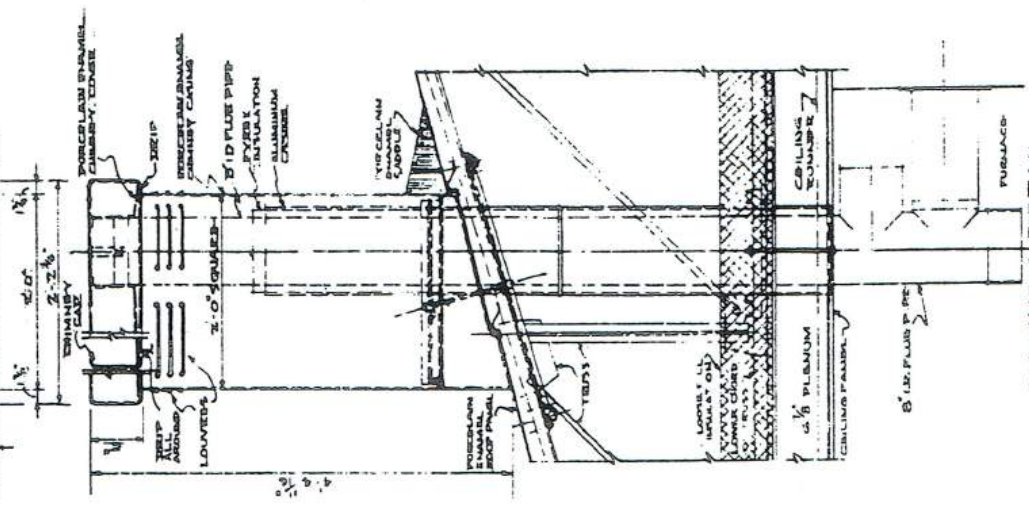
CHIMNEY DETAIL  
SCALE 1/4"=1'-0"

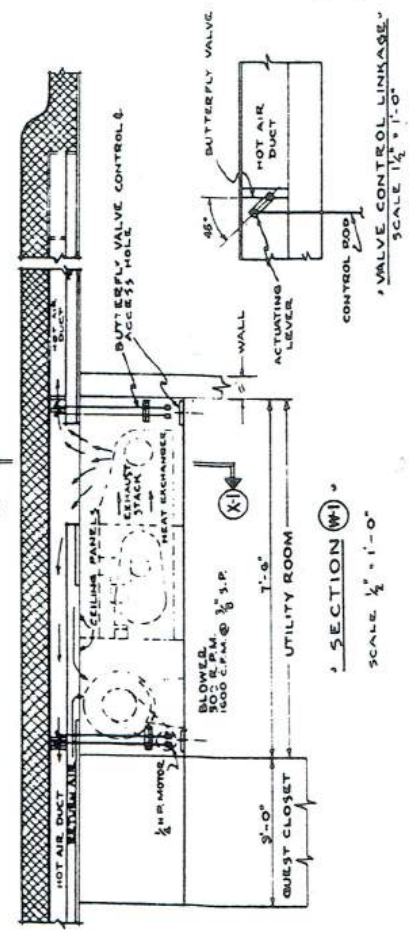
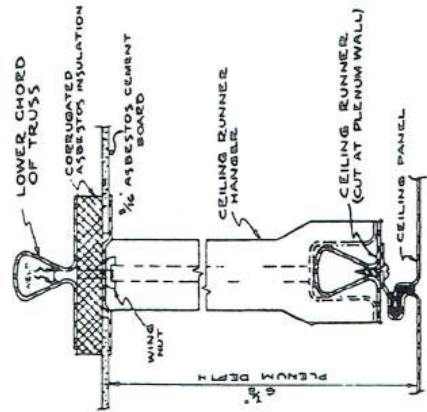
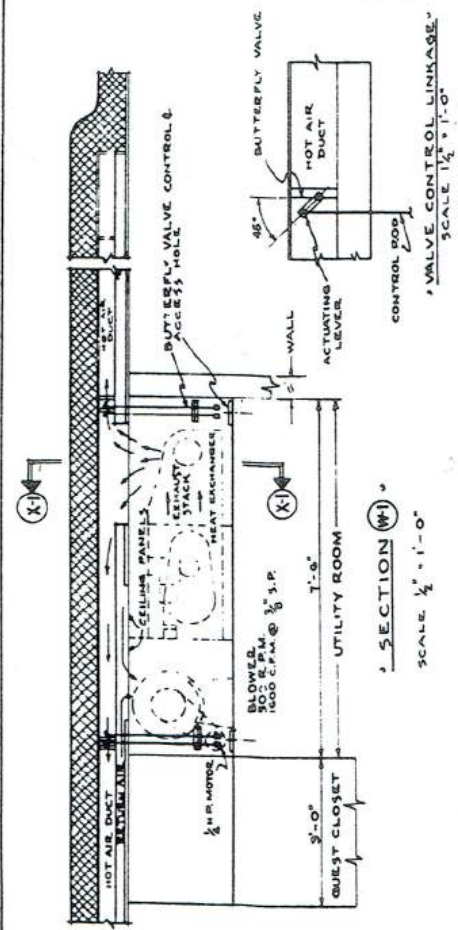
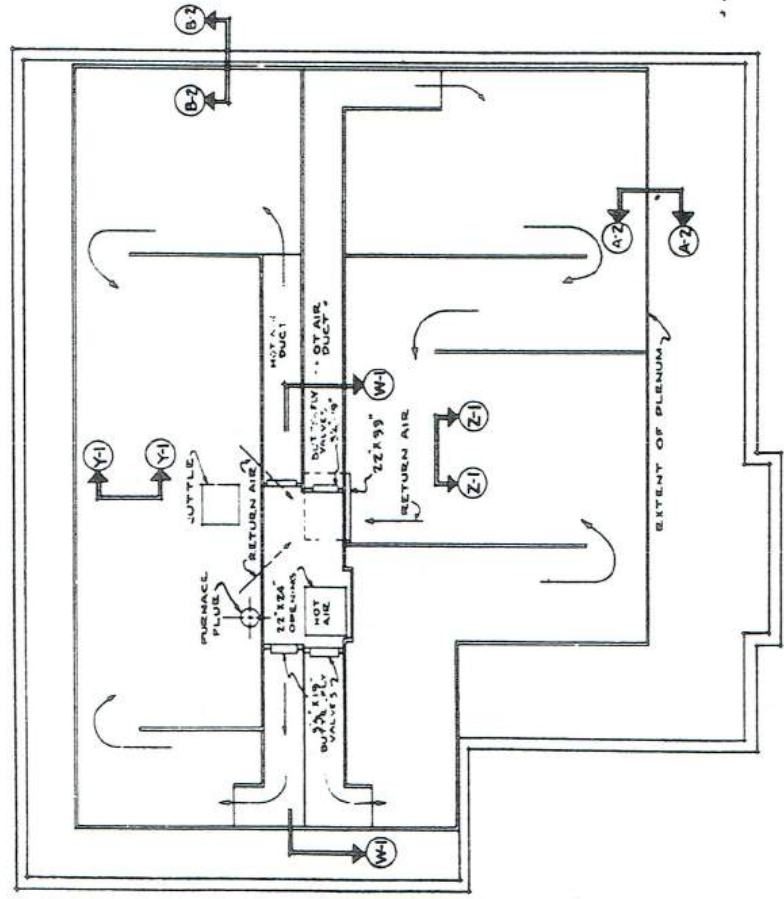
NOTE: SUPERSEDES AP2 DWGS. J-1, L-100.

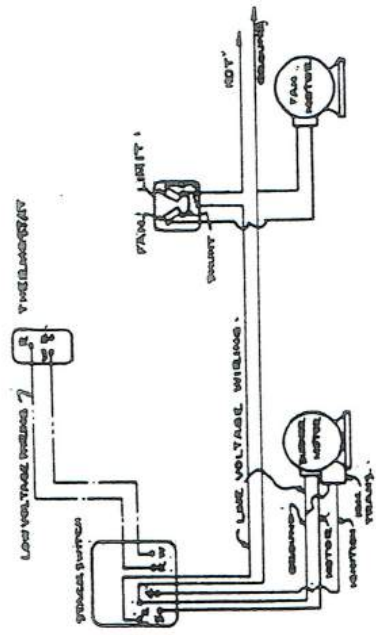
OIL BURNER CONTROL CIRCUIT - INTERMITTENT IGNITION (MELNIN SYSTEM)

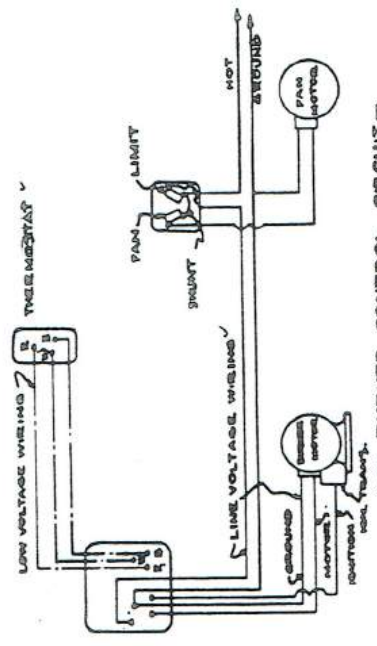
OIL BURNER CONTROL CIRCUIT - INTERMITTENT IGNITION (BIRNBAUMS - HONDEWELL SYSTEM)

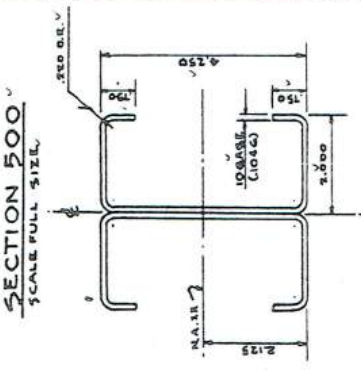
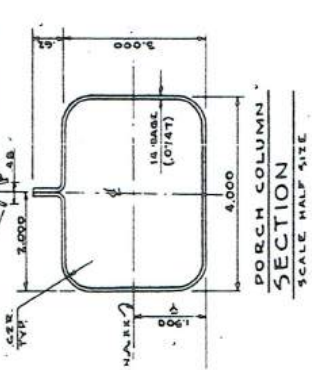
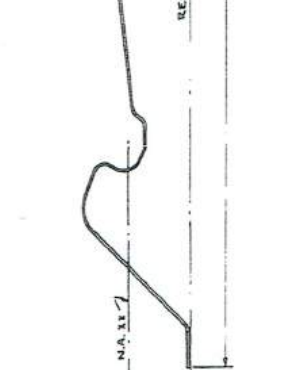
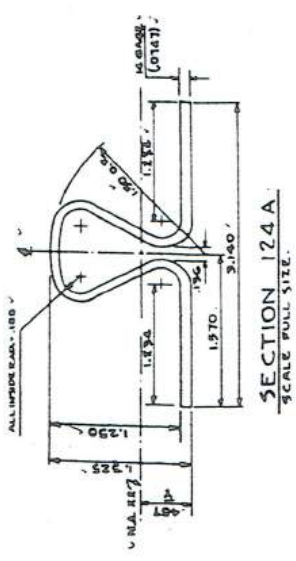
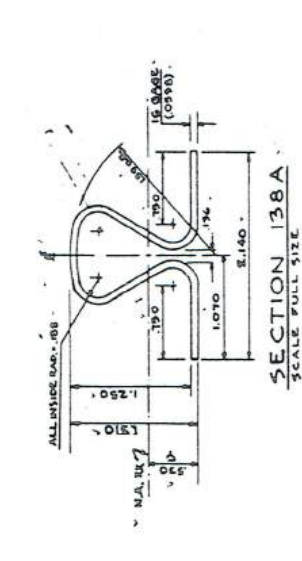
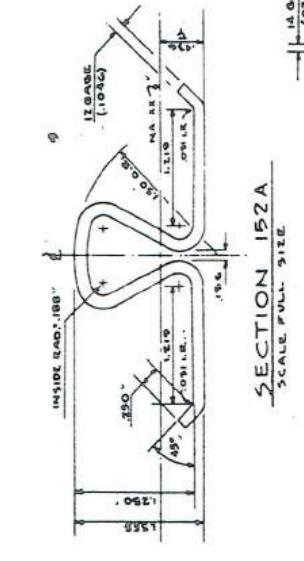
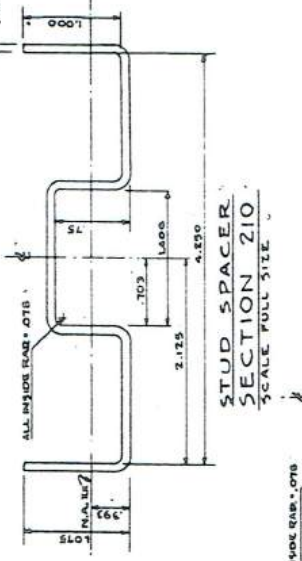
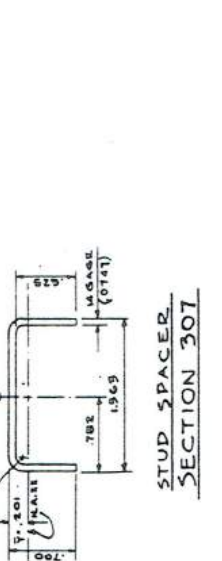
**LUSTRON**  
 CORPORATION  
 4200 E. FIFTH AVE., COLUMBUS 16, OHIO.  
 STRUCTURAL SECTIONS-  
 STANDARD  
 AP2-G-100  
 DRAWING NUMBER  
 REVISED  
 SCALE AS NOTED  
 APPR. AM.T. 8/26/08  
 CHD. N.J.B. 7/29/08  
 DR. O.D. 6/20/08  
 NOTE: SUPERSEDES AP2 DWGS. P.1; P.6; 0-1; 0-2; 0-3; 0-4; 0-5.

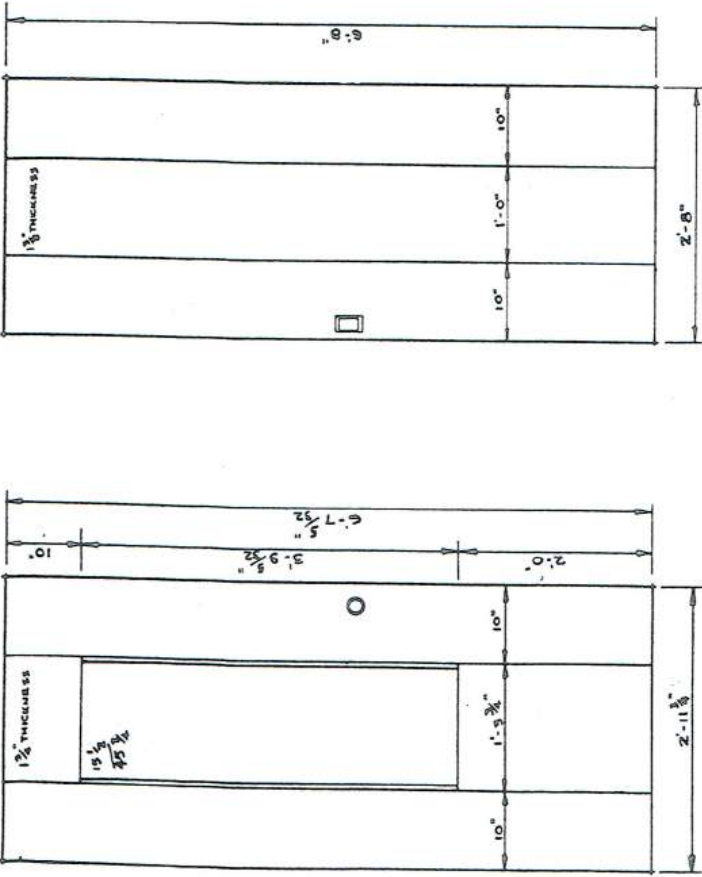
REVISIONS	DATE	BY	APPROVED
