## **MAINTENANCE AND REPAIR OF WOOD SHINGLES, CLAPBOARDS, AND OTHER WOOD SIDINGS**

## GUIDELINES FOR SHINGLES, CLAPBOARDS, AND OTHER SIDINGS

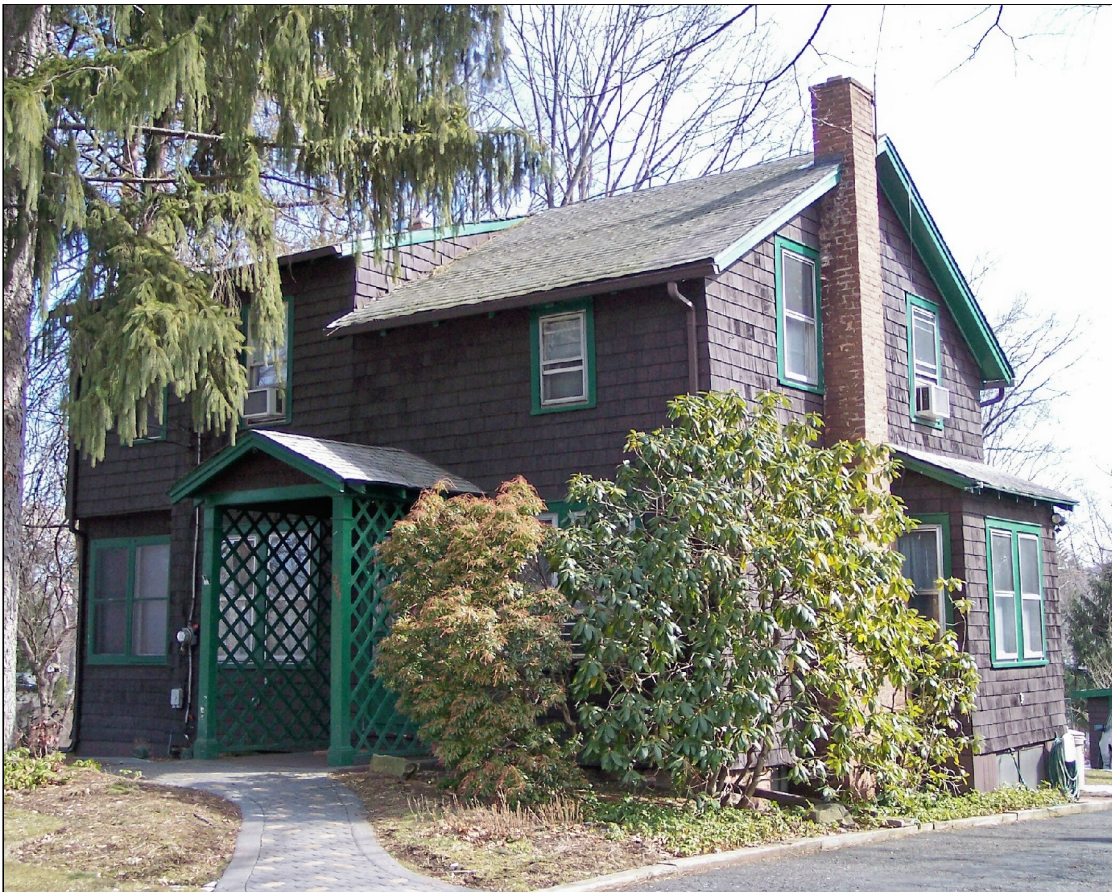
*The unpainted shingles of this house are a character-defining feature.*

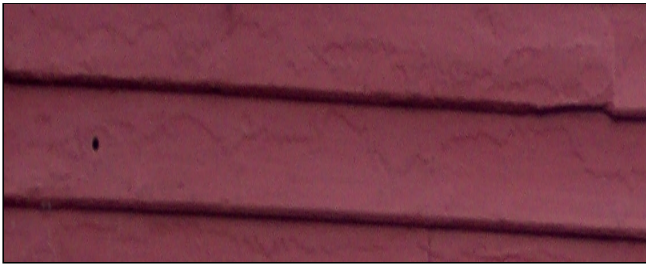
**Recommended:** Retain, maintain, and repair historic exterior cladding such as this wood clapboard.

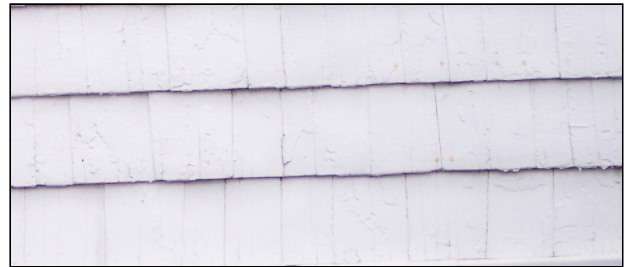
**Recommended:** Repaint previously painted historic exterior cladding such as these wood shingles.

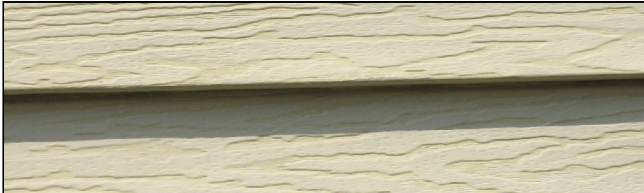
**Not Recommended:** Using synthetic siding with embossed wood graining.

- Sandblasting wood cladding.
- Removing, changing, or covering exterior materials that are important in defining the overall historic character of the building.
- Removing or encapsulating decorative features such as cornices, eaves, window trim, brackets, and porch posts and railings during installation of new cladding.
- Newly installing aluminum siding or synthetic stucco (Exterior Insulation and Finish Systems, E.I.F.S)
- Using vinyl siding that has embossed wood graining because this exaggerated graining is not a characteristic of real wood cladding.
